Building Information - Willoughby-Eastlake City SD (45104) - Willoughby-Eastlake Tech Centers A, B & C

Program Type	Expedited Local Partnership Program (ELPP)
Setting	Suburban
Assessment Name	Tech Center_2010_TCI
Assessment Date	2010-03-16
Cost Set:	2010
Building Name	Willoughby-Eastlake Tech Centers A, B & C
Building IRN	64634
Building Address	25 Public Square
Building City	Willoughby
Building Zipcode	44094
Building Phone	440/602-5090
Acreage	5.60
Current Grades	10-12
Teaching Stations	48
Number of Floors	3
Student Capacity	1125
Current Enrollment	214
Enrollment Date	2010-04-01
Enrollment Date is the date in which the current enrollment was taken.	
Number of Classrooms	45
Historical Register	NO
Building's Principal	Mr. Dave Palmer
Building Type	Joint Vocational

Building Construction Information - Willoughby-Eastlake City SD (45104) - Willoughby-Eastlake Tech Centers A, B & C (64634)

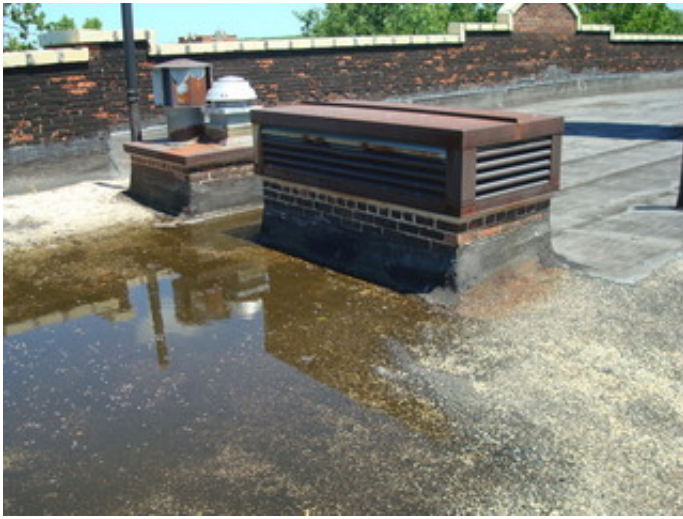
Standing water on Building A 1915 Original Construction

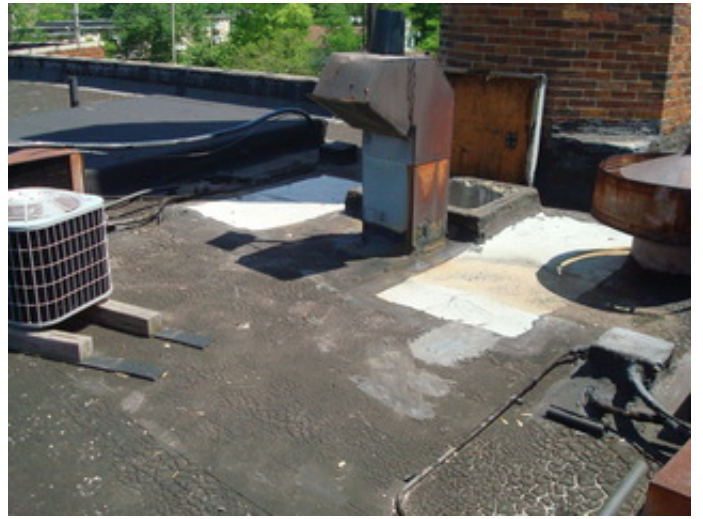
Built-up roof on Building B Original Construction

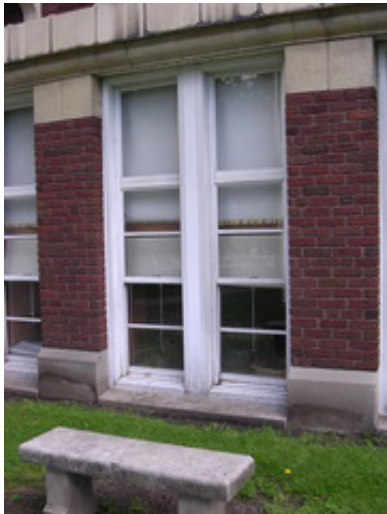
Typical aluminum windows Building "A."

Recommendations: Provide a new insulated window system with integral blinds to meet with Ohio School Design Manual requirements. Replace storefront window system in the overall facility.

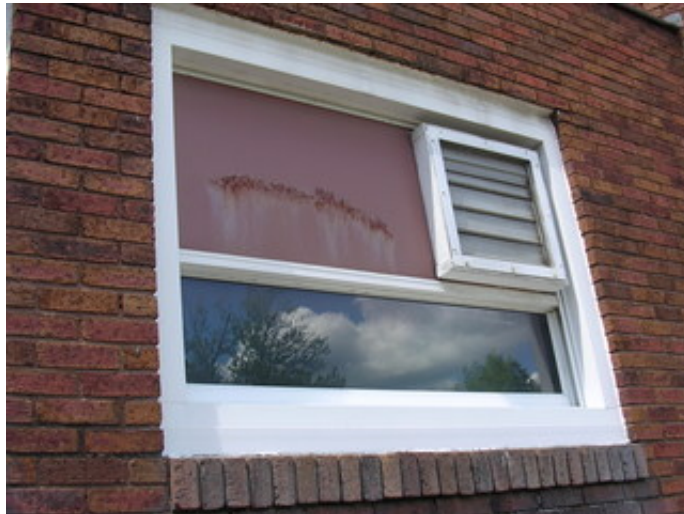
Typical aluminum windows Building "B."

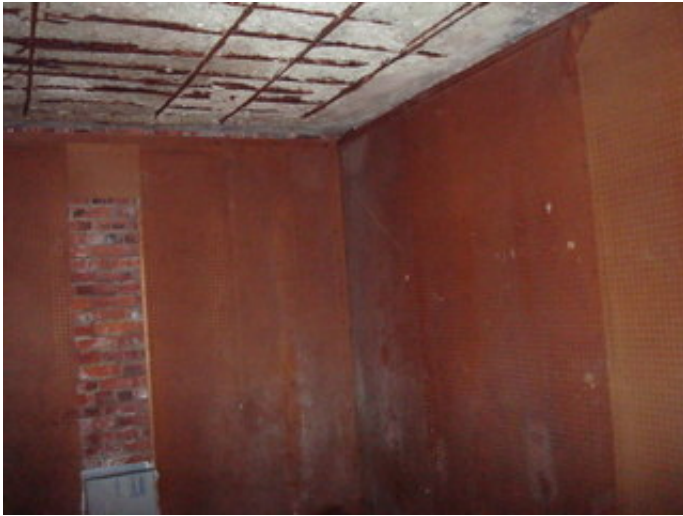
Basement wall in Building A

Recommendations: Replace entry stoop foundation and stairs at Building "B" Regrade along south-west edge of Building "C" to prevent future erosion at foundation. Repair gutter at north face of building to prevent continued erosion at foundation wall. See Item B for scope of work.

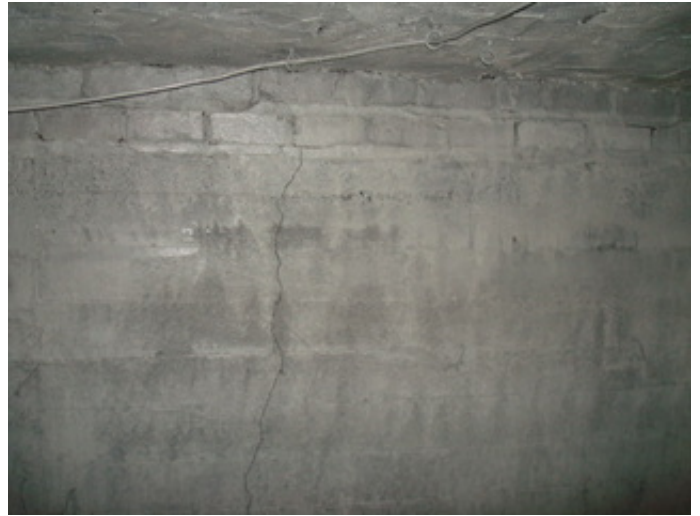
Crawl wall in Building B

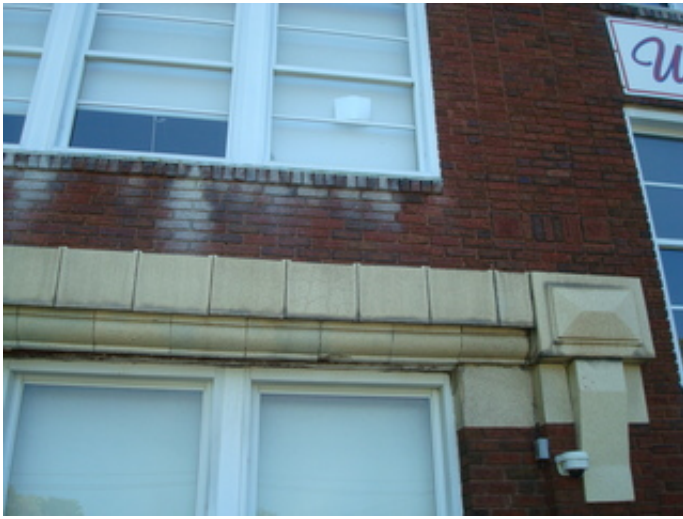
The roofs leak. Rusting lintels are expediting brick deterioration. Building C has a bee infestation causing damage to the wood gutter system. Stair towers in the 1924 Building B do not have proper doors or hardware. Egress from those spaces is not maintained in a trip-free manner.

Deteriorated lintel and accent block on 1915 Original Construction to Building A

Exterior Caulking:	\$5.50	in.ft.							57 Required		29 Required			66 Required	52 Required	\$1,122.00	(removing and replacing)
Replace Brick Veneer System:	\$35.00	sq.ft. (Qty)		72 Required		309 Required								50 Required		\$15,085.00	(total removal and replacement including pinning and shoring)
Lintel Replacement:	\$250.00	in.ft.		276 Required		178 Required			87 Required		87 Required			64 Required		\$173,000.00	(total removal and replacement including pinning and shoring)
Sill Replacement:	\$45.00	in.ft.		16 Required					23 Required		13 Required					\$2,340.00	(remove and replace)
Coping Replacement Stone and Masonry:	\$100.00	in.ft.		497 Required		561 Required			394 Required		424 Required					\$187,600.00	(remove and replace)
Install Control Joints	\$60.00	in.ft.							8 Required							\$480.00	
Other: Prep and Paint Steel Lintels	\$5.00	in.ft.		153 Required		18 Required			101 Required		126 Required					\$1,990.00	sand, prime, and paint lintels

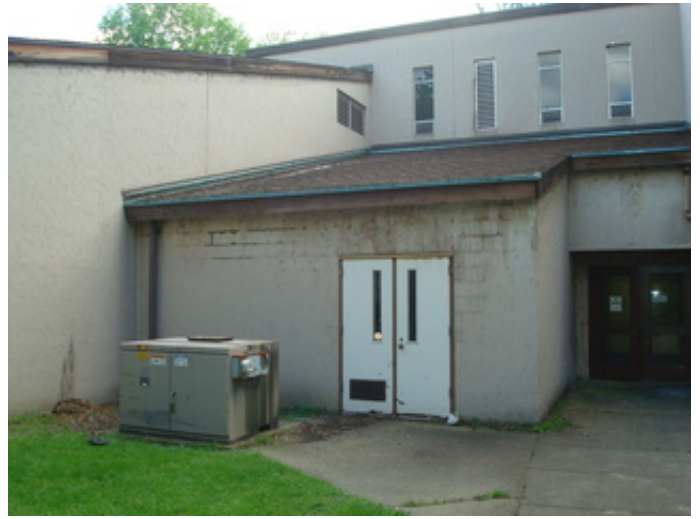
Deteriorated stucco on 1974 Original Construction Building C

Other: Repair existing stucco	\$15.00	sq.ft. (Qty)		445 Required					92 Required					24,086 Required		\$369,345.00	Clean and re-coat stucco
Sum:			\$911,642.00	\$173,830.00	\$0.00	\$180,945.00	\$0.00	\$0.00	\$92,263.50	\$0.00	\$79,982.00	\$0.00	\$0.00	\$379,403.00	\$5,218.50

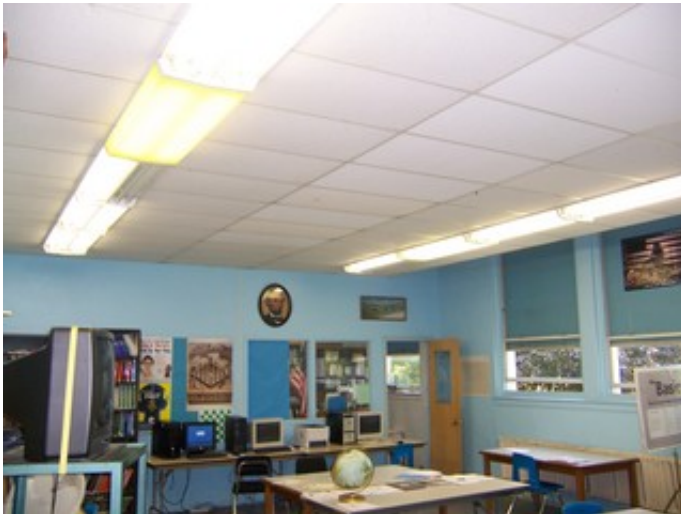
Classroom Lighting Site (B)

Provide complete replacement of lighting systems in all buildings due to condition, utilization of T12 fixtures and installation of fire protection system. Note: Recommendation made at assesment and lighting fixtures should be examined before replacement, as they were scheduled to be replaced prior to assesment.

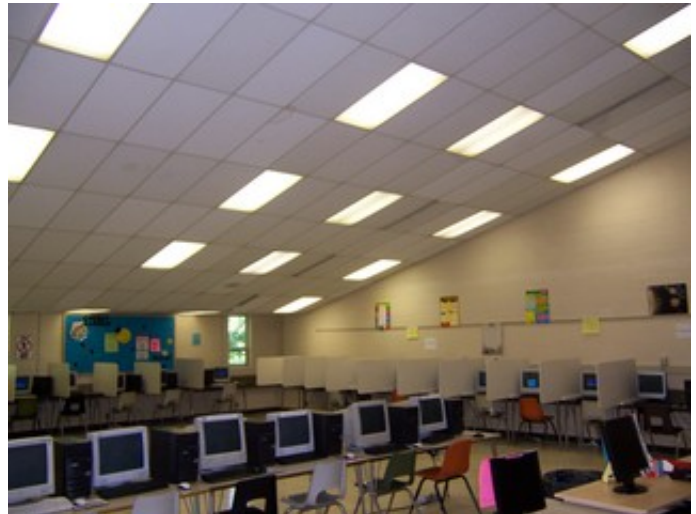
Computer Room Lighting Site (C)

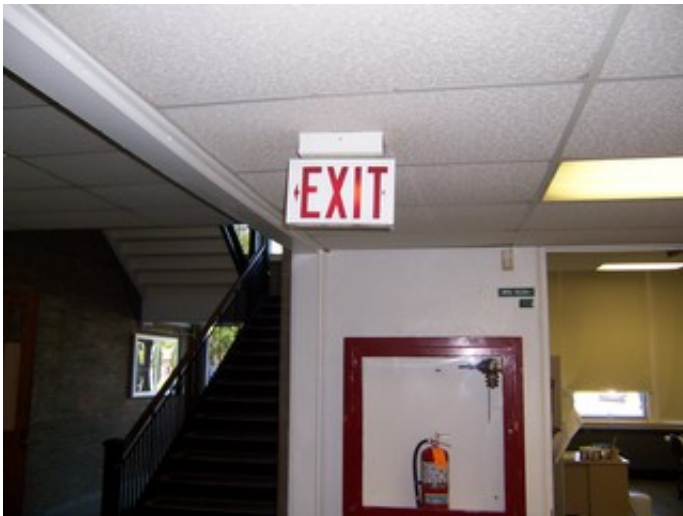
Ceiling Mounted Exit Sign

Recommendations: Provide complete replacement of emergency / egress lighting system in buildings 'A', 'B' and 'C' to meet Ohio School Design Manual guidelines.

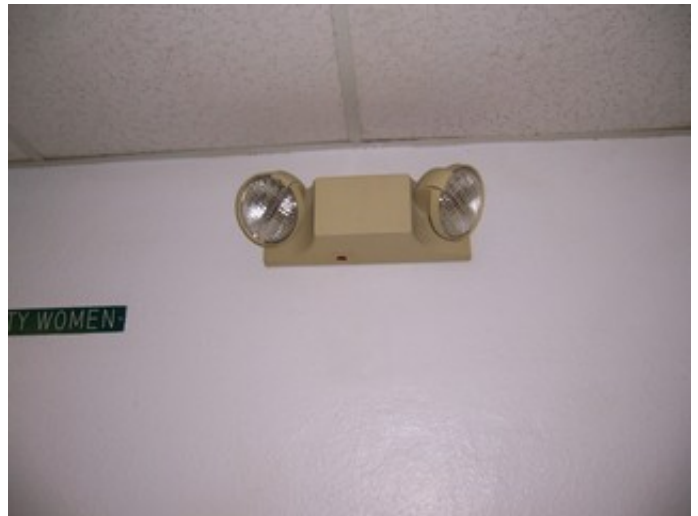
Wall Mounted Emergency Lighting

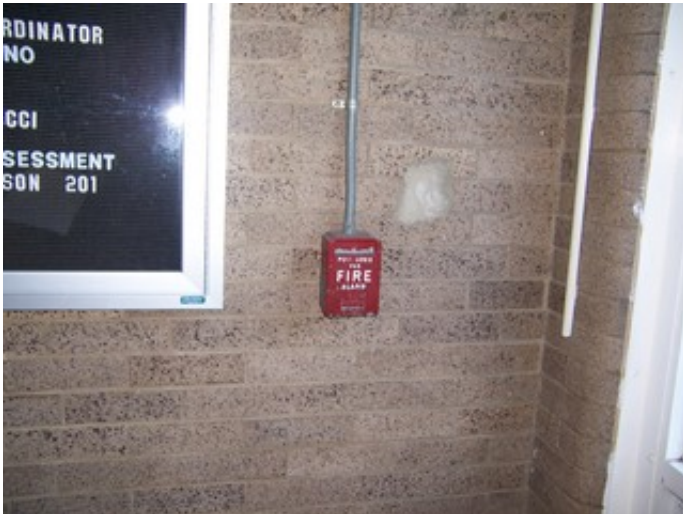
Fire Alarm Pull Device Site (A)

Recommendations: Provide complete replacement of fire alarm systems in buildings 'A', 'B' and 'C' to meet OBC, NFPA, and Ohio School Design Manual guidelines.

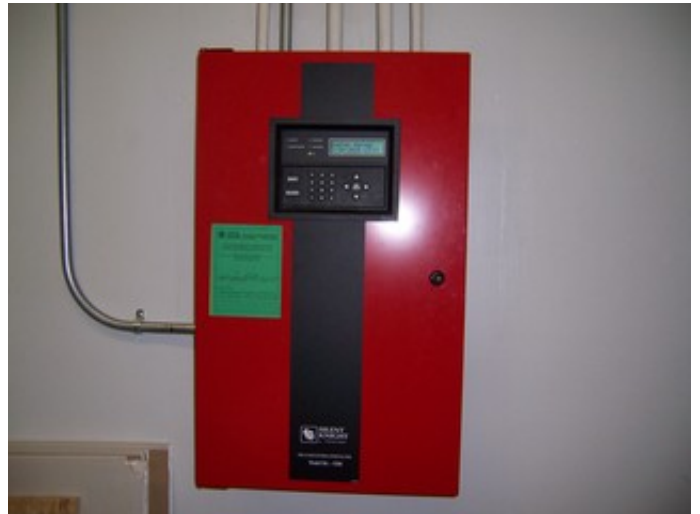
Fire Alarm Panel Site (B)

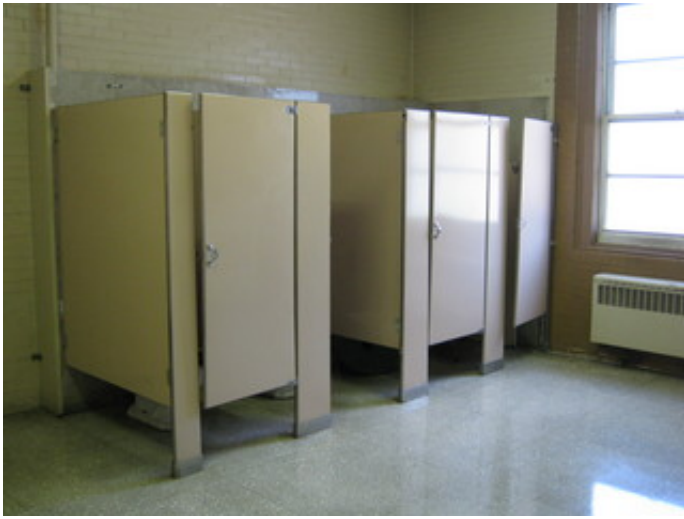
Typical non-compliant toilet partitions

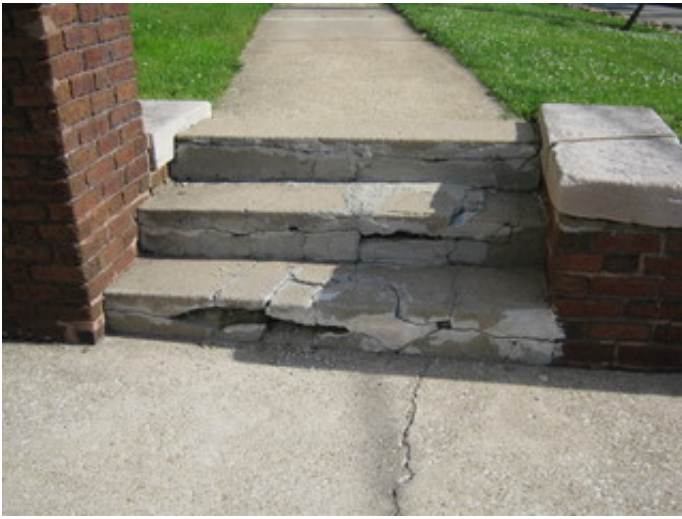
Deteriorated exterior steps

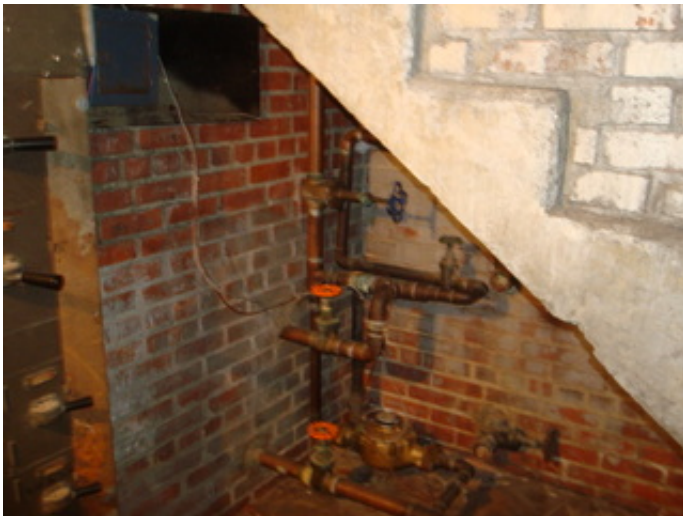
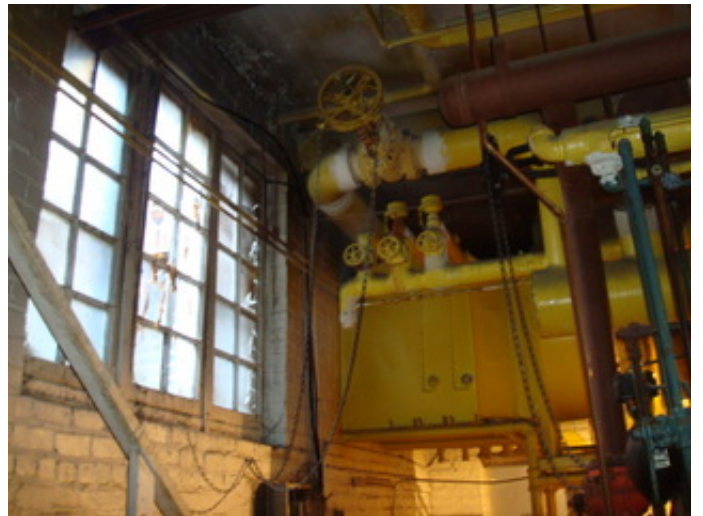
Piping

Recommendations: The facility is not equipped with an automated fire suppression system, and the existing water supply will not provide adequate support for a future system.

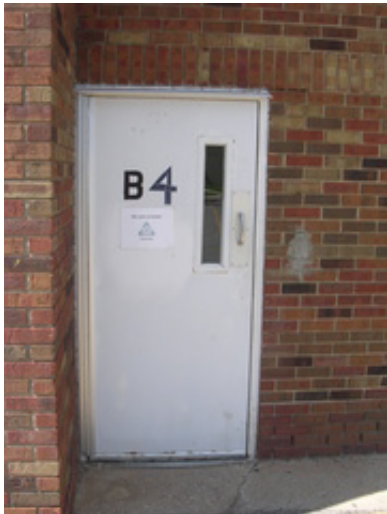
Typical hollow metal door.

Recommendations: Replace all exterior doors to comply with Ohio Building Code, ADA, and Ohio School Design Manual guidelines. Replace overhead doors in Building "A" and "C" due to poor condition. Sidelite replacement included in item F.

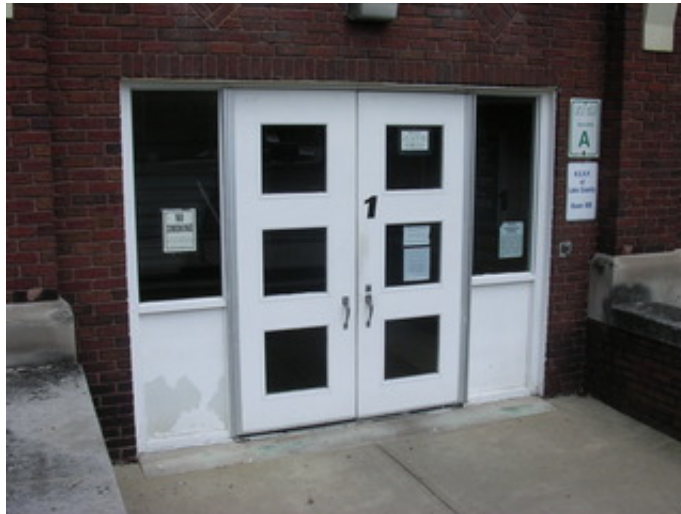
Typical aluminum door Building "A".

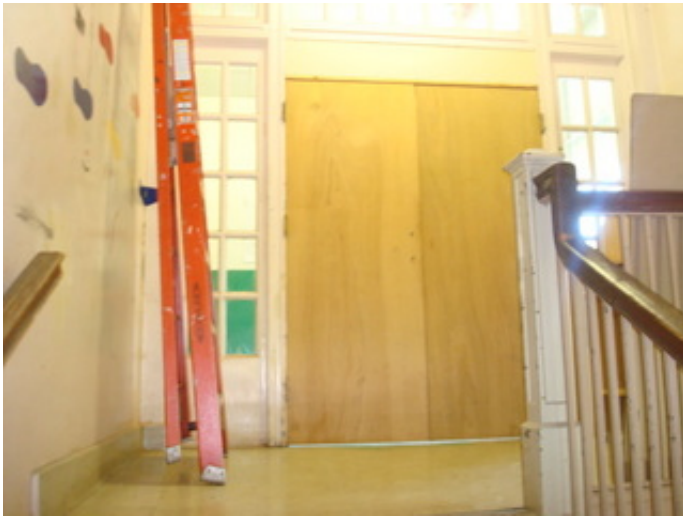
Non compliant door and handrails

Handrails:	\$5,000.00	per level		9 Required					3 Required						2 Required	\$70,000.00	
Other: Guardrail	\$7,500.00	per level							1 Required					8 Required	1 Required	\$75,000.00	Provide OBC compliant guardrail
Other: Second egress door	\$3,000.00	each							2 Required					1 Required		\$9,000.00	Provide second means of egress from room with more than 50 occupants
Sum:				\$730,602.25	\$173,976.75	\$33,939.75	\$81,714.25	\$5,456.75	\$24,280.75	\$84,970.00	\$21,209.50	\$25,645.75	\$2,336.75	\$13,435.50	\$231,557.00	\$32,079.50

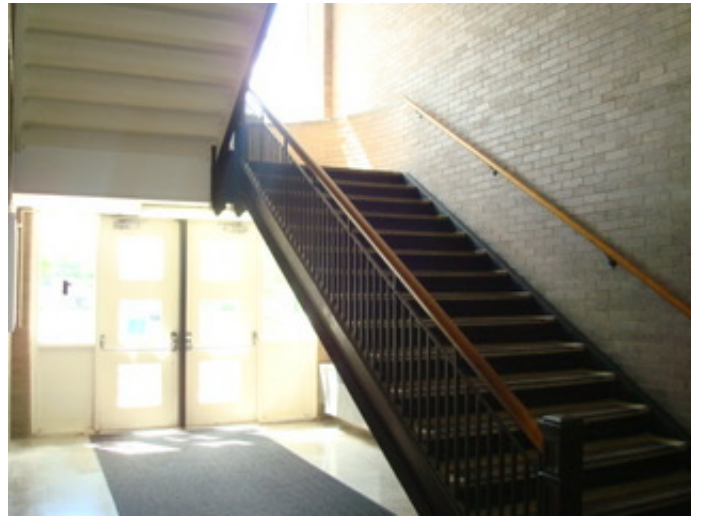
Non complaint stair and handrails
