Building Information - Willoughby-Eastlake City SD (45104) - South High School

Program Type	Expedited Local Partnership Program (ELPP)
Setting	Suburban
Assessment Name	South H_2010_TCI
Assessment Date	2010-03-16
Cost Set:	2010
Building Name	South High School
Building IRN	35089
Building Address	5000 Shankland Rd
Building City	Willoughby
Building Zipcode	44094
Building Phone	440/975-3628
Acreage	47.03
Current Grades	9-12
Teaching Stations	53
Number of Floors	2
Student Capacity	1250
Current Enrollment	1413
Enrollment Date	2010-04-01
Enrollment Date is the date in which the current enrollment was taken.	
Number of Classrooms	50
Historical Register	NO
Building's Principal	Mr. Paul Lombardo
Building Type	High

Building Construction Information - Willoughby-Eastlake City SD (45104) - South High School (35089)

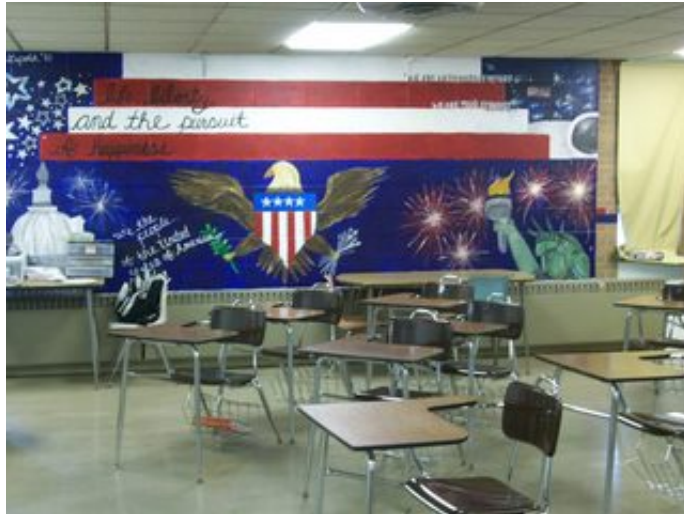
Baseboard Heating Panel

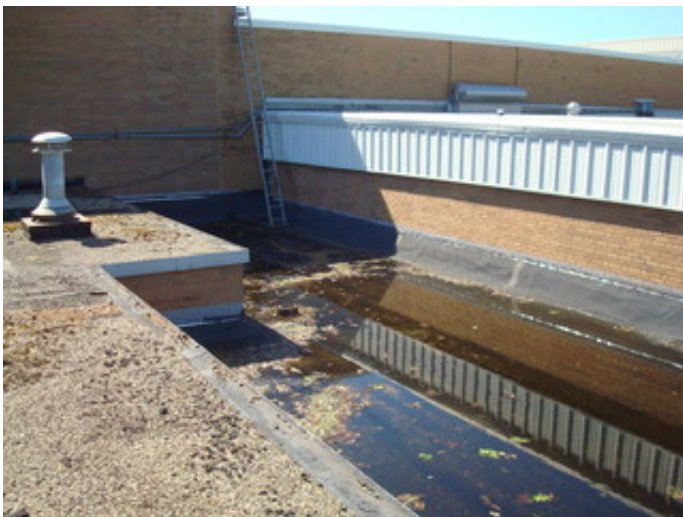
Description: The roof over the 1958 Original is a built-up roofing system that is presumed to have been installed in 1958 and is in poor condition. The roof over the 1961 Addition is standing seam metal roofing retrofit installed in 1991 and is in fair condition. The roof over the 1967 Addition is standing seam metal roofing retrofit installed in 1991 and is in fair condition, although some areas leak and are in poor condition. Part of the roof over the 1967 Addition to the gymnasium area and over the vocational area is a built-up roof presumed installed in 1967 and is in poor condition. There are District reports of extensive current leaking in the vocational area of 1967 Addition, along the entire east wall of the 1958 Original Construction, near the lobby of the auditorium in the 1961 Addition, near the southeast door of the 1967 Addition, and over the entrance in the 1958 Original Construction near the cafeteria. Signs of past leaking were observed during the physical assessment. Access to the roof was gained by access hatch that is in poor condition, and by an aluminum ladder that is in poor condition. Fall safety protection cages are required. There were observations of standing water on the roof. Metal cap flashings are in poor condition on the built-up areas of the roof, and in fair condition on the standing seam metal areas of the roof. Roof storm drainage is addressed through a system of gutters and downspouts on the standing seam metal areas of the roof which are properly located and are in poor condition, with insufficient downspouts provided. Roof storm drainage is addressed through a system of roof drains which are properly located, and in poor condition. The roof is not equipped with overflow roof drains though they are needed in the built-up areas of roof. Roof penetration conditions were consistent with the condition of the roofing material. There are not any covered walkways attached to this structure.

Rating: 3 Needs Replacement

Ponding on 1958 Original Construction and roof ladder

Recommendations: Replace built-up roof areas to meet Ohio School Design Manual guidelines for age of system and due to condition. Repair part of the standing seam metal roof due to condition. Provide tapered insulation with re-roofing for thermal purposes and positive slope to drain. Replace flashing and coping due to condition. Replace gutters and downspouts due to condition. Replace roof drains and install overflow drains. Replace roof hatch in poor condition and provide access ladder with cage.

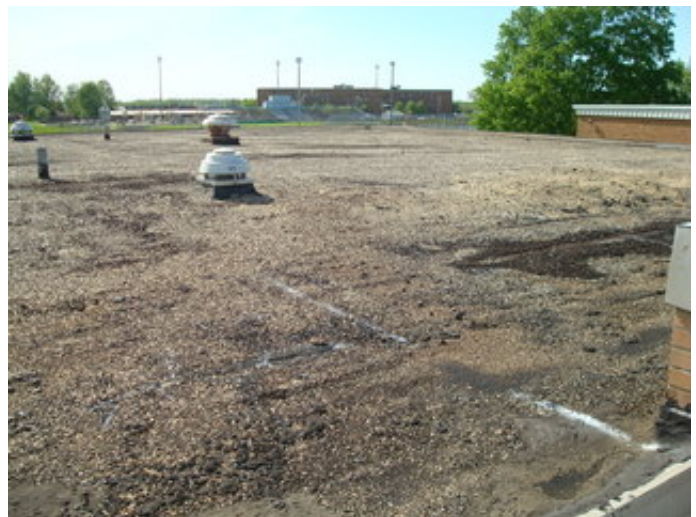
Built-up roofing over vocational area in 1967 Addition

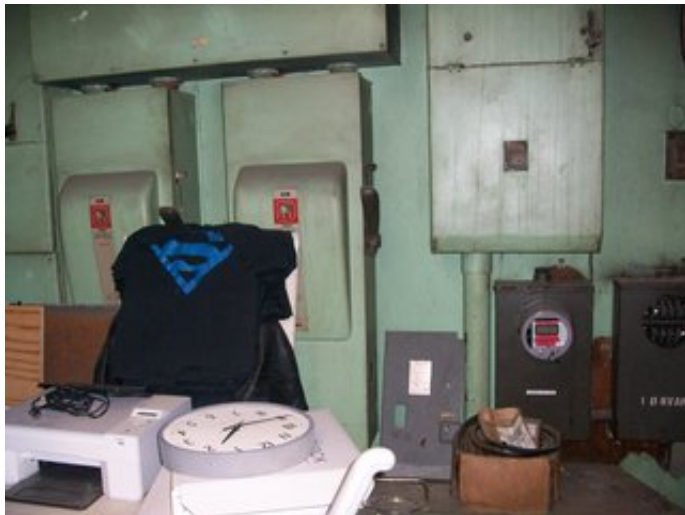
Description: The electrical system provided to the overall facility; is based on a four (4) - switch service including two (2) 800 amp 120/240 volt, 1 phase, 3 wire switches, one (1) 800 amp 120/208 volt 3 phase 4 wire switch and one (1) 400 amp 240 volt 3 phase 3 wire switch. The original electrical system from the year 1958 is older but in operating condition. The later electrical systems added under a later building additions in 1961 and 1967 is in fair to poor condition. Power is provided to the school by transformers within a vault room located near the rear of the school. The main distribution panels cannot be expanded to add additional capacity that would be required by the OSDM total air conditioning requirements. The Classrooms are not equipped with adequate electrical outlets in some of the original areas per OSFC recommendations. The typical Classroom contains usually 2 to 3 general purpose outlets with certain classrooms having added outlets used for Classroom computers, and television. There are some spaces that have no electrical outlets such as storage areas and Janitor Closets. Some Corridors are not equipped with adequate electrical outlets for electrical servicing. Adequate GFI protected exterior outlets are not provided around the perimeter of the building. The facility is not equipped with an emergency generator. There is a 100 amp disconnect switch which feeds the Fire Alarm panel. Adequate building lightning protection safeguards are not provided. The overall electrical system does not meet Ohio School Design Manual requirements, and will be inadequate to meet the facility's future needs.

Rating: 3 Needs Replacement

Typical Main Disconnect Switches

Recommendations: The entire electrical systems requires replacement to meet Ohio School Design Manual guidelines and the Ohio Building Code for overall capacity due to lack of OSDM - required features and to accommodate the addition of air conditioning through-out the entire facility.

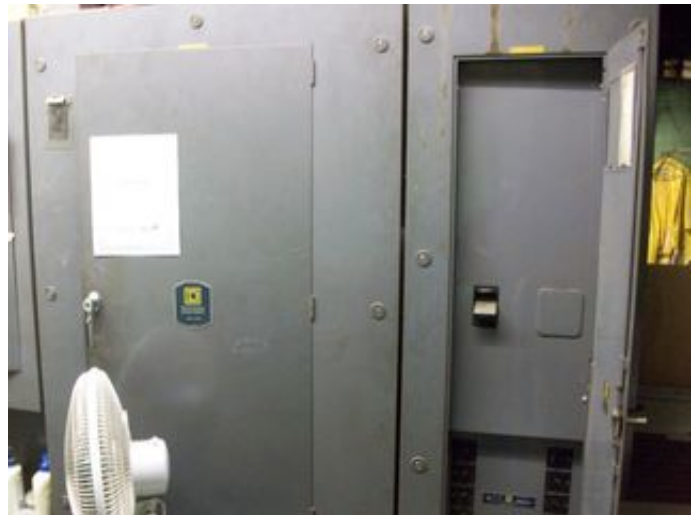
Main Distribution Panelboard

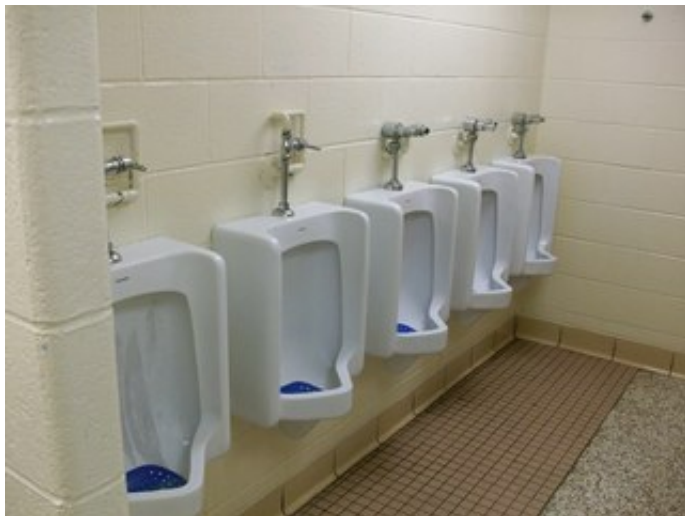
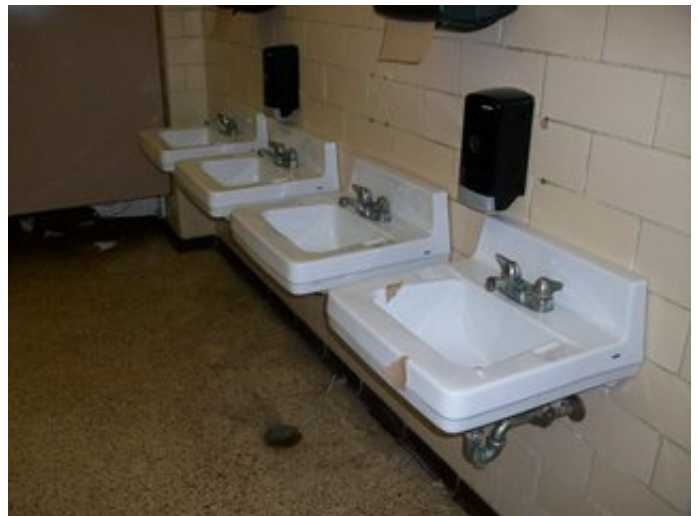
Rating: 3 Needs Replacement

Toilet room fixtures

Recommendations: Provide additional new fixtures to replace existing fixtures because they are not the new low flow type and do not meet ADA requirements. Replace grease interceptor as part of plumbing replacement.

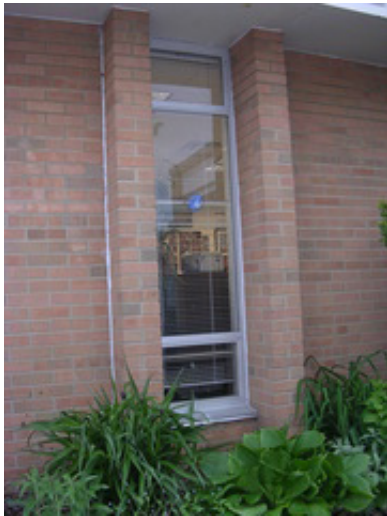
Description: The overall facility is equipped with non-thermally broken aluminum frame windows with single glazed non-insulated glazing type window system, which was installed at the time of construction and are in poor condition. Window system seals are in poor condition, with district reports of air and water infiltration being experienced. Window system hardware is in poor condition. The window system features surface mounted blinds, which are in moderate condition. The window system is not equipped with insect screens on operable windows. Hollow metal frame and aluminum storefront window systems with tempered and non-tempered single glazing, and porcelain and metal panels are found in the overall facility and are in poor condition. This facility does not feature any glass block windows. The school does not contain skylights. Window security grilles are not provided for ground floor windows. There is not a Greenhouse associated with this school.

Rating: 3 Needs Replacement

Typical aluminum window.

Recommendations: Provide a new insulated window system with integral blinds to meet with Ohio School Design Manual requirements. Replace storefront window system in the overall facility due to condition to meet with Ohio School Design Manual requirements.

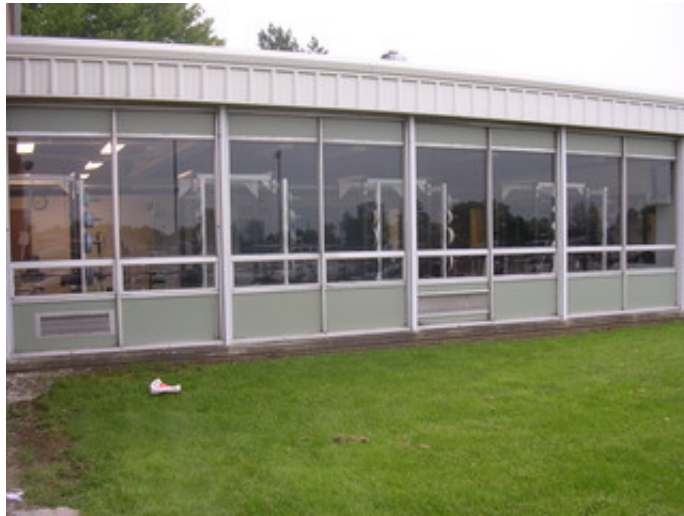
Typical aluminum storefront system.

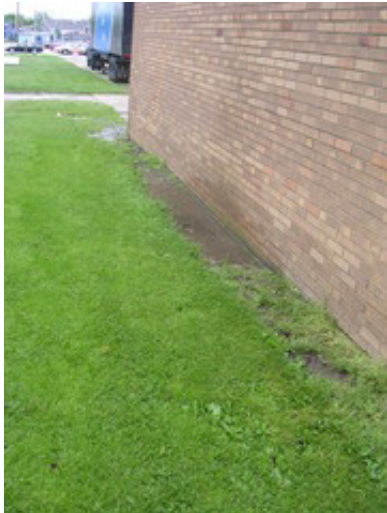
Description: The 1958 Original Facility and the 1967 Addition are equipped with concrete trench type foundation wall footings. The 1961 addition is equipped with concrete grade beams on concrete piers, which displayed no locations of significant differential settlement, cracking, or leaking, and are in fair condition. The District reports that there has been no past leaking. Grading and site drainage deficiencies were noted around the perimeter of the structure that could contribute to foundation / wall structural deterioration. The perimeter underground rainwater collection tiles on the 1961 and 1967 additions on the north and west sides of the building and courtyard are clogged and backing up on grade. The gutters are also overflowing at these areas.

Rating: 2 Needs Repair

Poor grading at foundation.

Recommendations: Provide drainage tile system at the 1961 and 1967 additions on the north and west sides of the building and courtyard to facilitate proper drainage. The site requires re-grading to allow for proper drainage.

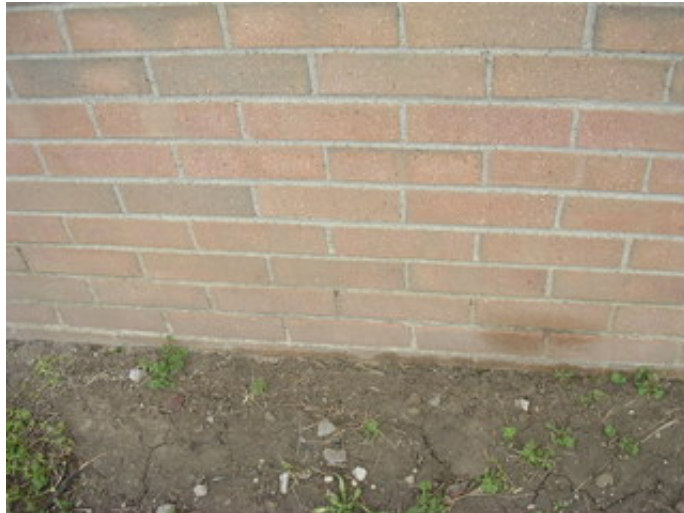
Typical foundation condition.

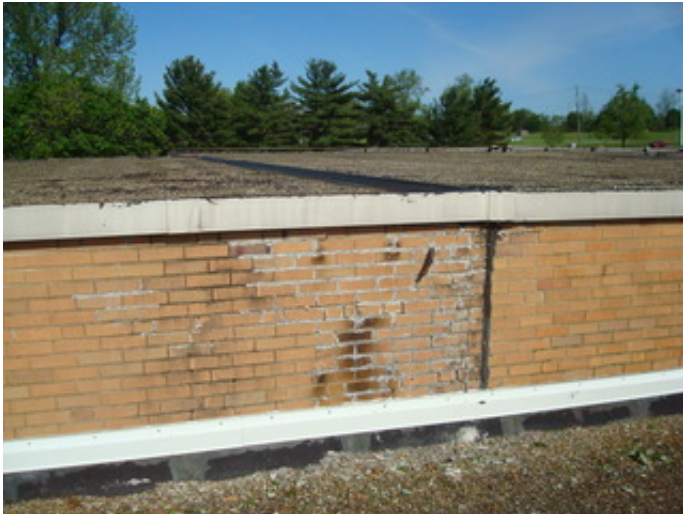
Description: The overall facility has a brick veneer on a masonry bearing wall system and steel frame with brick veneer and curtain wall system which displayed locations of deterioration, and is in fair condition. The exterior masonry appears to have appropriately spaced and adequately caulked control joints in fair to poor condition. Control joints are not provided at lintel locations at doors and windows. The school has sufficient expansion joints, and they are in poor condition in the 1958 Original Construction as evidence of leaking was observed. The exterior masonry has not been cleaned and sealed in recent years, and shows evidence of mortar deterioration throughout the 1961 Addition, along walkways and at the gymnasium area. Interior walls are concrete masonry units and glazed block and are in fair condition. Interior masonry appears to have adequately spaced and caulked control joints in fair condition. Soffits are in poor condition and replacement is recommended in item I. The window sills are an element of the aluminum window system, and are in poor condition. The exterior lintels are steel, and are rusting. Chimneys are in fair condition however mortar deterioration was observed. Canopies over entrances are built-up roof and metal soffit type construction, and are in poor condition.

Rating: 2 Needs Repair

Water-damaged wall area at expansion joint at 1958 Original Construction

Recommendations: Provide tuckpointing in all areas of mortar deterioration as required through the overall facility. Provide masonry cleaning, sealing & caulking as required through the overall facility. Sawcut and caulk new appropriately spaced control joints in existing masonry in the 1967 Addition. Recaulk existing control joints as required through the overall facility. Replace masonry lintels as required through the overall facility.

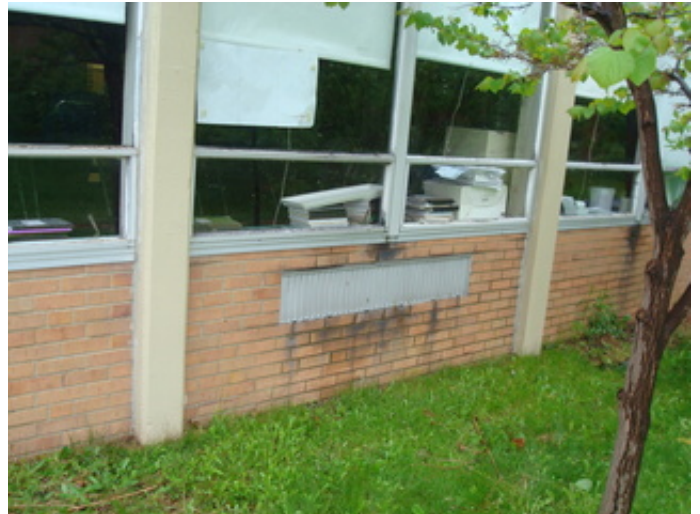
Deteriorated lower lintel at 1958 Original Construction

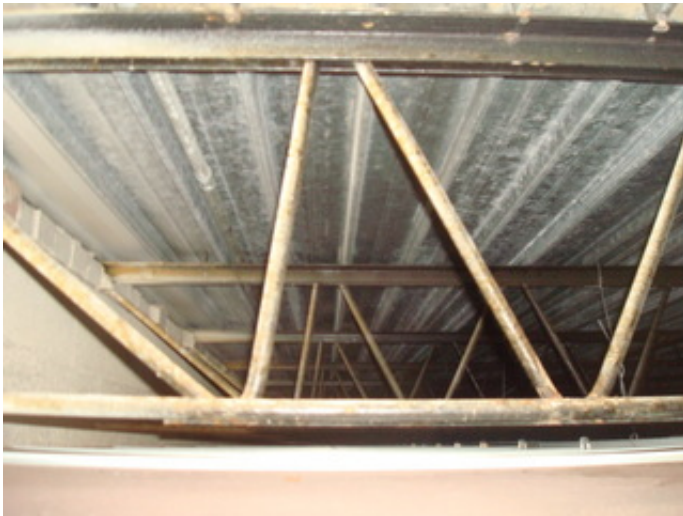
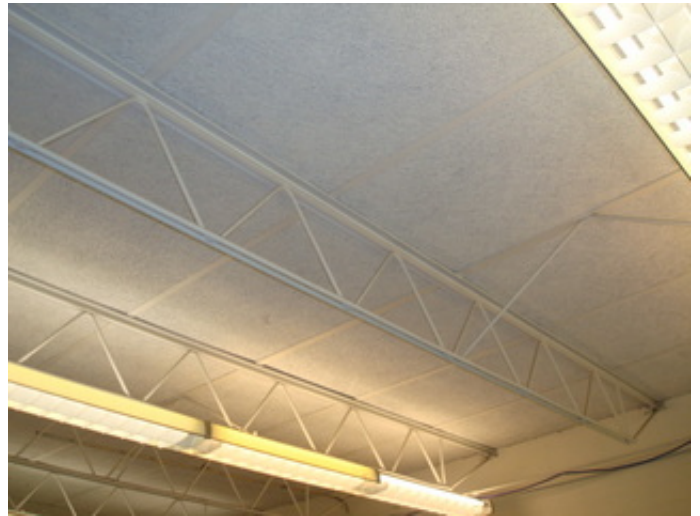
Description: The floor construction of the base floor of the overall facility is concrete slab on grade type construction, and is in fair condition. There is no crawl space. The floor construction of the second floor and mezzanines of the 1967 Addition is cast-in-place concrete on steel frame construction, and is in fair condition. Ceiling to structural deck spaces are insufficient in all areas to accommodate HVAC, electrical, and plumbing scopes of work in required renovations. The ceilings throughout the overall facility are scheduled for removal for the addition of a sprinkler/fire suppression system per Item U. The roof construction of the overall facility is metal deck on steel joists with areas of cast-in-place concrete on steel frame construction, and is in fair condition. The 1967 addition also features metal deck with lightweight concrete fill on steel joists. Some soffits are in poor condition.

Rating: 2 Needs Repair

Roof structure

Roof structure exposed in classrooms

Recommendations: Refer to Item J for pricing of reconfiguring ceilings. Replace soffits that are in poor condition as required.

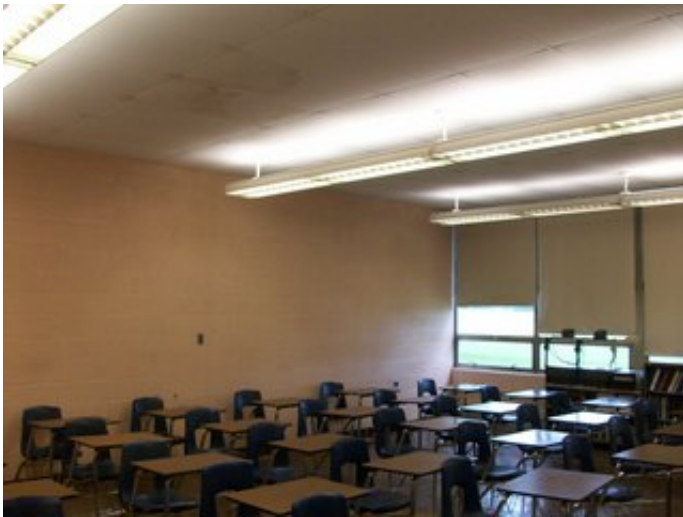
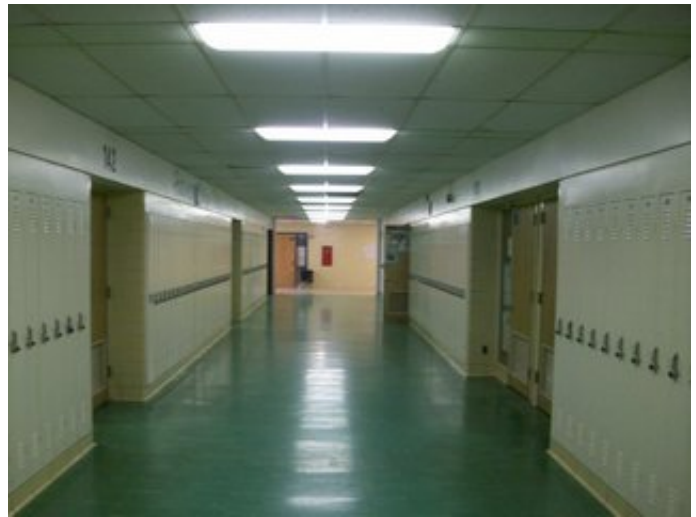
Description: The typical Classrooms of the original facility are equipped with T-12 1'X4' pendant mounted style fluorescent fixtures with single level switching. Some of the additions to the school have semi-recessed 2' X 4' fluorescent fixtures. Some of these Classrooms provide 60 to 70 footcandles while others only provide 50 to 60 footcandles of light which is adequate for the recommended 50 FC. The typical Corridors in the overall facility are equipped with T-12, 2'X4' recessed mounted fluorescent fixtures with single level switching. Corridor fixtures are in fair condition, providing an average illumination of 20 to 30 FC; complying with the 20 FC recommended by the OSDM. The Multi Purpose / Cafeteria area / Gymnasium is equipped with pendant mounted mercury vapor type lighting in fair condition, providing an average illumination of 50 to 60 FC; complying with the 50 FC recommended by the OSDM. The Library is equipped with T-12, 1'X4' semi-recessed mounted fluorescent type lighting in fair condition, providing an average illumination of 50 to 55 FC; complying with the 50 FC recommended by the OSDM. The Kitchen space is equipped with T-12 1'X4' surface mounted fluorescent type lighting fixtures with single level switching. Kitchen fixtures are in fair condition, providing an average illumination of 55 to 60 FC, which is less than the 75-80 FC recommended by the OSDM. The Service Areas in the overall facility are equipped with pendant or surface mounted T-12 surface mounted fluorescent type lighting and occasionally surface mounted incandescent fixtures in poor condition. The typical Administrative spaces in the overall facility are equipped with 2'X4' semi-recessed fluorescent fixtures and 1'X4' surface mounted T-12 wrap-around fluorescent type lighting in fair condition, providing adequate illumination based on OSDM requirements. The overall lighting systems of the facility are not compliant with Ohio School Design Manual requirements.

Rating: 3 Needs Replacement

Typical Classroom Lighting

Hallway Lighting

Recommendations: Provide complete replacement of lighting system due to age, of lighting fixtures and installation of a fire protection system.

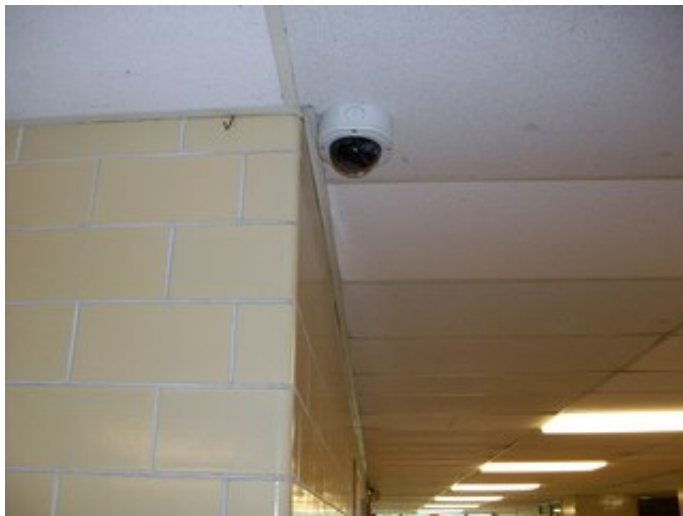
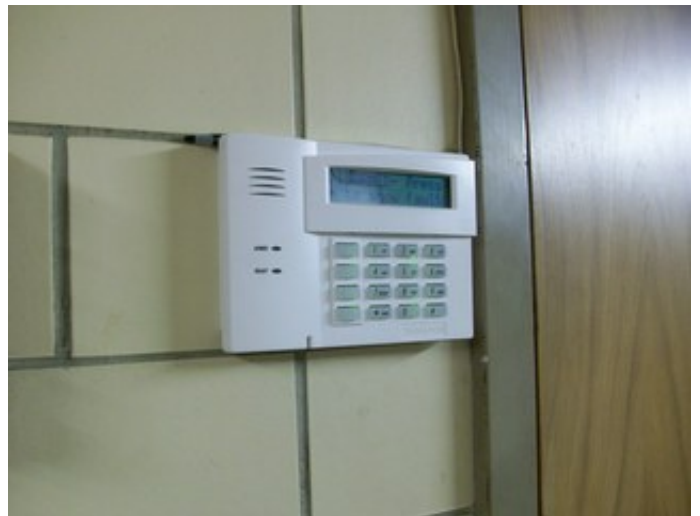
Description: The overall facility contains a security system including head-end equipment, cameras and security buzzer at main entry. The security system is not adequately provided throughout, and is not fully compliant with Ohio School Design Manual guidelines regarding security lighting throughout the site. The exterior building lighting system is equipped with incandescent semi-recessed mounted lights and mercury vapor floodlights lights; all in fair condition. Parking and bus pick-up / drop off areas are illuminated with pole mounted par 38 floodlight fixtures in fair condition. The exterior site lighting system provides inadequate coverage per the OSDM guidelines.

Rating: 3 Needs Replacement

Ceiling Mounted Security Camera

Wall Mounted Security Panel

Recommendations: Provide complete replacement of security system to meet Ohio School Design Manual guidelines. Provide complete replacement of exterior site lighting system to meet Ohio School Design Manual guidelines.

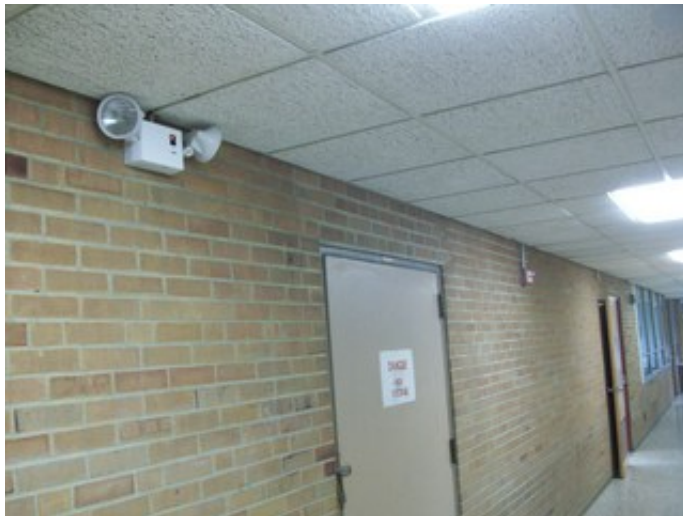
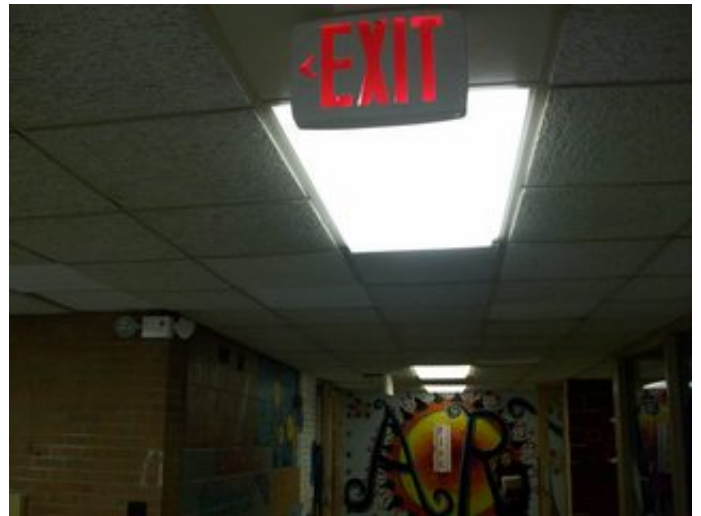
Description: The overall facility is equipped with an emergency egress lighting system consisting of exit lighting fed from the emergency panel. There are some stand alone emergency floodlight units in several areas of the entire facility. The exterior egress doors have semi-recessed incandescent type lights or incandescent wall mounted fixtures, but are not provided with emergency lighting heads. Most of the system is in fair condition. The emergency egress lighting units that are provided with appropriate battery backup but, no written battery replacement schedule was available. The system is not adequately provided throughout, and does not meet Ohio School Design Manual and Ohio Building Code requirements in all cases.

Rating: 3 Needs Replacement

Wall Mounted Emergency Lighting

Ceiling Mounted Exit Sign

Recommendations: Provide complete replacement of the emergency / egress lighting system throughout to meet the Ohio School Design Manual guidelines.

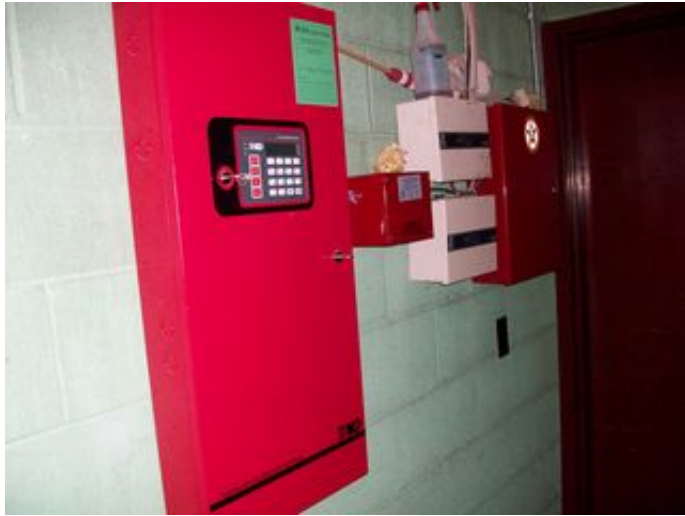
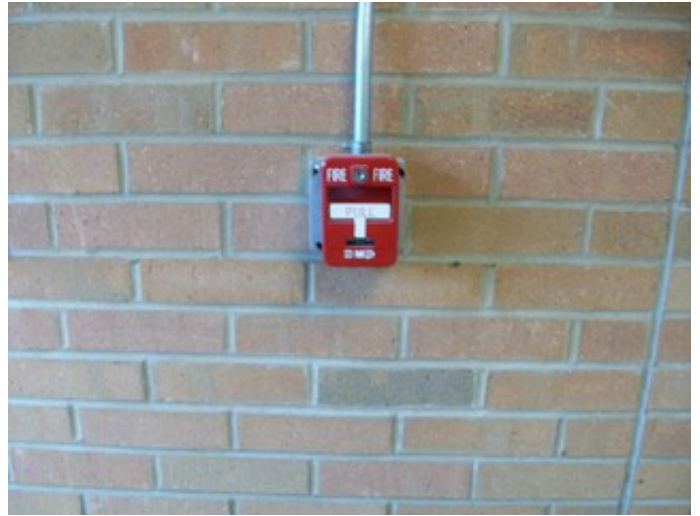
Rating: 3 Needs Replacement

Fire Alarm Panel

Fire Alarm Pull Station

Recommendations: Recommend providing a complete new Fire Alarm System to meet the Ohio School Design Manual and the Ohio Building Code.

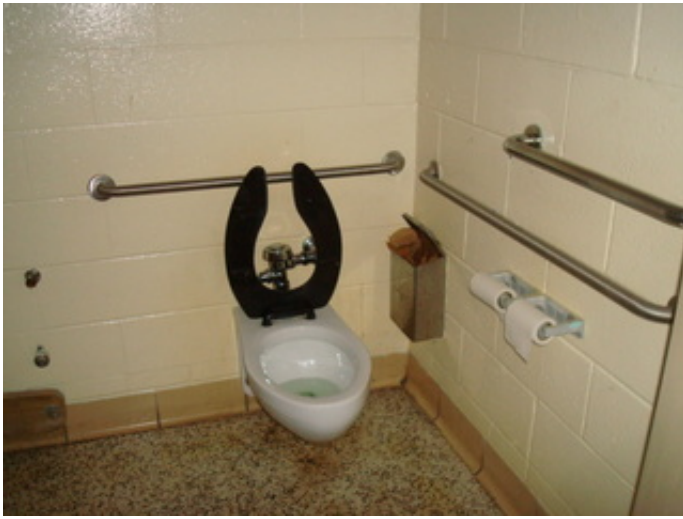
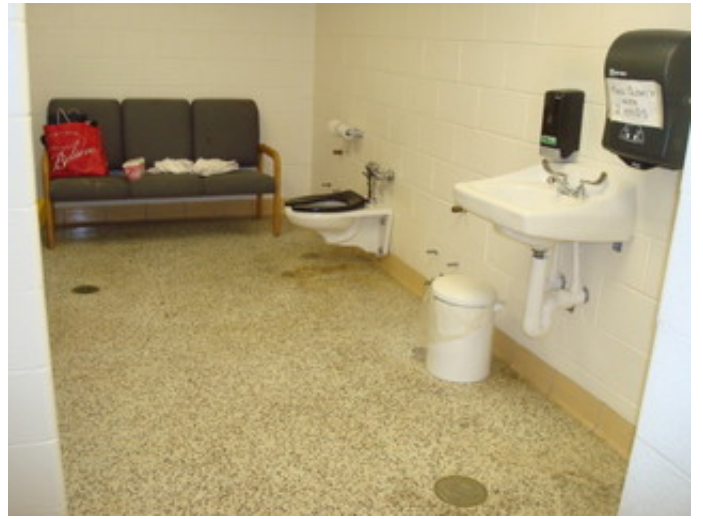
Rating: 3 Needs Replacement

Accessible toilet

Special Education toilet room

Recommendations: Provide ADA compliant signage. Provide power assist door opener at main entry. Provide chair lift. Provide elevators to auxiliary Gymnasiums. Provide new toilet partitions and accessories. Replacement of fixtures covered in item D. Parking issues are corrected in Item P. Replace doors in poor condition as noted in Item J. Rework wall openings for narrow doors.

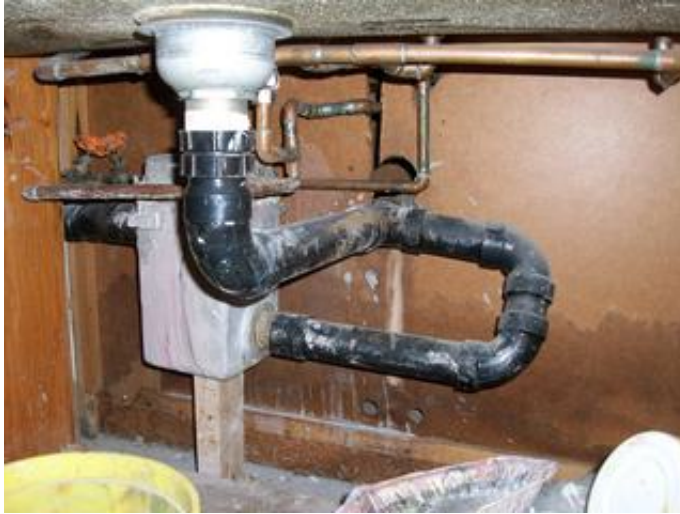
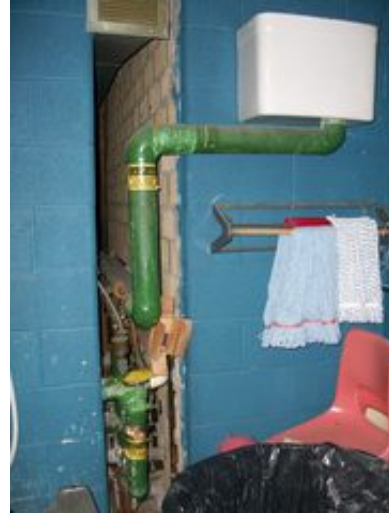
Rating: 3 Needs Replacement

Sanitary piping below sink

Sanitary drainage Piping in chase

Recommendations: Replace existing system due to age of pipe.

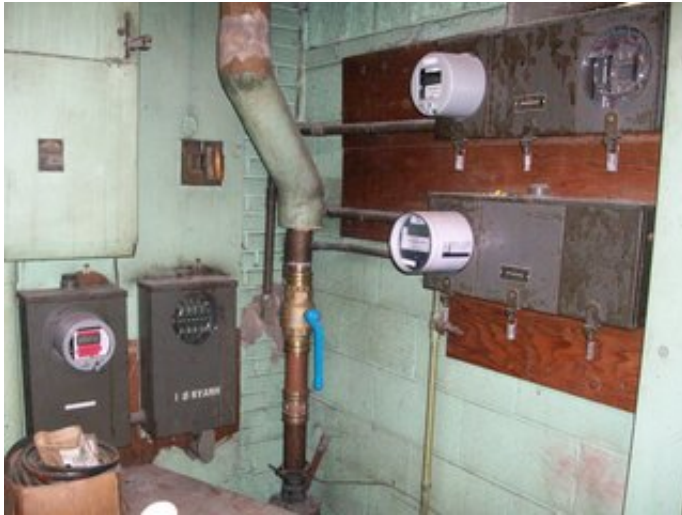
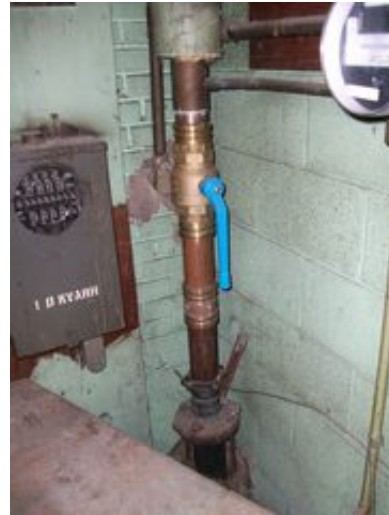
Domestic Water Piping

Domestic water piping

Recommendations: The facility is not equipped with an automated fire suppression system, and the existing water supply will not provide adequate support for a future system.

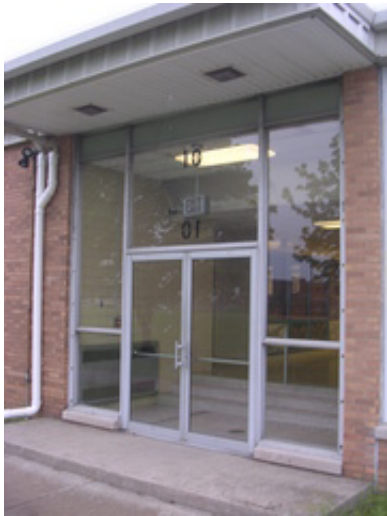
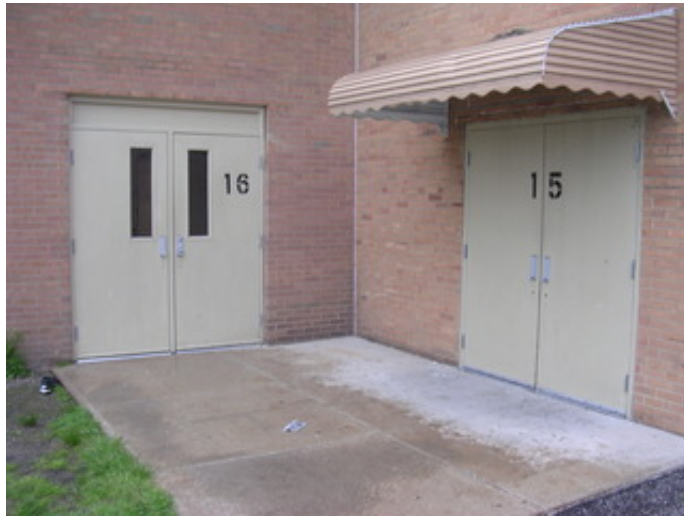
Typical aluminum entry doors.

Typical hollow metal doors.

Recommendations: Replace all exterior doors to comply with Ohio Building Code, ADA, and Ohio School Design Manual guidelines and due to condition. Sidelite replacement included in item F.

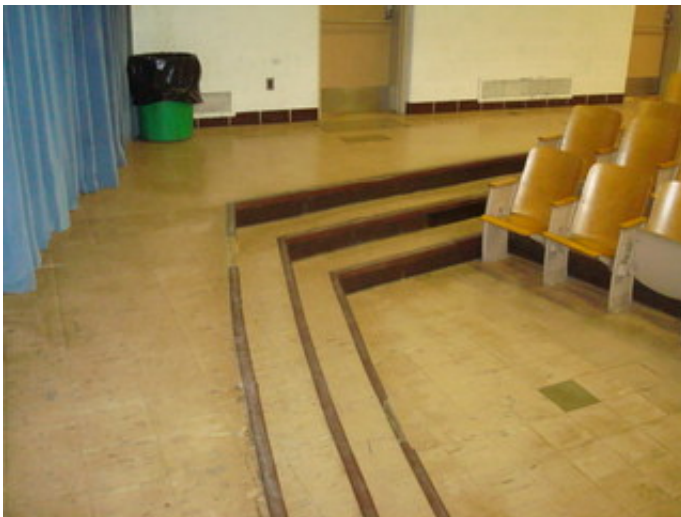
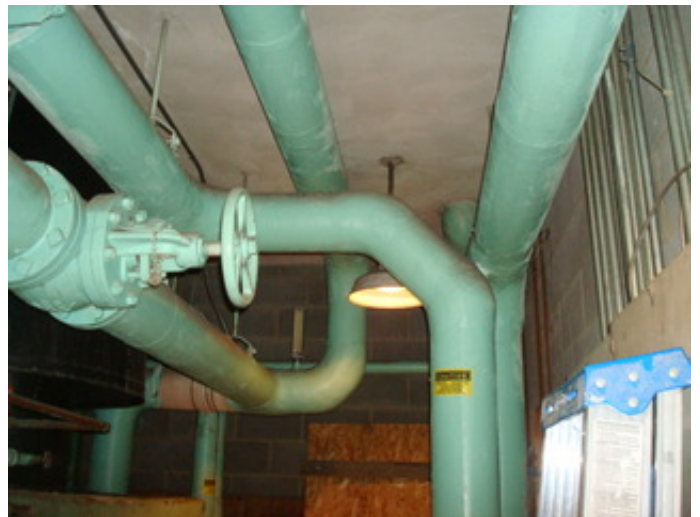
9x9 resilient tile

Pipe insulation

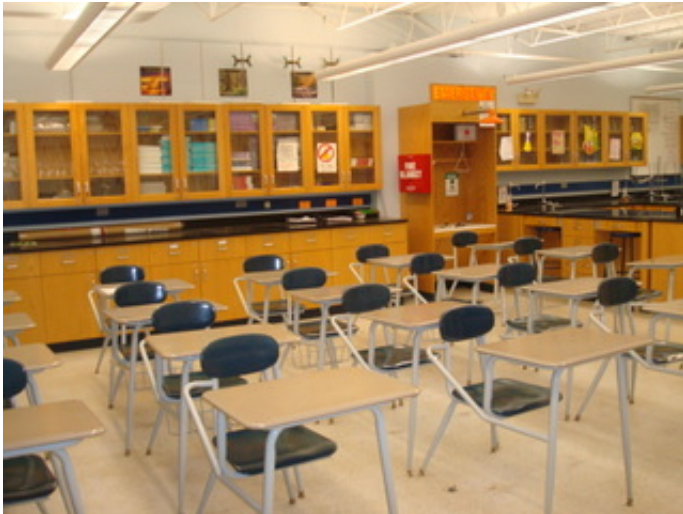
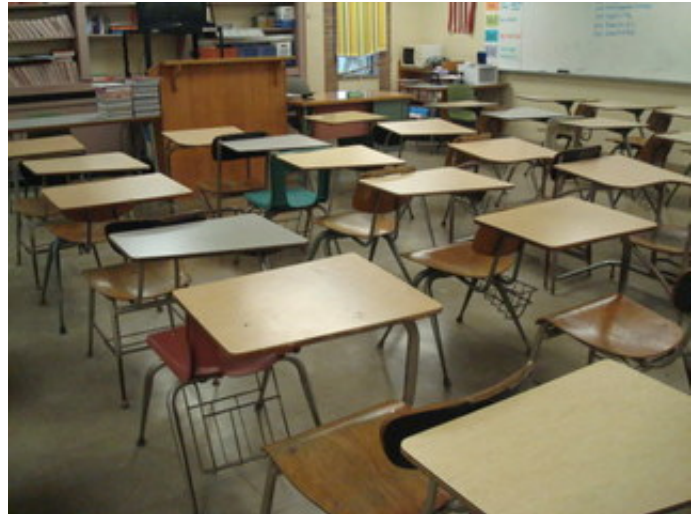
Classroom furniture

Recommendations: Provide for replacement of outdated or inadequate furniture.
