Building Information - Willoughby-Eastlake City SD (45104) - Willoughby Middle

Program Type	Expedited Local Partnership Program (ELPP)
Setting	Suburban
Assessment Name	Willoughby M_2010_TCI
Assessment Date	2010-03-16
Cost Set:	2010
Building Name	Willoughby Middle
Building IRN	41509
Building Address	36901 Ridge Rd
Building City	Willoughby
Building Zipcode	44094
Building Phone	440/975-3601
Acreage	19.60
Current Grades	6-8
Teaching Stations	42
Number of Floors	3
Student Capacity	975
Current Enrollment	971
Enrollment Date	2010-04-01
Enrollment Date is the date in which the current enrollment was taken.	
Number of Classrooms	39
Historical Register	NO
Building's Principal	Mr. Lawrence Keller
Building Type	Middle

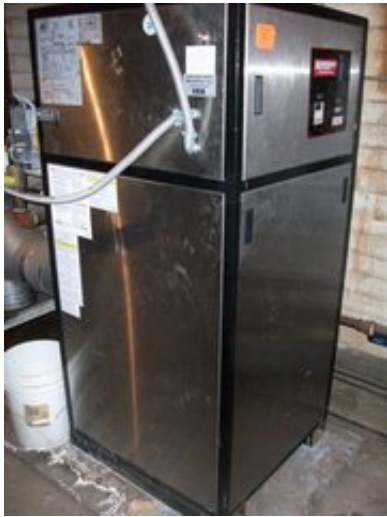
Description: The existing heating system for the overall facility is composed of forced air heating systems utilizing mostly electric heat with some hot water boiler heating installed new in 1970 and early 2000's respectively. The units are in good condition. The heating system in the overall facility is part of the Original Construction and newly updated with each renovation. Heating is distributed through a forced air ducted system utilizing several air handlers with electric heaters and two additional air handlers with hot water coils. The heating system also includes terminal equipment such as perimeter baseboard electric heaters and miscellaneous electric unit heaters. With very limited capacity for simultaneous heating and cooling operation, this system is not compliant with the OSDM requirements for basic system type. The heating terminal equipment was installed in 1970 and new with each addition/renovation and is in good condition. The system does not comply with the 15 CFM per person fresh air requirements of the Ohio Building Code/mechanical code and Ohio School Design Manual. The non DDC type system temperature controls were installed in 1970 and are in working condition. The system does feature individual heating temperature controls in all spaces required by the OSDM. The overall system does not feature any central energy recovery systems. The facility is equipped with louvered interior doors in some rooms to facilitate Corridor utilization as return air plenums while others have a return air system. The existing system is ducted in majority of the areas, and area floor to structural deck heights will accommodate the installation of properly sized ductwork for a future Ohio School Design Manual approved system. The overall heating system is evaluated as being not in safe and efficient working order, though long term life expectancy of the existing system is anticipated. The facility is equipped with central air condition. The site does not contain underground fuel tanks that are currently in use.

Rating: 3 Needs Replacement

Gas Fired Hot Water Boiler

Recommendations: Provide new overall heating, ventilating, and air conditioning system to achieve compliance with Ohio Building Code and Ohio School Design Manual standards. Replace ducted system to facilitate efficient exchange of conditioned air.

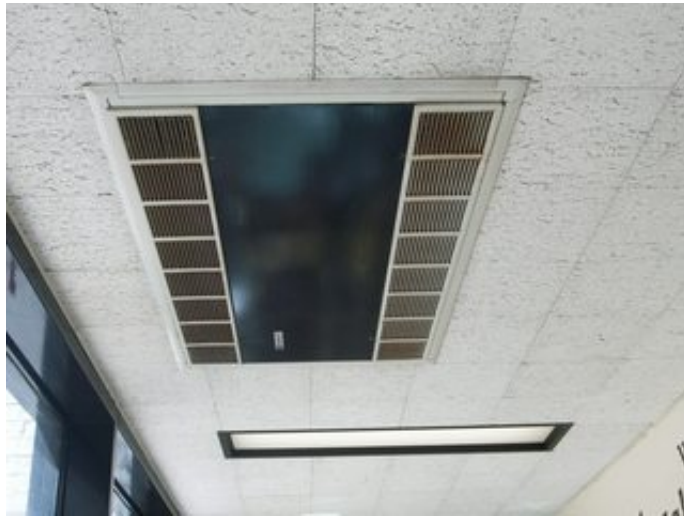
Electric Unit Heater

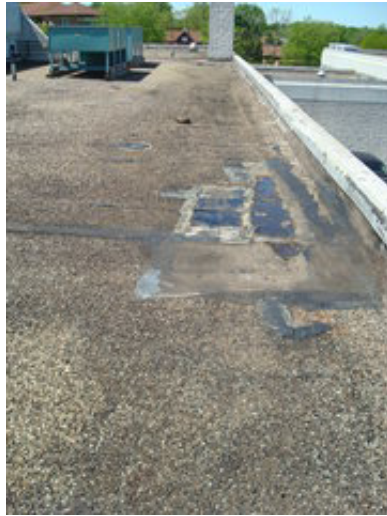
Description: The roof over the overall facility is a built-up system that was installed in 1971 and 1997, and is in poor condition. The District reported current leaking along the loading dock walls and over the stage and student dining areas. Signs of past leaking were observed during the physical assessment. Access to the roof was gained by access doors that is are in poor condition addressed in section S. Fall safety protection cages are not required. There were observations of standing water on the roof above the loading dock wall. Precast concrete copings are in fair condition. Roof storm drainage is addressed through a system of roof drains which are properly located, and in poor condition. The roof is not equipped with overflow roof drains though they are needed on this building. Roof penetrations are in poor condition consistent with the roofing materials. There are not any covered walkways attached to this structure.

Rating: 3 Needs Replacement

Ponding and patches on built-up roofing

Recommendations: Replace roof of overall facility to meet Ohio School Design Manual guidelines due to age of system and condition. Provide tapered insulation for both thermal insulation and to provide positive slope. Due to existing conditions roof drains require replacement. Overflow drains require installation. Roof ladders require installation on various roof surfaces.

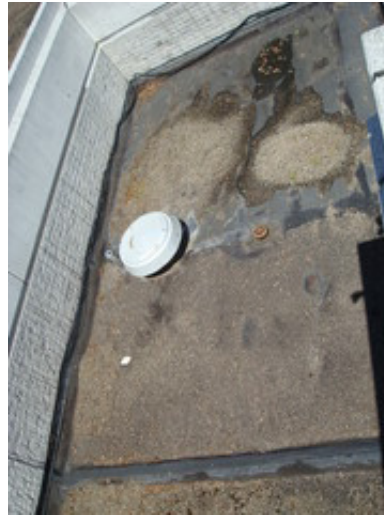
Built-up roofing in poor condition

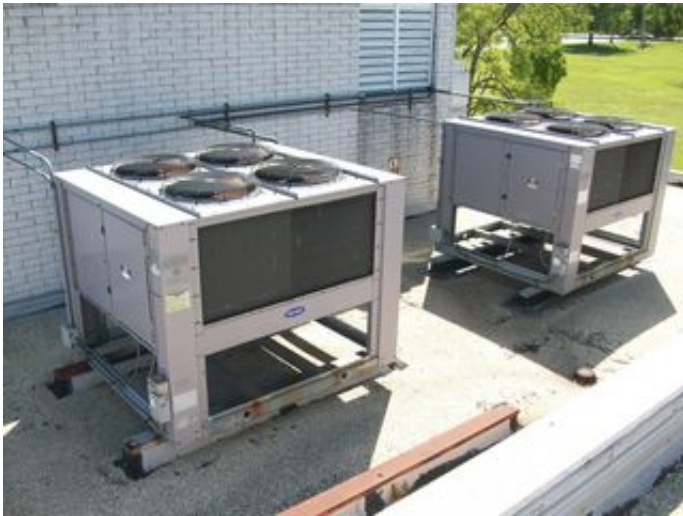
Description: The overall facility is equipped with a central air conditioning system. Central systems consisting of an air handler and a remote condenser or a rooftop cooling package system is provided. The ventilation system in the overall facility consists of unit ventilators and ducted air handlers installed initially in 1970 and new with each addition / renovation and are in good condition, providing fresh air to classrooms and other miscellaneous spaces such as Gymnasiums, Student Dining, Media Center etc. Relief air venting is provided by relief fans and roof vents. The ventilation system does not meet the Ohio Building Code 15 CFM per occupant fresh air requirement. The overall system is not compliant with Ohio Building Code and Ohio School Design Manual requirements. Dust collection systems are not required in this facility and no system is provided. The Art program is not equipped with a kiln. Exhaust systems for Restrooms, Locker Rooms, Kitchen, Gymnasiums, Storage Rooms, Custodial Closets and specialized areas are adequately placed, and in working condition.

Roof Top A/C And Exhaust Fans

Recommendations: Provide an air conditioning system to meet with Ohio Building Code and Ohio School Design Manual requirements. Pricing included in Item A. Provide kiln exhaust system for kiln listed in item J.

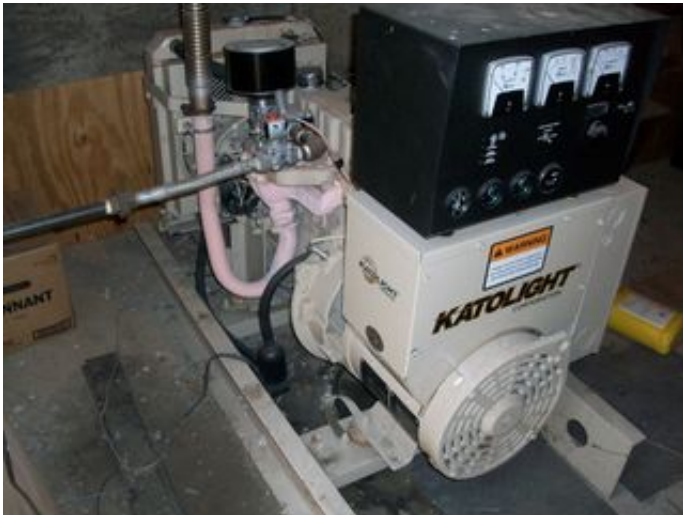
Rating: 3 Needs Replacement

Emergency Generator

Recommendations: The entire electrical systems requires replacement to meet Ohio School Design Manual guidelines due to age.

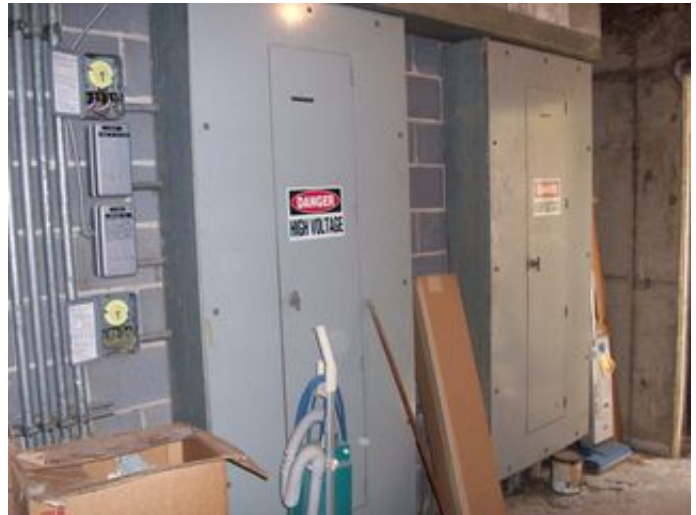
Main Lighting & Heating Panels

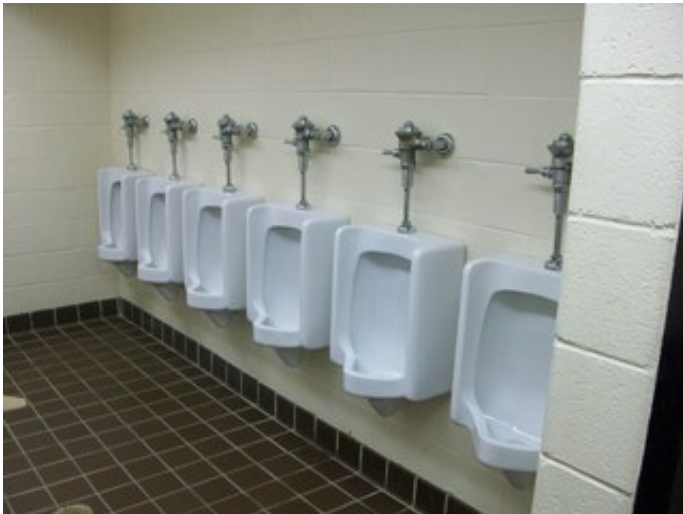
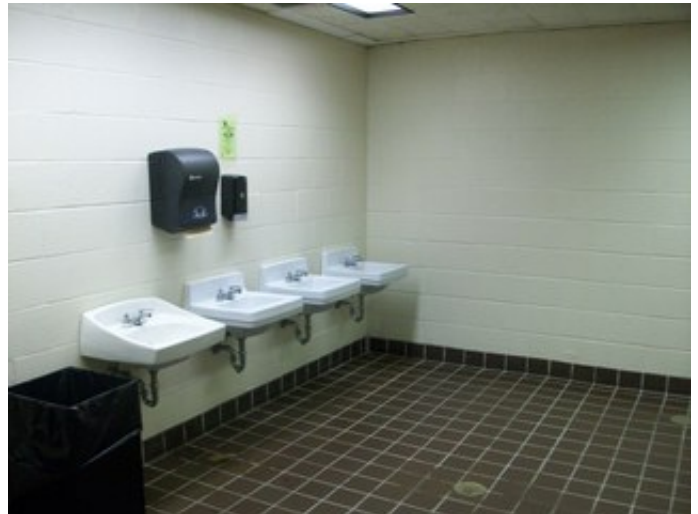
Rating: 3 Needs Replacement

Toilet room fixtures

Recommendations: Provide additional new fixtures to replace existing fixtures because they are not the new low flow type and do not meet ADA requirements. Replace grease interceptor as part of plumbing replacement.

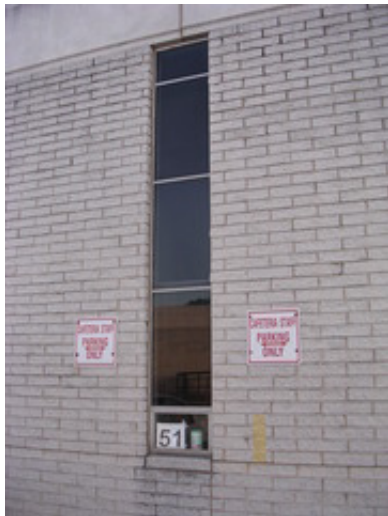
Description: The overall facility is equipped with non-thermally broken aluminum frame windows with single glazed non-insulated glazing type window system, which was installed at the time of construction and are in fair condition. Window system seals are in moderate condition, with no district reports of substantial air and water infiltration being experienced. Window system hardware is in moderate condition. The window system features surface mounted blinds, which are in moderate condition. The window system is not equipped with insect screens on operable windows. Hollow metal frame storefront window systems with tempered and non-tempered single glazing are found in the overall facility and are in poor condition. This facility does not feature any glass block windows. The school does not contain skylights. Window security grilles are not provided for ground floor windows. There is not a Greenhouse associated with this school.

Rating: 3 Needs Replacement

Typical aluminum window system.

Recommendations: Provide a new insulated window system with integral blinds to meet with Ohio School Design Manual requirements. Replace storefront window system in the overall facility due to condition to meet with Ohio School Design Manual requirements.

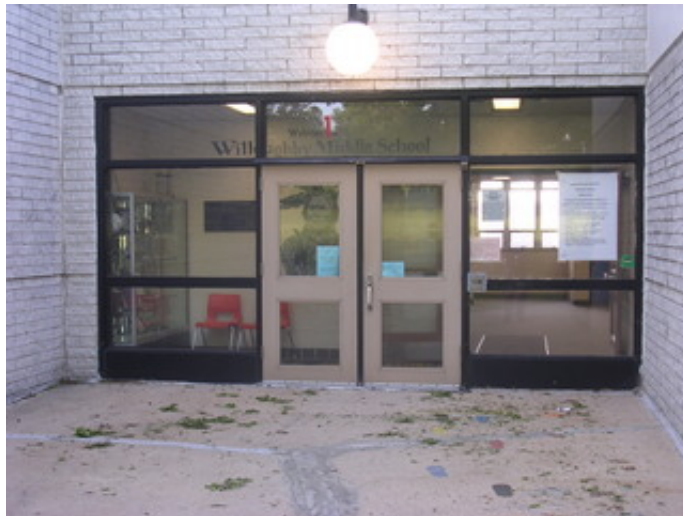
Typical hollow metal storefront system.

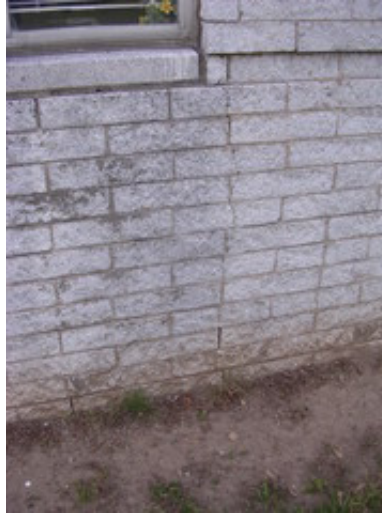
Description: The overall facility is equipped with concrete masonry unit and concrete foundation walls on concrete footings, which displayed no locations of significant differential settlement, cracking, or leaking, and are in fair condition. The District reports that there has been no past leaking. No grading or site drainage deficiencies were noted around the perimeter of the structure that are contributing or could contribute to foundation / wall structural deterioration.

Typical foundation condition.

Recommendations: Existing conditions require no renovation or replacement at the present time.

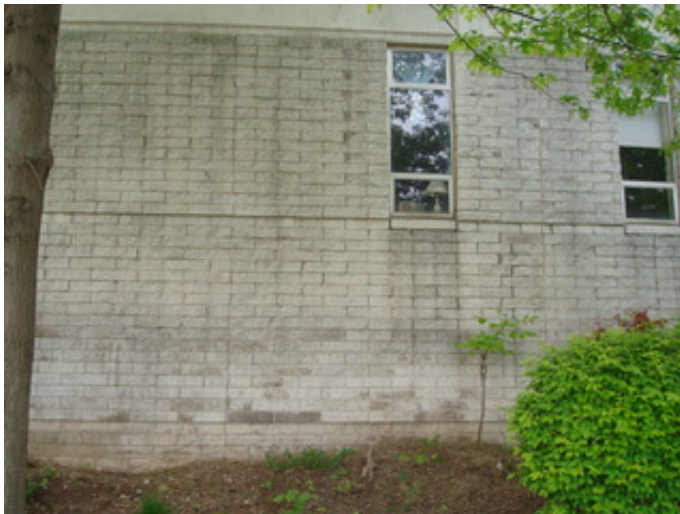
Description: The overall facility has a splitface concrete block veneer on a masonry bearing wall system which displayed locations of deterioration, and is in fair condition. The exterior masonry appears to have appropriately spaced and adequately caulked control joints in poor condition, although differential expansion appears to be occurring and several vertical cracks are apparent. Control joints are not provided at lintel locations at doors and windows. The school has sufficient expansion joints, and they are in poor condition. The exterior masonry has not been cleaned and sealed in recent years, and shows evidence of mortar deterioration in most areas and has locations of efflorescence and mold. Interior walls are concrete masonry units and metal stud framed partitions with gypsum board and are in fair condition. Interior masonry appears to have adequately spaced and caulked control joints in fair condition. Soffits are in poor condition. The window sills are concrete and are in fair condition. The exterior lintels are steel and precast, and are in fair condition. Chimneys are in fair condition although some mortar deterioration is apparent.

Rating: 2 Needs Repair

Expansion joint and vertical crack

Recommendations: Provide tuckpointing in all areas of mortar deterioration as required through the overall facility. Provide masonry cleaning, sealing and caulking as required through the overall facility. Sawcut and caulk new appropriately spaced control joints in existing masonry as required through the overall facility. Recaulk existing control joints as required through the overall facility. Replace masonry lintel as required through the overall facility. Provide masonry sill at clerestory window.

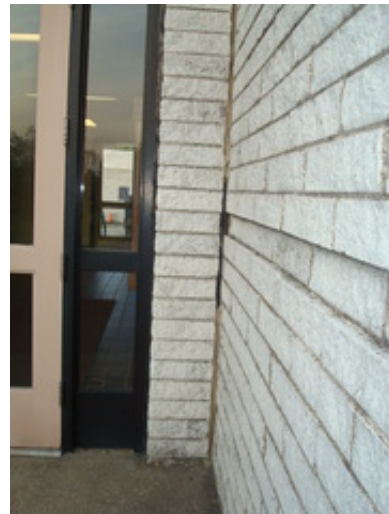
Damaged expansion joint caulk

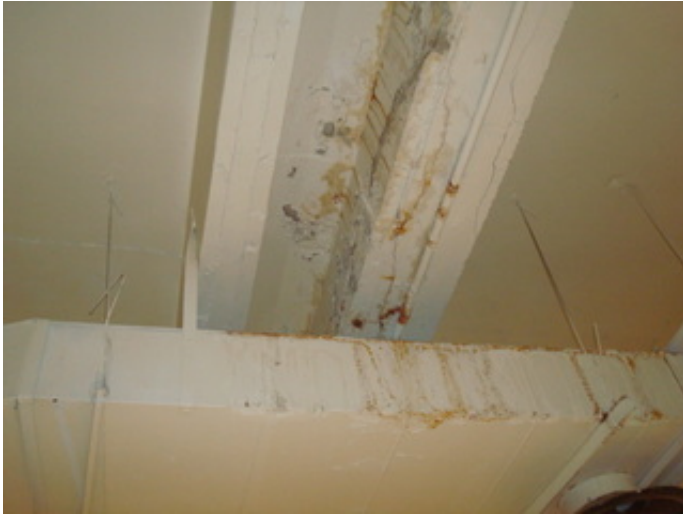
Description: The floor construction of the base floor of the overall facility is concrete slab on grade construction, and is in fair condition. No crawl space is present. The floor construction of the intermediate floors of the overall facility is precast concrete planks with concrete topping construction, and is in fair condition. Ceiling to structural deck spaces are sufficient to accommodate HVAC, electrical, and plumbing scopes of work in required renovations. The roof construction of the overall facility is precast concrete as well as metal joist and metal deck construction, and is in fair condition. A portion of the lower level roof serves as the concrete stoop for upper level. Cracks and leaks were reported by the district and evidence of past water infiltration was noted.

Rating: 2 Needs Repair

Previous roof leak

Recommendations: Replace portion of lower level roof that has signs of water infiltration.

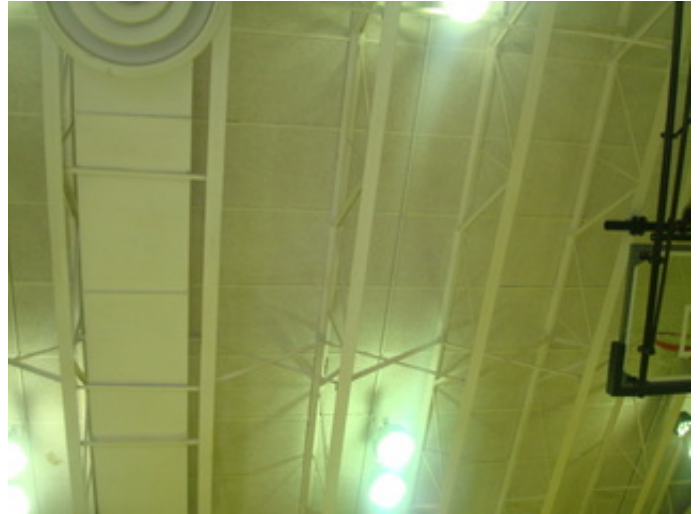
Gymnasium roof

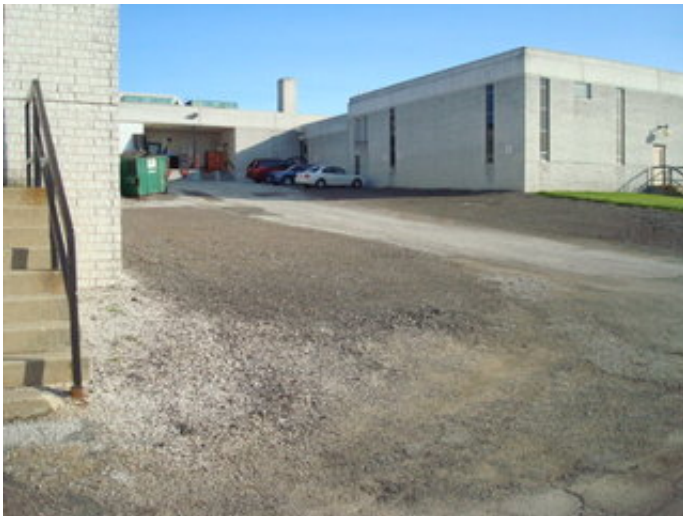
Rating: 2 Needs Repair

Unpaved parking lot with dumpster location

Recommendations: Replace damaged concrete curbs. Pave gravel parking area. Replace exterior handrails. Repair damaged soil areas. Provide extra parking spaces based on student population. Repair damaged concrete steps.

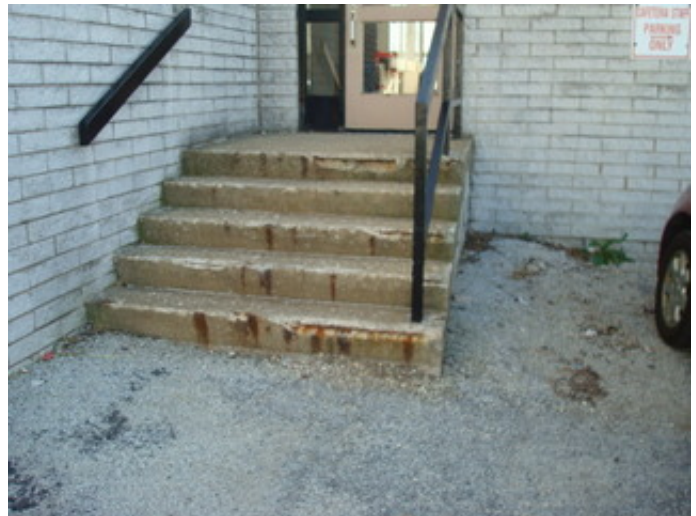
Concrete steps

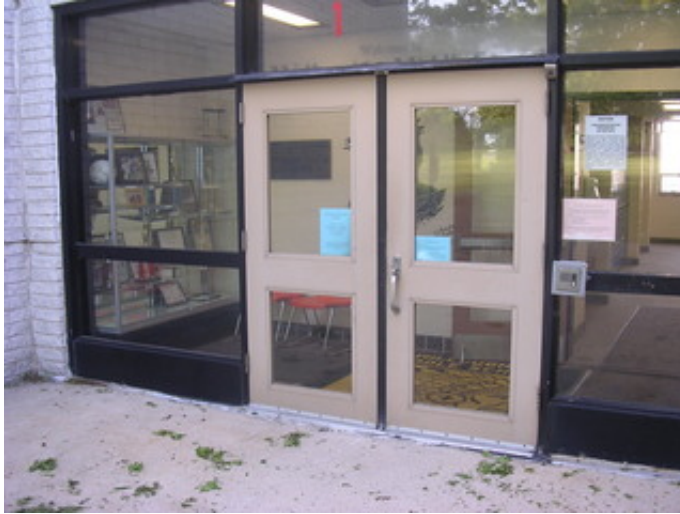
Description: Typical exterior doors in the overall facility are hollow metal type construction, installed on hollow metal frames, and are in poor condition. Typical exterior doors feature single glazed non-insulated wired glass / tempered glass and non-tempered glass vision panels. Entrance doors in the overall facility are aluminum hollow metal type construction, installed on hollow metal frames, and are in poor condition. Entrance doors feature single glazed non-insulated tempered and non-tempered glass vision panels. There are no overhead doors in the facility.

Rating: 3 Needs Replacement

Typical hollow metal entry door.

Recommendations: Replace all exterior doors in poor condition to comply with Ohio Building Code, ADA, and Ohio School Design Manual guidelines.

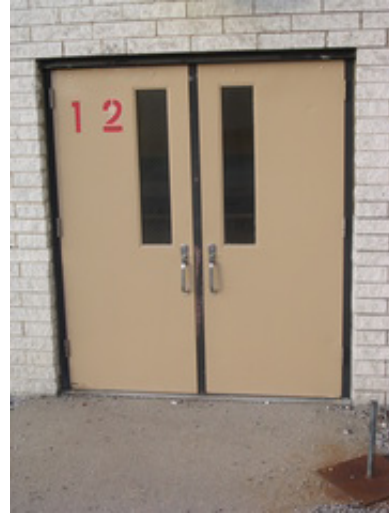
Typical hollow metal door.

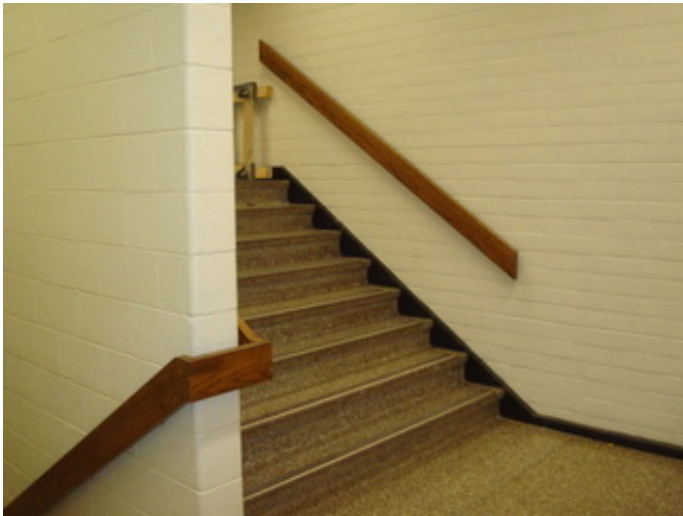
Description: The overall facility is not equipped with an automated fire suppression system. Exit corridors are situated such that dead-end corridors are not present. The facility features 4 interior stair towers, which are not protected by a two hour fire enclosure. The facility features 6 exterior concrete stairways providing egress from intermediate floors, which are in fair to poor condition. Guardrails do not meet the 4" ball test, and do not extend past the top and bottom stair risers as required by the Ohio Building Code. Stair towers wider than 5' do not have an intermediate handrail. The Kitchen hoods are in fair condition, and is equipped with the required UL 300 compliant wet chemical fire suppression system. The required 6" overhang of the cooking equipment is provided by the hood. Kitchen hood exhaust ductwork is of proper construction / material / insulation / and/or installed as required by the OSDM and OBCMC. The cooking equipment is interlocked to shut down in the event of discharge of the fire suppression system. Fire extinguishers are provided in sufficient quantity. Existing fire extinguishers are adequately spaced. The facility is equipped with an emergency generator. The emergency generator is a natural gas fired type unit, is located inside the building. The emergency generator is in poor condition, and does not provide adequate capacity for the future needs of the school. The existing water supply is provided by a tie-in to the municipal system, and is insufficient to meet the future fire suppression needs of the school. Rooms with a capacity greater than 50 occupants are not equipped with adequate egress.

Handrail without extension

Recommendations: Provide new automated fire suppression system to meet Ohio School Design Manual guidelines. Provide increased water service of a capacity sufficient to support the fire suppression system, funding included in fire suppression funding. Provide new handrails at ramps to meet the requirements of the Ohio Building Code. Provide fire-rated enclosure around existing stair towers that connect more than 2 levels. Provide second door in rooms greater than 1000 square feet where not already provided.
