Building Information - Willoughby-Eastlake City SD (45104) - Edison Elem

Program Type	Expedited Local Partnership Program (ELPP)
Setting	Suburban
Assessment Name	Edison E_2010_TCI
Assessment Date	2010-03-16
Cost Set:	2010
Building Name	Edison Elem
Building IRN	9985
Building Address	5288 Karen Isle Dr
Building City	Willoughby
Building Zipcode	44094
Building Phone	440/954-3555
Acreage	17.88
Current Grades	K-5
Teaching Stations	29
Number of Floors	1
Student Capacity	600
Current Enrollment	636
Enrollment Date	2010-04-01
Enrollment Date is the date in which the current enrollment was taken.	
Number of Classrooms	24
Historical Register	NO
Building's Principal	Mr. Brian Patrick
Building Type	Elementary

Edison Elementary, which is not on the National Register of Historic Buildings, and originally constructed in 1962, is a 1 story, 44,771 square foot brick school building located in a suburban residential setting. The existing facility features a conventionally partitioned design, and does utilize modular buildings. The modular unit is 4,020 square feet with electrical service. Water, gas, and sanitary services are not provided. The unit is in fair condition. The structure of the overall

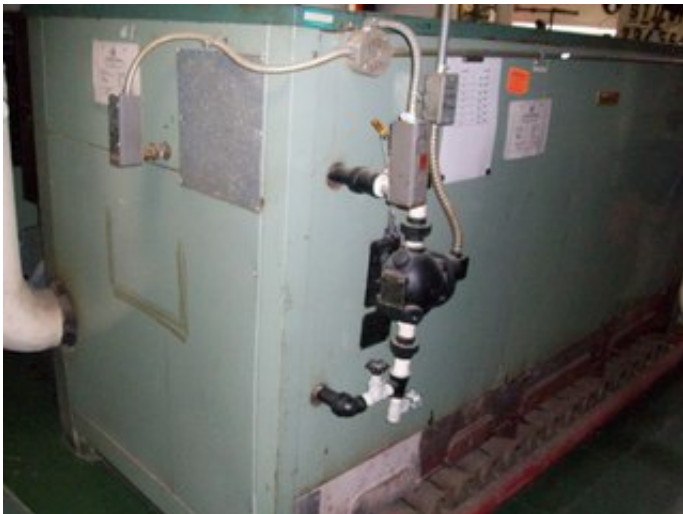
Description: The existing heating system for the overall facility is composed of two major hot water boilers centrally located in the main mechanical room which were installed in 1962. The units are in good condition. The heating system in the overall facility is part of the Original Construction and is a 2-pipe system supplying hot. With very limited capacity for simultaneous heating and cooling operation, this system is not compliant with the OSDM requirements for basic system type. The forced draft hot water boilers, manufactured by Peerless were installed in 1962 and are in decent condition. Heating hot water is distributed to terminal units consisting of unit ventilators, cabinet heaters, unit heaters, and fin tubes. The terminal equipment was installed in 1962 and is in fair condition. The system does not comply with the 15 CFM per person fresh air requirements of the Ohio Building Code mechanical code and Ohio School Design Manual. The non DDC type system temperature controls were installed in 1962 and are in working condition. The system does feature individual heating temperature controls in all spaces required by the OSDM. The overall system does not feature any central energy recovery systems. The facility is equipped with louvered interior doors in storage and utility rooms to facilitate Corridor utilization as return air plenums while the classrooms have a return air systems. The existing system is not ducted, and floor to structural deck heights will not accommodate the installation of properly sized ductwork for a future Ohio School Design Manual approved system. The overall heating system is evaluated as being not in safe and efficient working order, though long term life expectancy of the existing system is anticipated. The structure is not equipped with central air conditioning. The site does not contain underground fuel tanks that are currently in use.

Rating: 3 Needs Replacement

Gas Fire Hot Water Boilers

Recommendations: Provide new overall heating, ventilating, and air conditioning system to achieve compliance with Ohio Building Code and Ohio School Design Manual standards. Convert to ducted system to facilitate efficient exchange of conditioned air.

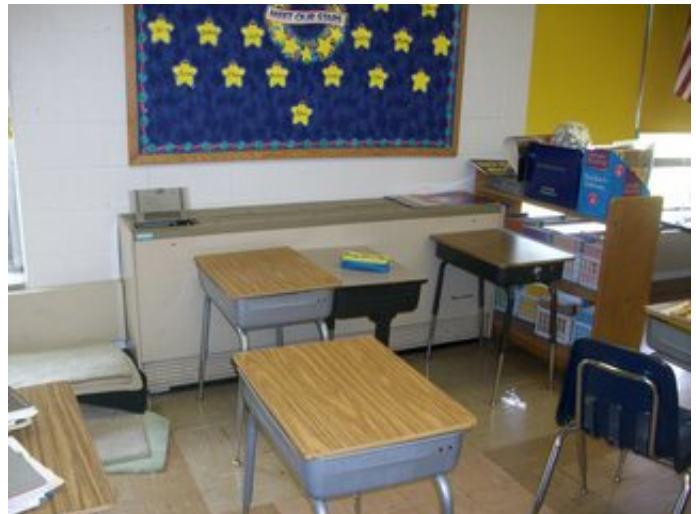
Typical Room Unit Ventilator

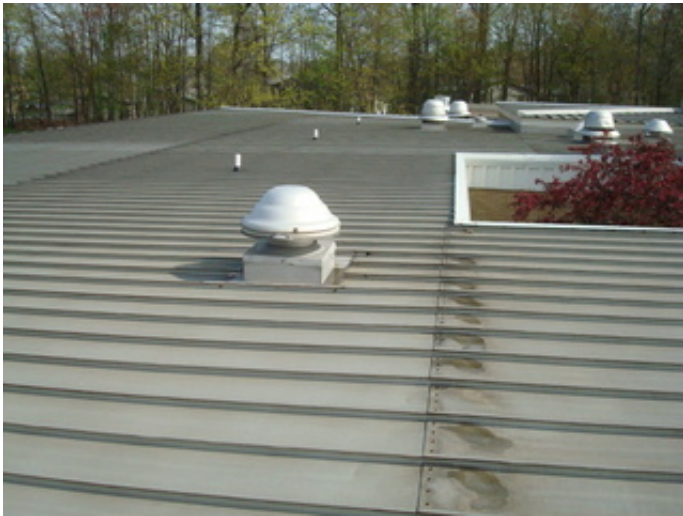
Description: The roof over the overall facility is a standing seam metal system that was installed in 1987, and is in fair condition. District reports current leaking. Roof currently leaks in one classroom, and was recently repaired in a second classroom. Signs of past leaking or condensation due to thermal bridging were observed throughout the facility during the physical assessment. Insulation is provided but is not sufficient to provide compliance. Access to the roof was gained by portable ladder. Fall safety protection cages are not required, and are not provided. Standing water was not observed on the roof. Most metal cap flashings are in fair condition, and the cap flashings around the courtyards are in poor condition. Roof storm drainage is addressed through a system of gutters and downspouts, which are properly located, and in poor condition. Overflow roof drains are not required. Roof flashing at the chimney is in need of replacement. No other problems requiring attention were encountered with other roof penetrations. Covered walkways are attached to this structure. A covered walkway constructed of wood structure with shingle roofing connects the school building with the modular classrooms. It appears to be constructed within the past five years and is in good condition.

Rating: 3 Needs Replacement

Metal roofing seam

Recommendations: The roof over the overall facility requires replacement to meet Ohio School Design Manual guidelines due to insufficient insulation and thermal bridging. A membrane roofing system is recommended to replace the existing standing seam metal system. The flashing and / or coping require replacement with the roofing system. Due to existing conditions gutters and downspouts require replacement with the roofing system.

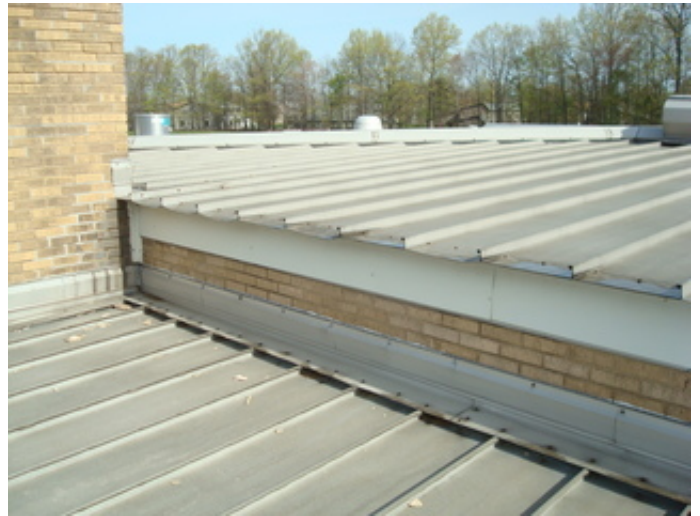
Metal roof flashings

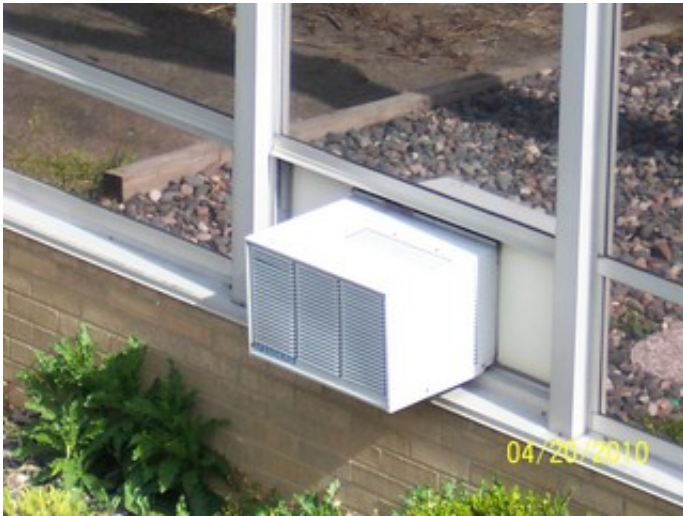
Description: The overall facility is not equipped with a central air conditioning system. Window units are provided in miscellaneous locations such as offices, library, and media center. The ventilation system in the overall facility consists of unit ventilators and ducted air handlers installed initially in 1962 and are in fair condition, providing fresh air to classrooms and other miscellaneous spaces such as Gymnasiums, Student Dining, Media Center etc.). Relief air venting is provided by relief fans and roof vents. The ventilation system does not meet the Ohio Building Code 15 CFM per occupant fresh air requirement. The overall system is not compliant with Ohio Building Code and Ohio School Design Manual requirements. Dust collection systems are not required in this facility and no system is provided. The Art program is non-existent. Exhaust systems for Restrooms, Locker Rooms, Kitchen, Gymnasiums, Storage Rooms, Custodial Closets and Career Tech specialized areas are adequately placed, and in working condition.

Typical Window Air Conditioner Unit

Recommendations: Provide an air conditioning system to meet with Ohio Building Code and Ohio School Design Manual requirements. Pricing included in Item A. Provide kiln exhaust system for kiln listed in item J.

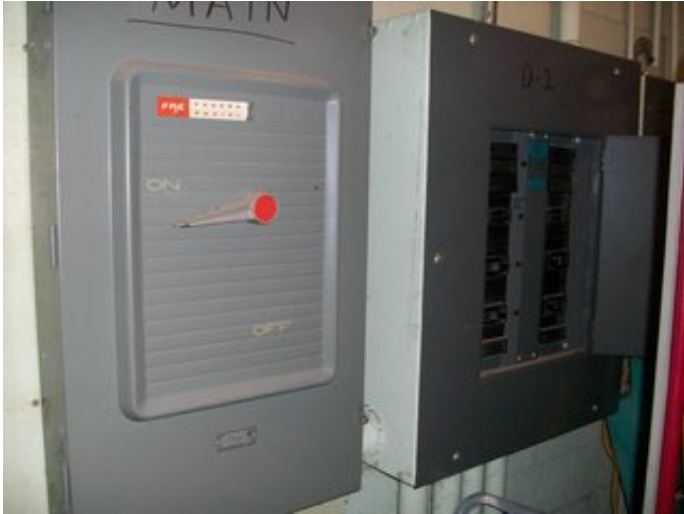
Description: The electrical system provided to the overall facility is a 400 amp 120/208 volt, 3 phase, 4 wire original system from the year 1962, and is in good condition. Power is provided to the school by a pole mounted utility owned transformer, located at the rear of the school near the property line. Sight condition of the transformer looks to be satisfactory. The main distribution panel cannot be expanded to add additional capacity that would be required by the OSDM air conditioning requirements. The Classrooms are not equipped with adequate electrical outlets per OSFC recommendations. The typical Classroom contains usually 2 general purpose outlets also used for Classroom computers, and television. There are some spaces that have no electrical outlets such as storage areas and some toilet rooms. There are some Corridors that are not equipped with adequate electrical outlets for electrical servicing. Adequate GFI protected exterior outlets are not provided around the perimeter of the building. The facility is not equipped with an emergency generator. There is a 100 amp emergency panel LP-EM which feeds items such as exit lights and the Fire Alarm panel. The emergency panel is fed directly from the double lugged main disconnect switch and is in good condition. Adequate building lightning protection safeguards are not provided. The overall electrical system does not meet Ohio School Design Manual requirements, and will be inadequate to meet the facility's future needs.

Rating: 3 Needs Replacement

Main Electrical Switch & Distribution Panel

Recommendations: The entire electrical system requires replacement to meet Ohio School Design Manual guidelines for overall capacity due to lack of OSDM - required features and to accommodate the addition of an air conditioning system.

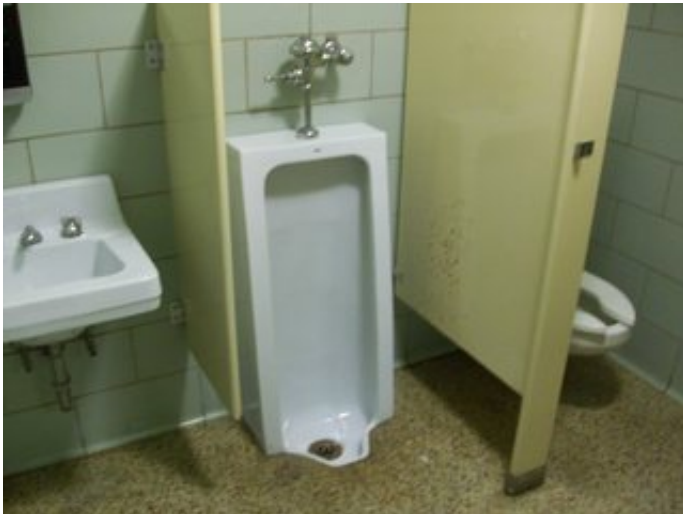
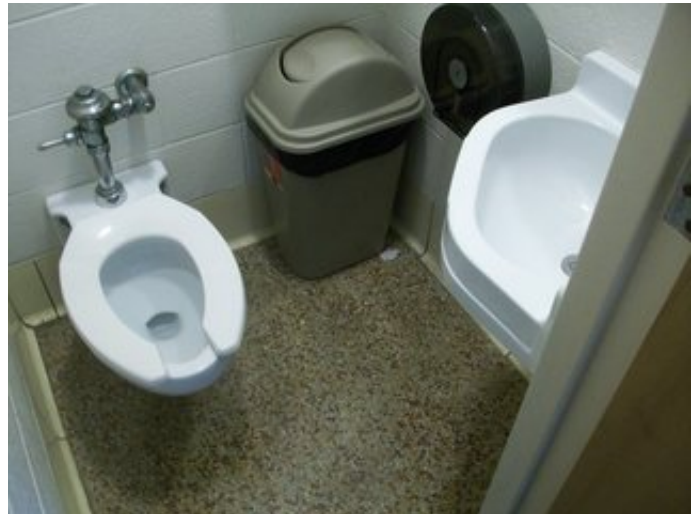
Description: This school has 22 wall hung water closets, 13 wall hung urinals, 20 lavatories, 0 wash fountains, 4 wall hung electric water coolers, 26 lab sinks, 0 shower heads, and 3 mop sinks. Most of the plumbing fixtures are in fair condition, but ADA requirements are not met. A 3 inch reduced principle backflow preventer is required. The building has a 3 inch domestic water supply line. There is one 100 gallon gas fired hot water heater that provides domestic hot water for the entire building, which needs to be replaced. Domestic water piping is copper and appears to be in good condition. Sanitary drainage and vent piping is cast iron that appears to be in good condition.

Rating: 3 Needs Replacement

Toilet room fixtures

Recommendations: Provide all new plumbing fixtures, faucets and flush valves to replace the existing because of ADA requirements and condition of old plumbing fixtures. Provide grease trap for kitchen and provide new wall hydrants on exterior building wall. Refer to item O for the additional fixture replacements. Replace existing domestic water heater with new high efficient gas fired water heater. The recommendation for domestic water piping is in section R. The recommendation for sanitary drainage piping is in section Q.

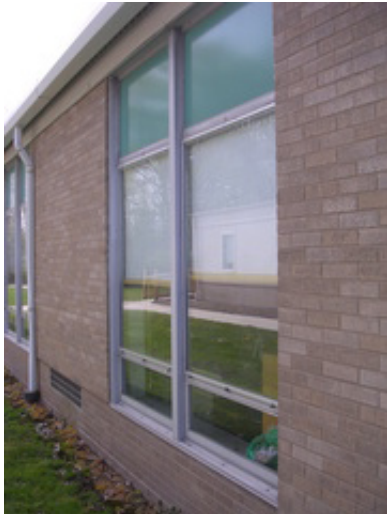
Description: The overall facility is equipped with non-thermally broken aluminum windows with a single glazed type window system, which was installed in 1962, and is generally in fair condition. Aluminum sills are in fair condition. Window system seals are in moderate condition, with moderate air and water infiltration being experienced. Window system hardware is in moderate condition. The window system features surface mounted shades which are in poor condition. The window system is partially equipped with insect screens on operable windows, which are in poor condition. Steel frame and aluminum frame storefront systems are found in the overall facility, in fair to poor condition. This facility does not feature any glass block windows. The exterior doors in the overall facility are equipped with non-thermally broken aluminum and steel sidelights and transoms with single glazing in fair to poor condition. Glazing panels are a combination of tempered, non-tempered, and wired glass, with porcelain coated spandrel panels. The school does contain (4) acrylic bubble type skylights that are in poor condition. Window security grilles are not provided for ground floor windows. There is not a Greenhouse associated with this school.

Rating: 3 Needs Replacement

Typical aluminum window system.

Recommendations: Provide a new insulated window system with integral blinds to meet with Ohio School Design Manual requirements for the overall facility. Replace storefront window systems and, skylights in the overall facility to meet with Ohio School Design Manual requirements.

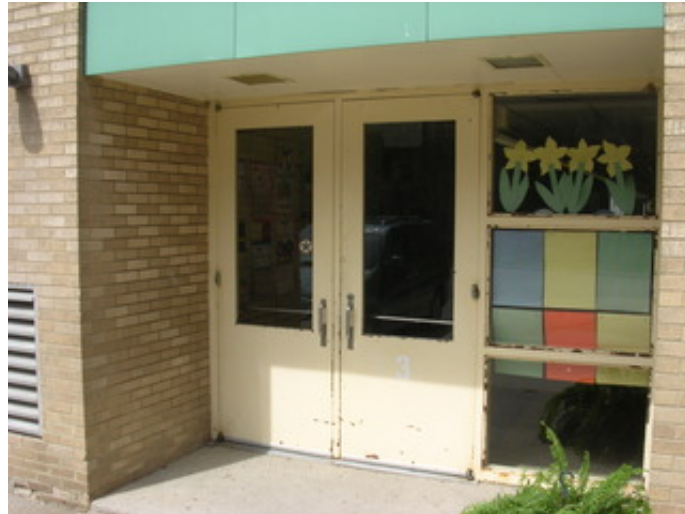
Typical hollow metal storefront system.

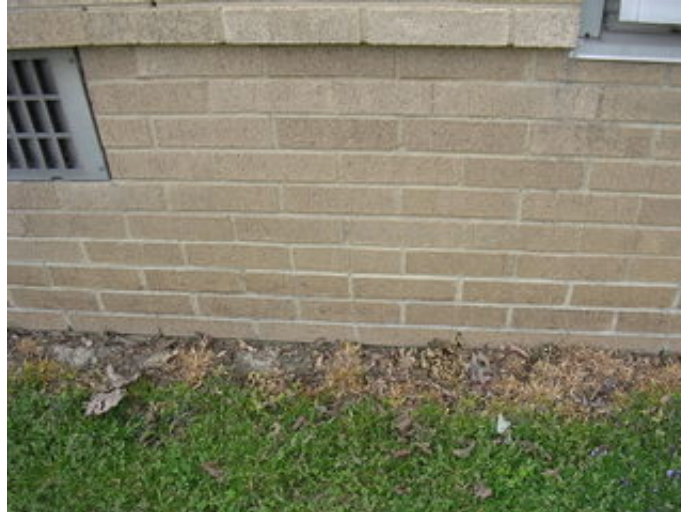
Description: The overall facility is equipped with concrete masonry unit foundation walls on concrete footings which displayed no locations of significant differential settlement, cracking, or leaking, and are in good condition. The District reports that there has been no past leaking. No grading or site drainage deficiencies were noted around the perimeter of the structure that are contributing or could contribute to foundation / wall structural deterioration.

Typical foundation condition.

Recommendations: Replace one missing downpipe drainage boot. Existing conditions require no other renovation or replacement at the present time.

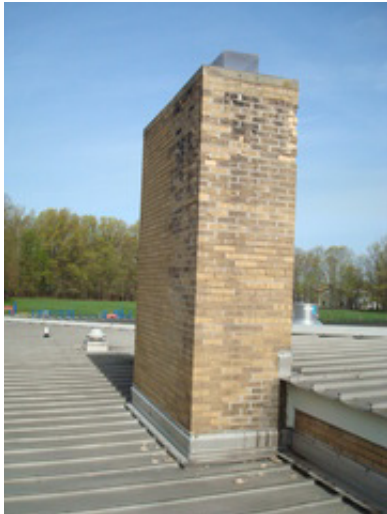
Description: The overall facility has a brick veneer on a masonry bearing wall and steel frame system, which displayed locations of deterioration along the base of the wall, and is in fair condition. Control joints are provided at lintel locations at doors and windows. The school appears to contain insufficient expansion joints, but additional joints are not needed due to no indication of exterior masonry cracking or separation. The exterior masonry has not been cleaned and sealed in recent years, and shows evidence of brick deterioration where insufficient weep holes are provided, especially on the north and south elevations. Architectural exterior accent materials consist of porcelain ceramic panels over recessed entries which are in fair condition. Interior walls are concrete masonry units and glazed block and are in fair condition. Interior masonry appears to have no caulked control joints in. Soffits are in fair condition. The window sills are an element of the aluminum window system, and are in fair condition. The exterior lintels are concealed, and are assumed to be steel and in fair condition. Chimneys are in poor condition, with ample spalling brick. Canopies over entrances are porcelain-enamel panel type construction, and are in fair condition.

Rating: 2 Needs Repair

Chimney with damaged brick

Recommendations: Replace spalling brick and install weep vents and flashing in various locations. Provide masonry cleaning and sealing as required through the overall facility.

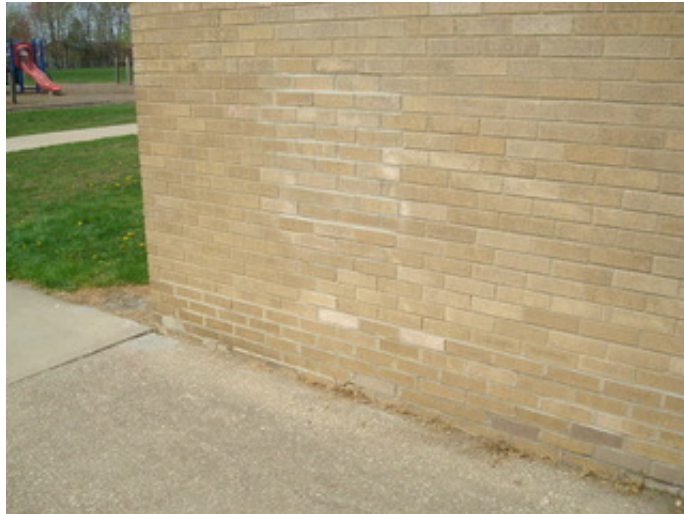
Damaged brick with insufficient weep holes

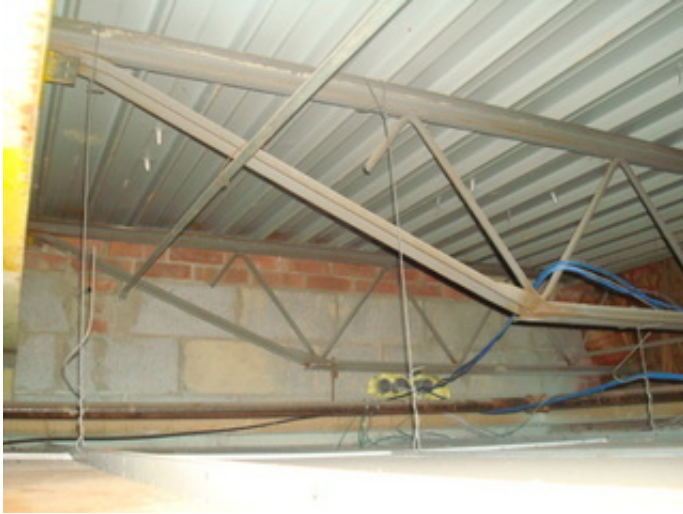
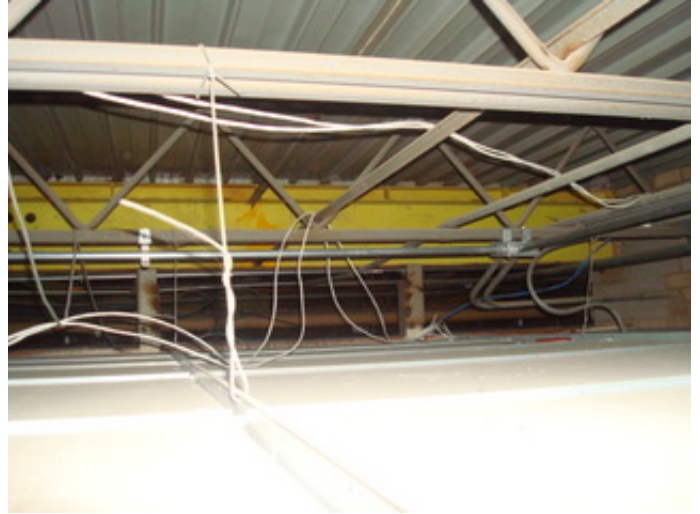
The building has thermal bridging at the wall to roof connection. The roof system structure has thermal bridging that appears to cause condensation within the classrooms. Cracks appear in the walls due to building settlement. Portions of the roof structure are rusting due to condensation.

Description: The floor construction of the base floor of the overall facility is concrete slab on grade construction, and is in good condition. There is no crawl space. There are no intermediate floors in this single story structure. Ceiling to structural deck spaces are insufficient to accommodate HVAC, electrical, and plumbing scopes of work in required renovations. The ceiling system is at 8 feet above finish floor. The roof system is approximately 2 feet above the ceiling level. The roof construction of the overall facility is steel with metal deck construction, and is in fair to poor condition. Some locations are rusting due to roof system conditions, but do not appear to be structurally deficient.

Roof structure

Recommendations: Existing conditions require no renovation or replacement at the present time.

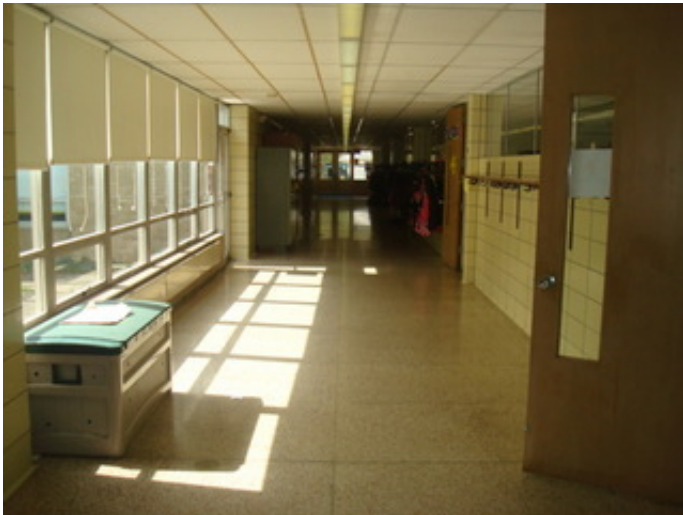
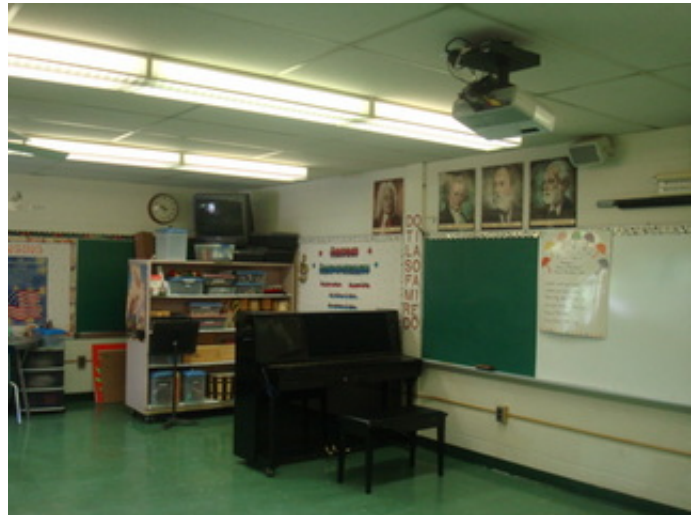
Description: The overall facility features conventionally partitioned Classrooms with vinyl tile and carpet flooring in poor condition, lay in acoustical tile ceilings in poor condition, as well as painted block wall finishes in fair condition. The overall facility has Corridors with terazzo flooring in good condition, lay in acoustical tile ceilings in poor condition, as well as glazed block wall finishes in good condition. The overall facility has Restrooms with terazzo flooring in fair condition, lay in acoustical tile ceilings in poor condition, as well as glazed block wall finishes in fair condition. Toilet partitions are metal, and are in poor condition. Classroom casework in the overall facility is wood type construction with plastic laminate tops, is inadequately provided, and in poor condition. The typical Classroom contains four lineal feet of casework, and Classroom casework provided ranges from zero to four feet. Classrooms are provided adequate chalkboards, markerboards, and tackboards, which are in fair condition. The Classroom storage cubbies, located in the Corridors, are adequately provided, and in poor condition. The Art program is not equipped with a kiln or room. The facility is equipped with wood non-louvered interior doors that are flush mounted without proper ADA hardware and clearances, and in fair to poor condition. The Gymnasium space has vinyl tile flooring, exposed roof system ceilings, as well as painted masonry wall finishes, and they are in poor condition. The Media Center, has carpet flooring, lay in acoustical tile ceilings, as well as painted block wall finishes, and they are in poor condition. Student Dining, has vinyl tile flooring, exposed roof system ceilings, as well as painted block wall finishes, and they are in fair condition. The facility does not have a stage. The existing Kitchen is satellite from Willoughby Middle School facility, is undersized based on current enrollment, and the existing Kitchen equipment, installed in before 2000, is in poor condition. The Kitchen does not have a hood. The kitchen does not have walk-in coolers /freezer.

Rating: 3 Needs Replacement

Recommendations: Provide complete replacement of finishes and casework due to installation of systems outlined in Items A, C, D, E, K, M, N, T, and U. Provide funding for replacement of interior doors in item O. Provide complete replacement of kitchen equipment. Provide Art Room Kiln. Replace toilet partitions and accessories due to condition. Rework toilet room walls per item O.

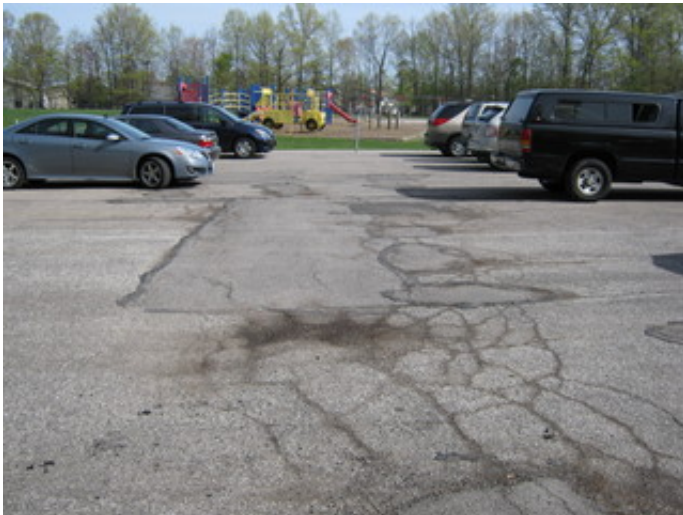
Description: The 17.88 acre relatively flat site is located in a suburban residential setting with generous tree, shrub and flower type landscaping. Evidence of ponding was observed in lawn areas beneath tall trees. Evidence of erosion was observed on the sloped lawn west of the facility. A small storage shed and a modular classroom are located on site. The site is bordered by lightly and moderately traveled city streets. There is a single vehicular entry to the site. A one-way bus loop which is separated from other vehicular traffic is provided in front of the school for student loading and unloading. Parking is facilitated by multiple asphalt parking lots containing 97 parking places, which provides adequate parking for staff and visitors. The front lots are in good condition; the back lot is in poor condition. Adequate designated parking for the disabled is not provided. The unpaved portions of the site are drained via sheet drainage and storm sewers near the building; the site is drained through natural streams and swales near the edges of the property and in the wooded areas. Some evidence of ponding and erosion was observed. The parking lot drainage design consists of sheet drainage and storm sewers and provides adequate evacuation of storm water. Evidence of ponding was observed at the back parking lot. Concrete curbs in fair to poor condition are appropriately placed. Trash pick-up and service drive pavement is not heavy duty. The concrete pad for dumpsters is in poor condition. The school is not equipped with a loading dock. Concrete sidewalks are properly sloped, are located to provide a logical flow of pedestrian traffic, and are in fair condition. The concrete area at the front entry is in poor condition. Play areas are adequately separated from vehicular traffic. Playground equipment is in fair condition and is placed to provide compliant fall zones on a compliant soft surface of sufficient depth. Athletic facilities are comprised of two basketball courts on asphalt surfaces in poor condition and one kickball field in fair condition. An outdoor seating area and two courtyards within the building are suitable for outdoor instruction. Extensive wooded areas are located on the west and northeast portions of the site and on the property south of the site. Paths connect the play areas with the residential neighborhoods to the north and west of the site. Sidewalks along the entry drive connect to the residential street to the east of the site. The site is mostly flat. There is sufficient space on the site for a future addition to the building.

Rating: 2 Needs Repair

Parking lot in poor condition

Recommendations: Provide new wearing course on back parking lot and both basketball courts. Replace concrete dumpster pad. Replace concrete sidewalks where required and concrete surfaces at both courtyards; include ramps for handicap access at courtyards. Replace curbs at play areas and drives where required. Stabilize soil erosion west of playground. Designate three additional accessible parking spaces. Costs for ADA signage are covered in item O.

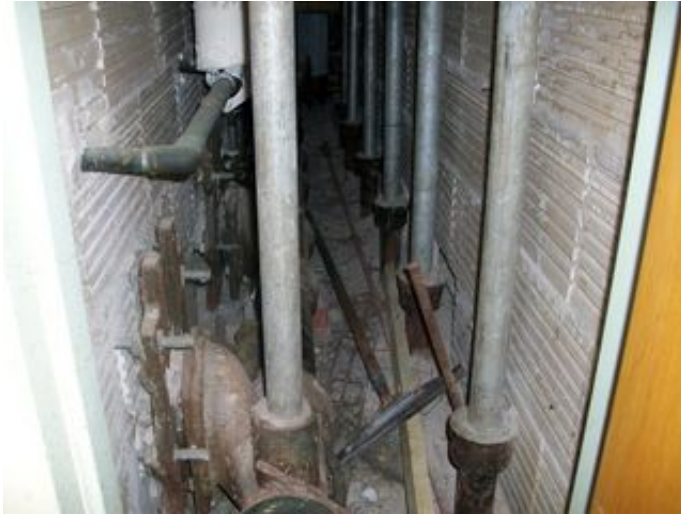
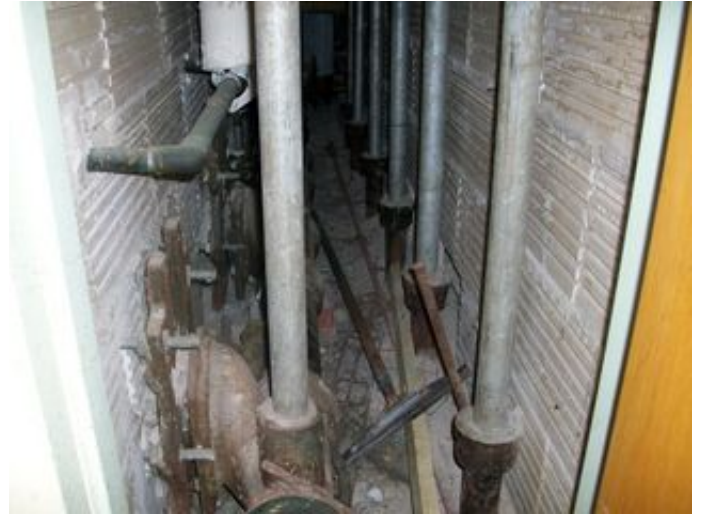
Rating: 3 Needs Replacement

Sanitary Piping

Recommendations: The sanitary drainage system is 48 years old. Recommend replacing with new sanitary and vent piping

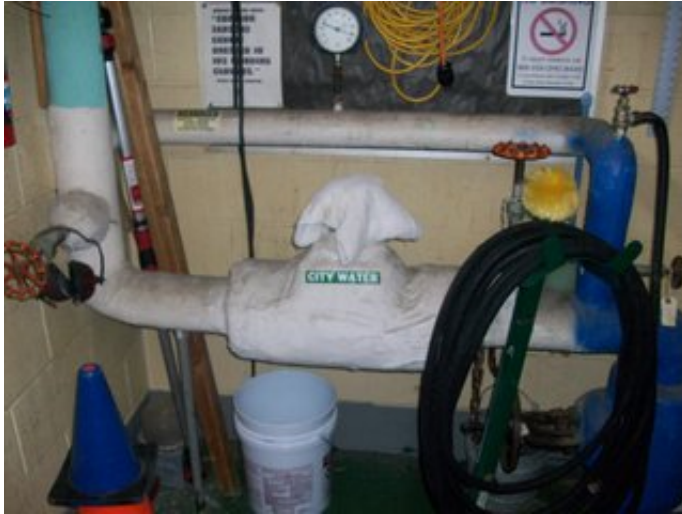
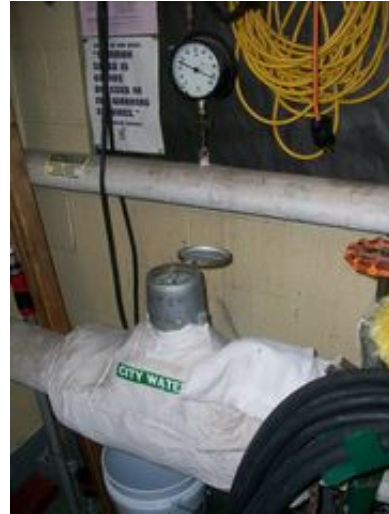
Rating: 3 Needs Replacement

Domestic Water Piping

Recommendations: The existing domestic water piping is 48 years old. Recommend replacing with new domestic water piping from the city site main. Backflow preventer provided in item E.

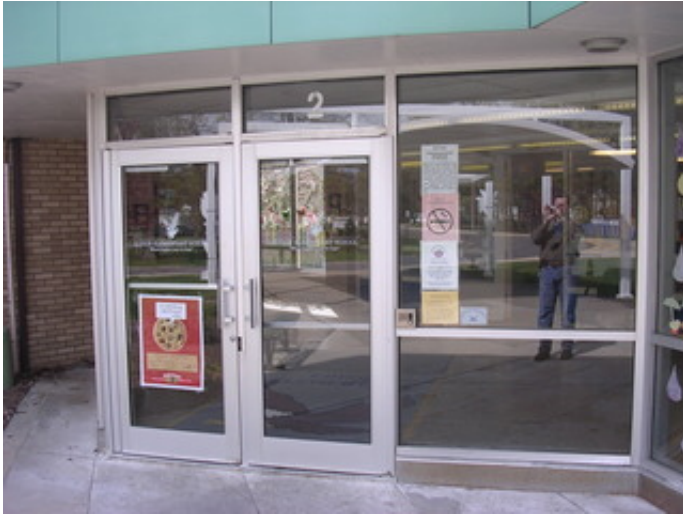
Description: Typical exterior doors in the overall facility are a combination of aluminum and hollow metal construction, installed on aluminum and hollow metal frames, and are in fair to poor condition. Typical exterior doors feature single glazed non-insulated glazing with a combination of wired glass, tempered glass, and non-tempered vision panels. One pair of exterior doors has been recently replaced with insulated aluminum doors with insulated tempered glazing that are in good condition. Entrance doors in the overall facility are aluminum construction on aluminum frames, and in poor condition. Typical entry doors feature single glazed non-insulated glazing with a combination of tempered glass, and non-tempered vision panels. There are no overhead doors in the facility.

Rating: 3 Needs Replacement

Typical aluminum entry doors.

Recommendations: Replace exterior doors to comply with Ohio Building Code, ADA, and Ohio School Design Manual guidelines and due to poor condition.

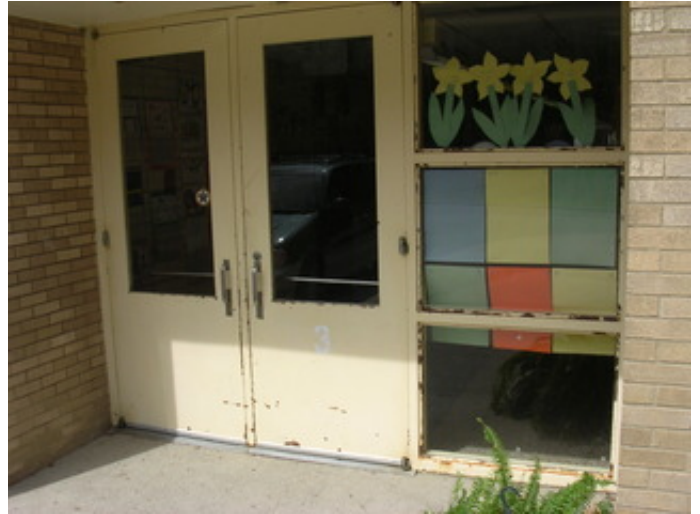
Typical hollow metal entry doors.

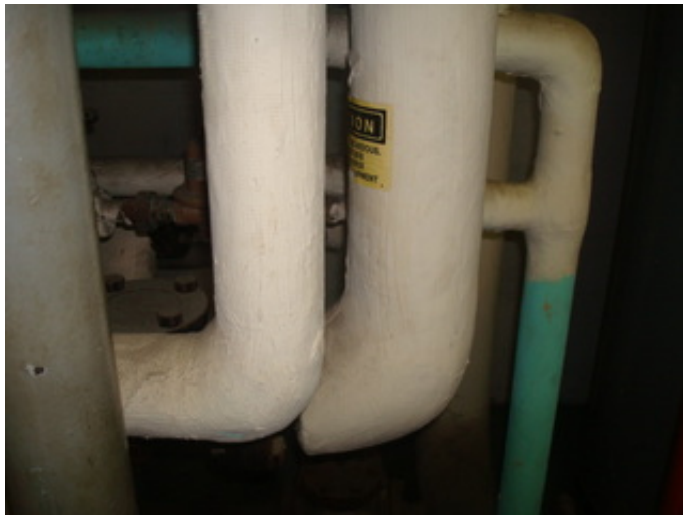
Description: The School District provided the AHERA three year reinspection reports, prepared by CTG Environmental LLC, and dated 2006, documenting known and assumed locations of asbestos and other hazardous materials. The district did not provide documentation of any abatement projects since that time. Vinyl asbestos floor tile and mastic, pipe insulation, and pipe fittings containing hazardous materials are located in the overall facility in fair condition. These materials were described in the report and open to observation and found to be in friable and non-friable condition moderate to light damage. There are no underground fuel oil storage tanks on the site. Due to the construction date, there is a potential for lead based paint. Fluorescent lighting will require special disposal.

Pipe fittings and insulation

Recommendations: Remove all hazardous materials, inclusive of asbestos-containing materials in the overall facility, as noted in the attached Environmental Hazards Assessment. Provide for the testing of paint that has the potential of being lead-based.

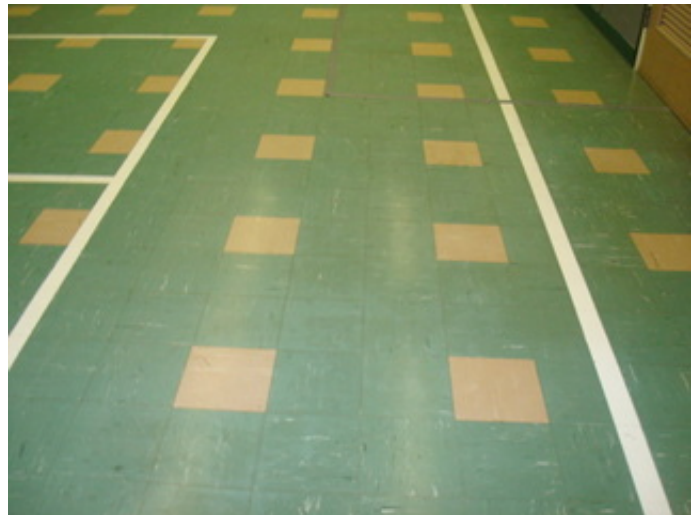
9x9 Vinyl tile

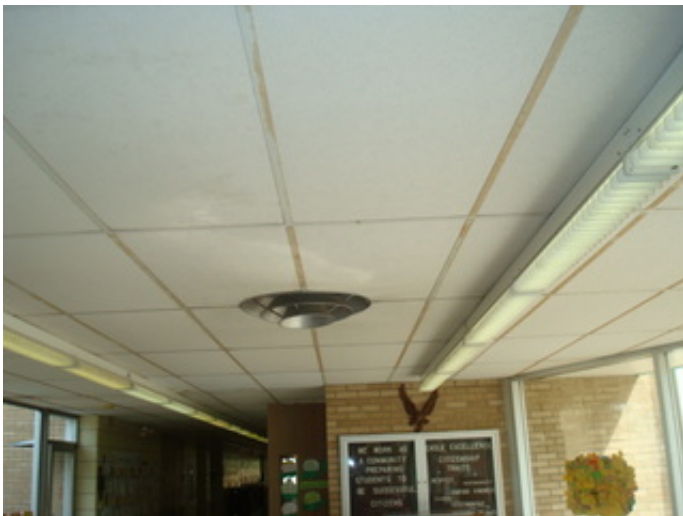
Rating: 3 Needs Replacement

Ceiling without fire suppression

Recommendations: Provide new automated fire suppression system to meet Ohio School Design Manual guidelines. Provide increased water service of a capacity sufficient to support the fire suppression system, funding included in fire suppression funding. Provide new emergency generator, with funding provided via complete replacement of electrical system in Item D.
