Building Information - Willoughby-Eastlake City SD (45104) - Grant Elem

Program Type	Expedited Local Partnership Program (ELPP)
Setting	Suburban
Assessment Name	Grant E_2010_TCI
Assessment Date	2010-03-16
Cost Set:	2010
Building Name	Grant Elem
Building IRN	14175
Building Address	38281 Hurricane Dr
Building City	Willoughby
Building Zipcode	44094
Building Phone	440/942-5944
Acreage	16.85
Current Grades	K-5
Teaching Stations	20
Number of Floors	1
Student Capacity	500
Current Enrollment	427
Enrollment Date	2009-09-01
Enrollment Date is the date in which the current enrollment was taken.	
Number of Classrooms	20
Historical Register	NO
Building's Principal	Ms. Sue Kahl
Building Type	Elementary

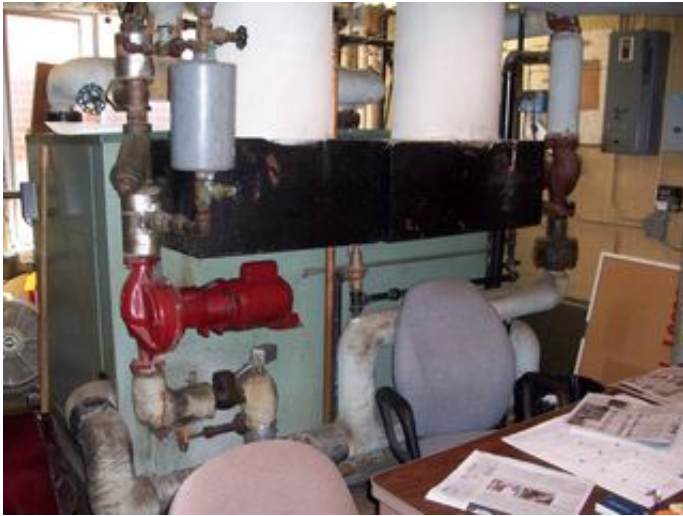
Description: The existing heating system for the overall facility is composed of a major hot water boiler centrally located in the main mechanical room which was installed in 1961. The unit is in good condition. The heating system in the overall facility is part of the Original Construction and is a 2-pipe system supplying hot water heating. With very limited capacity for simultaneous heating and cooling operation, this system is not compliant with the OSDM requirements for basic system type. The forced draft hot water boiler, manufactured by Peerless was installed in 1961 and is in decent condition. Heating hot water is distributed to terminal units consisting of unit ventilators, cabinet heaters, unit heaters, and fin tubes. The terminal equipment was installed in 1961 and new with each addition and is in fair condition. The system does (not) comply with the 15 CFM per person fresh air requirements of the Ohio Building Code mechanical code and Ohio School Design Manual. The non DDC type system temperature controls were installed in 1961 and are in working condition. The system does feature individual heating temperature controls in all spaces required by the OSDM. The overall system does not feature any central energy recovery systems. The facility is equipped with louvered interior doors in storage, utility rooms and a few classrooms to facilitate Corridor utilization as return air plenums while additional classrooms have a return air systems. The existing system is not ducted, and floor to structural deck heights will not accommodate the installation of properly sized ductwork for a future Ohio School Design Manual approved system. The overall heating system is evaluated as being not in safe and efficient working order, though long term life expectancy of the existing system is anticipated. The structure is not equipped with central air conditioning. The site does not contain underground fuel tanks.

Rating: 3 Needs Replacement

Gas Fired Hot Water Boiler

Recommendations: Provide new overall heating, ventilating, and air conditioning system to achieve compliance with Ohio Building Code and Ohio School Design Manual standards. Convert to ducted system to facilitate efficient exchange of conditioned air.

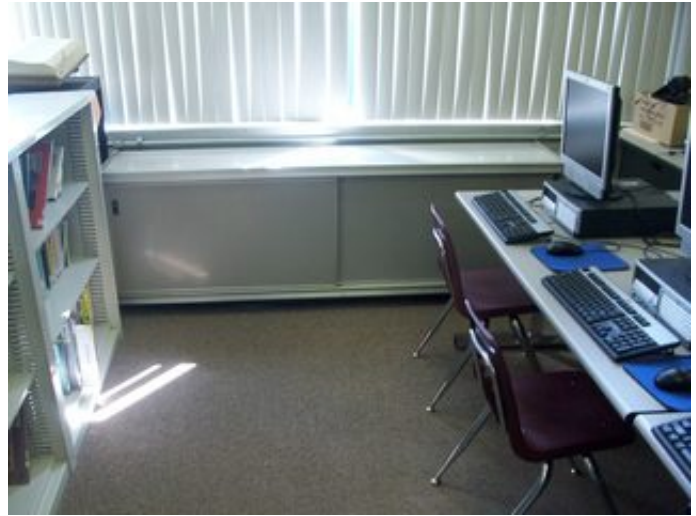
Typical Unit Ventilator

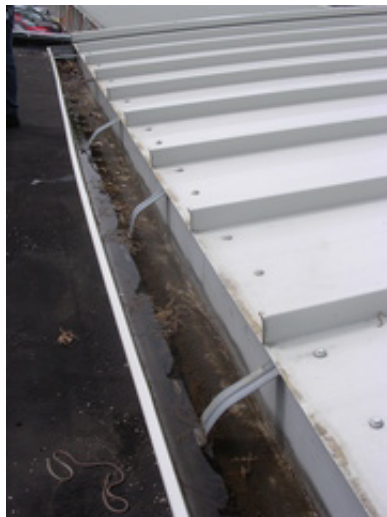
Description: The roof over the most of the overall facility is a standing seam metal roofing system that was installed in approximately 2005, and is in fair condition, except an area of built-up roofing over the 1973 Addition that was installed in approximately 2001 and is in poor condition. The District reported current leaking in the area between the 1961 Original Construction and the 1966 Addition which has not been confirmed to be roof-related. Signs of past leaking were observed during the physical assessment in the low-slope area of the 1973 Addition. Access to the roof was gained by portable ladder. Fall safety protection cages are not required. There are two mechanical units on the built-up roofing area of the 1973 Addition that require a guard rail to meet Ohio Building Code. There were observations of standing water on the low-slope area of roof in the 1973 Addition. Metal cap flashings on the 1973 Addition low-slope roof are in poor condition. Roof storm drainage is addressed through a system of gutters and downspouts which are properly located, and in poor condition. On the built-up roof area of the 1973 Addition, roof storm drainage is addressed through a system of roof drains which are in poor condition. The roof is not equipped with overflow roof drains, though they are needed on this building. Roof penetration condition matched that of the roof surface. There are not any covered walkways attached to this structure.

Rating: 2 Needs Repair

Typical standing seam metal roof and gutter condition.

Recommendations: Replace roof and provide insulation for the 1973 Addition to meet Ohio School Design Manual guidelines due to condition. Roof drains require replacement along with the addition of tapered insulation to slope to drain and overflow drainage. The flashing and coping at the built-up roofing area of the 1973 Addition require replacement due to condition. The gutters and downspouts throughout most of the facility require replacement due to condition, and snow guards are required to prevent further damage to the gutters. Provide guardrail at mechanical equipment.

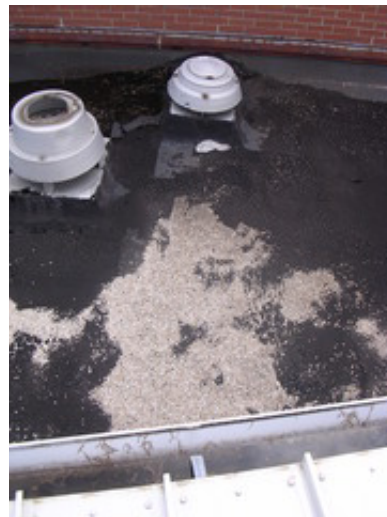
Typical built up roofing and flashings.

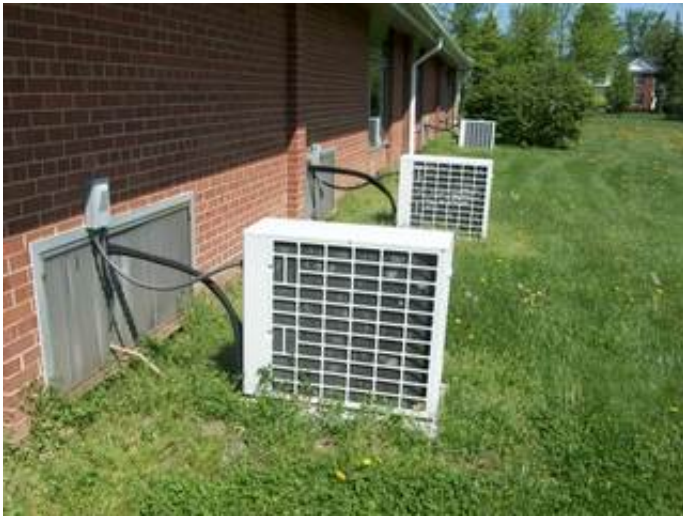
Description: The overall facility is not equipped with a central air conditioning system. Air conditioning is provided in miscellaneous locations such as offices, library, media center and Teacher's Lounge. The ventilation system in the overall facility consists of unit ventilators and ducted air handlers installed initially in 1961 and are in fair condition, providing fresh air to classrooms and other miscellaneous spaces such as Gymnasiums, Student Dining, Media Center etc.). Relief air venting is provided by relief fans and roof vents The ventilation system does not meet the Ohio Building Code 15 CFM per occupant fresh air requirement. The overall system is not compliant with Ohio Building Code and Ohio School Design Manual requirements. Dust collection systems are not required in this facility and no system is provided. The Art program is non existent. Exhaust systems for Restrooms, Locker Rooms, Kitchen, Gymnasiums, Storage Rooms, Custodial Closets and Career Tech specialized areas are adequately placed, and in working condition.

Mini Split Air Conditioners

Recommendations: Provide an air conditioning system to meet with Ohio Building Code and Ohio School Design Manual requirements. Pricing included in Item A. Provide kiln exhaust system for kiln listed in item J.

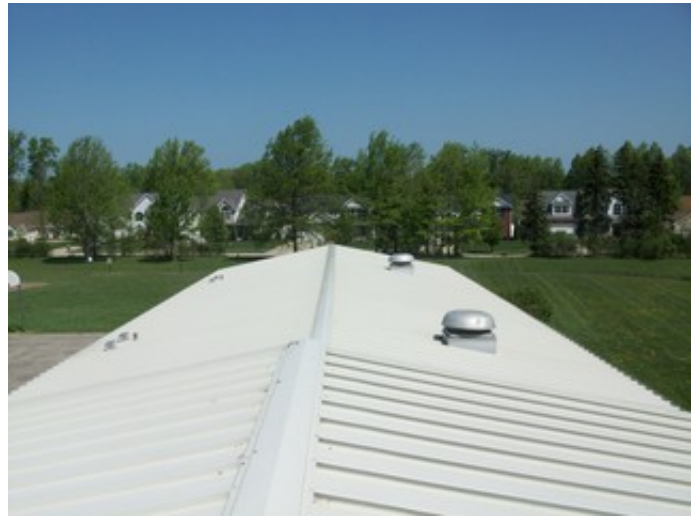
Roof top Ventilation Fans

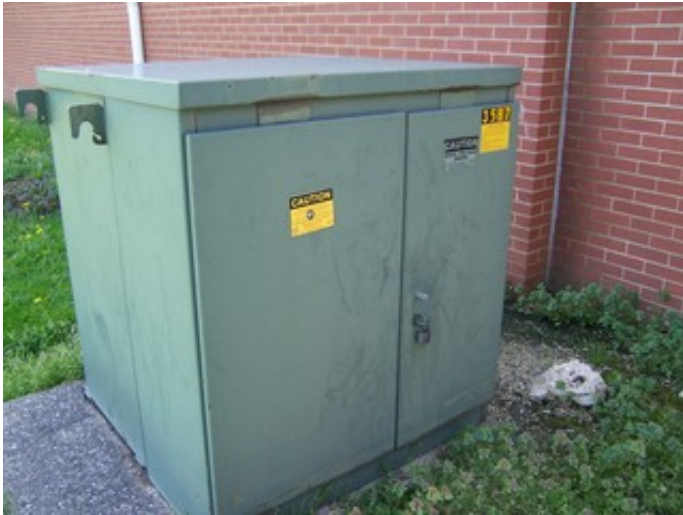
Description: The electrical system provided to the overall facility is a 400 amp 120/208 volt, 3 phase, 4 wire original system from the year 1961, and is in fair condition. Power is provided to the school by pole mounted utility owned transformers. The main distribution panel cannot be expanded to add additional capacity that would be required by the OSDM air conditioning requirements. The Classrooms are not equipped with adequate electrical outlets in some of the original areas per OSFC recommendations. The typical Classroom contains usually 2 to 3 general purpose outlets with certain classrooms having added outlets used for Classroom computers, and television. There are some spaces that have no electrical outlets such as storage areas and Janitor Closets. Most Corridors are equipped with adequate electrical outlets for electrical servicing. Adequate GFI protected exterior outlets are not provided around the perimeter of the building. The facility is not equipped with an emergency generator. There is a 100 amp emergency panel 'E', which feeds items such as exit lights, emergency lights and the Fire Alarm panel. Panel 'E' is fed directly from a 60 amp 240 V. disconnect switch. Adequate building lightning protection safeguards are not provided. The overall electrical system does not meet Ohio School Design Manual requirements, and will be inadequate to meet the facility's future needs.

Rating: 3 Needs Replacement

Pad Mounted Transformer

Recommendations: The entire electrical system requires replacement to meet Ohio School Design Manual guidelines for overall capacity due to lack of OSDM - required features and to accommodate the addition of an air conditioning system.

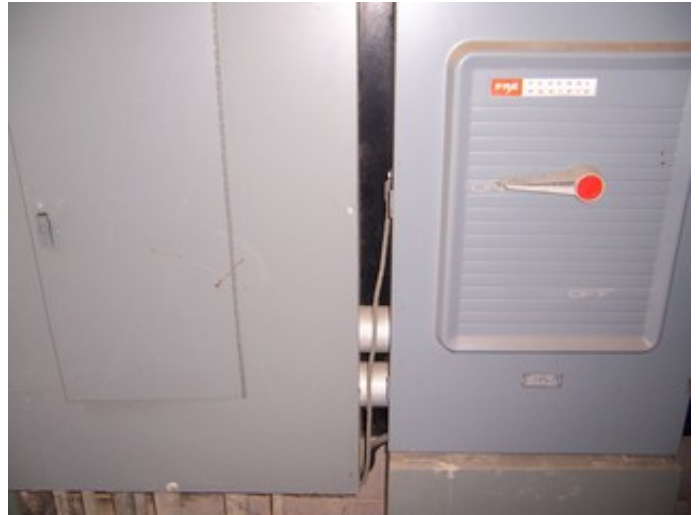
Main Electrical Switch & Panel

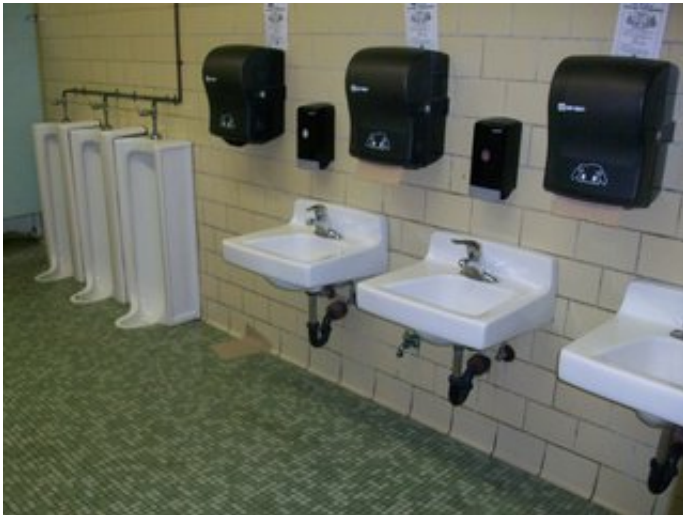
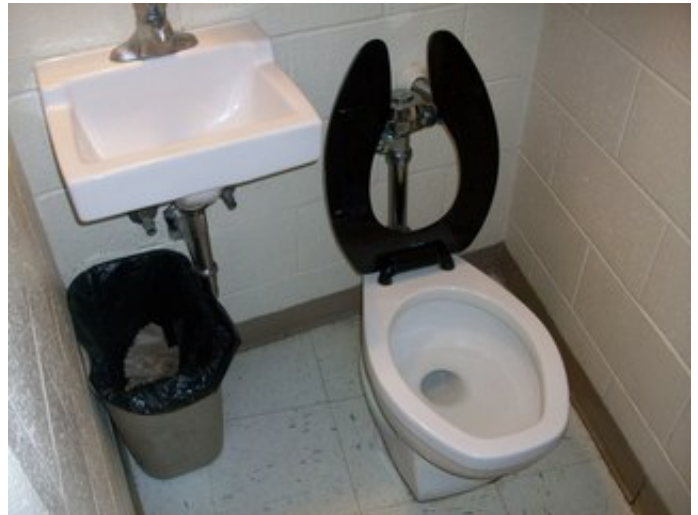
Description: This school has 18 water closets, 5 urinals, 15 lavatories, 2 wall hung electric water coolers, 11 sinks, and 2 mop sinks. Most of the plumbing fixtures are in fair condition, but ADA requirements are not met for plumbing fixtures. A reduced principle backflow preventer is required. The water heater appears to be in good condition. Domestic water piping is copper and appears to be in good condition. Sanitary drainage and vent piping is cast iron that appears to be in good condition.

Rating: 3 Needs Replacement

Toilet room fixtures

Recommendations: Provide all new plumbing fixtures, faucets and flush valves to replace the existing because of ADA requirements and condition of old plumbing fixtures. Replace existing domestic water heater with new high efficient gas water heater. The recommendation for domestic water piping is in section R. The recommendation for sanitary drainage piping is in section Q.

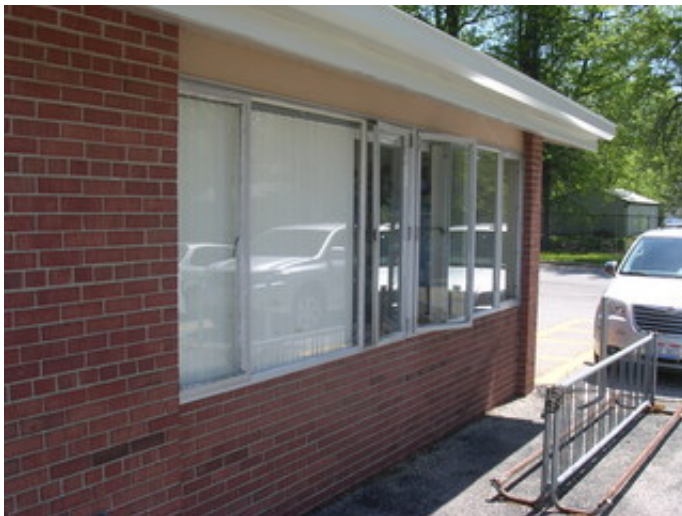
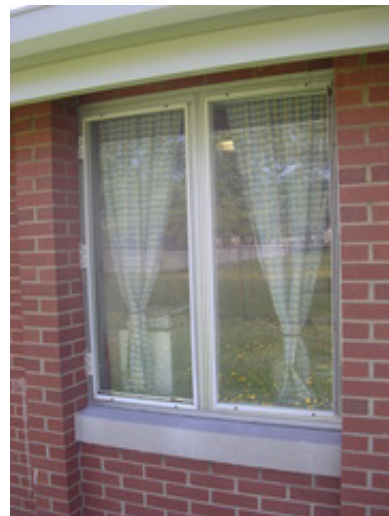
Description: The overall facility is equipped with non-thermally broken aluminum frame windows with single glazed non-insulated glazing type window system, which were installed in at the times of construction, and are in poor condition. Window system seals are in poor condition, with moderate air and no water infiltration being experienced. Window system hardware is in poor condition. The window system features surface mounted blinds, which are in moderate condition. The window system is equipped with insect screens on some of the operable windows, which are in moderate condition. Aluminum storefront systems are found in the 1961 original construction, and are in fair to poor condition. This facility does not feature any glass block windows. The exterior doors in the overall facility are equipped with non-thermally broken steel frame transoms with single glazed non-insulated glazing, in poor condition. Window security grilles are not provided for ground floor windows. There is not a Greenhouse associated with this school.

Rating: 3 Needs Replacement

Typical aluminum window system.

Recommendations: Provide a new insulated window system with integral blinds to meet with Ohio School Design Manual requirements. Replace storefront system in the 1961 Addition to meet with Ohio School Design Manual requirements. Replace window transoms in exterior doors of the 1973 Addition with approved safety glass.

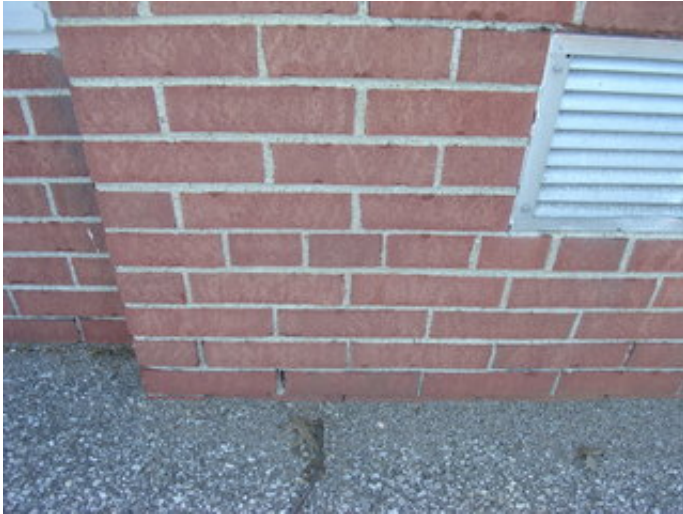
Description: The 1961 Original Construction and 1966 Addition foundations systems are concrete block on poured footings. The 1973 Addition has poured concrete foundations with poured footings. Damp proofing is noted on the 1966 Addition, but not on the 1961 Original Construction or 1973 Additions, which displayed no locations of significant differential settlement, cracking, or leaking, and are in fair condition. The District reports that there has been no past leaking. Minor grading/site drainage deficiencies were noted around the perimeter of the structure that could contribute to foundation / wall structural deterioration. The perimeter underground roof drainage tiles are showing signs of backing up causing site ponding.

Rating: 2 Needs Repair

Typical foundation condition.

Recommendations: Provide drainage tile system at the 1966 and 1973 additions because of poor drainage and site ponding.

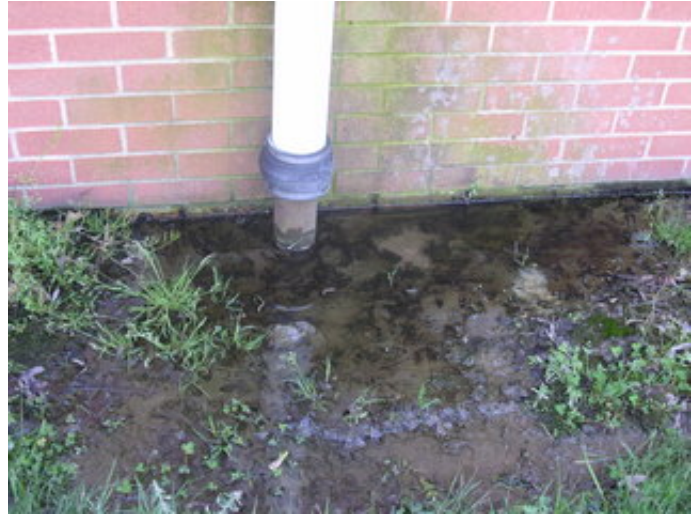
Condition at damaged underground drain tile.

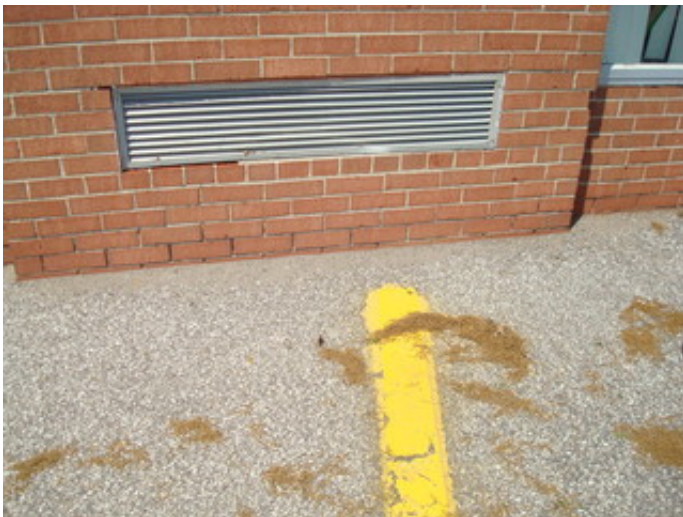
Description: The overall facility has a brick veneer on a masonry bearing wall system, which displayed no locations of deterioration, and is in fair condition. The exterior masonry appears to have appropriately spaced and adequately caulked control joints that are generally in fair condition, although some re-caulking is necessary, and there are several windows that require control joints from the sill to grade due to cracking. Control joints are not provided at lintel locations at doors and windows and are apparently not needed. The school does not contain expansion joints, and none are needed as there is no indication of exterior masonry cracking or separation. The exterior masonry has not been cleaned and sealed in recent years, and shows minimal evidence of mortar at walls facing the parking areas in the 1961 Original Construction and 1973 Addition. Interior walls are concrete masonry units and are in fair condition. Interior masonry appears to have adequately spaced and caulked control joints in fair condition. Soffits are in fair condition. The window sills in the 1966 Addition are precast concrete, and are in fair condition. The window sills in the 1961 Original Construction and the 1973 Addition are an element of the aluminum window system. The exterior lintels are steel, and are covered by the window head, although exterior steel lintels at exterior doors throughout the overall facility are rusting and in need of painting. The lintels at the electrical room of the 1973 Addition are in poor condition and need to be replaced. Chimneys are in fair condition, but some mortar deterioration is apparent and minimal tuck pointing is required. Canopies over entrances are metal roof with metal soffit type construction, and are in fair condition.

Rating: 2 Needs Repair

Tuck pointing needed at 1961 Original Construction

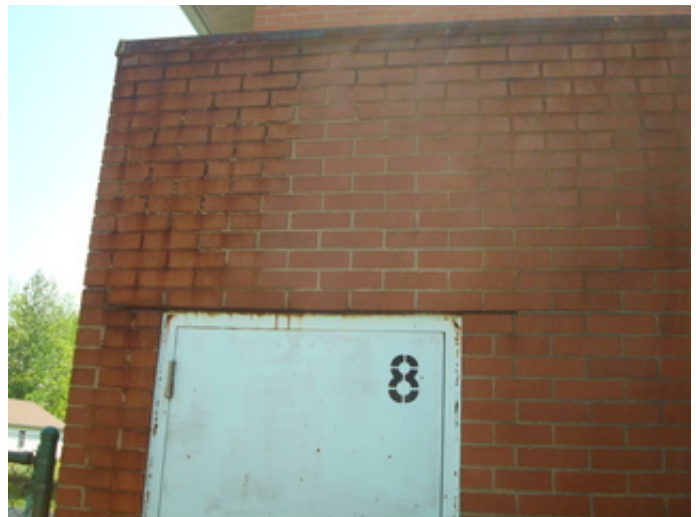
Lintel replacement needed at 1973 Addition electrical room

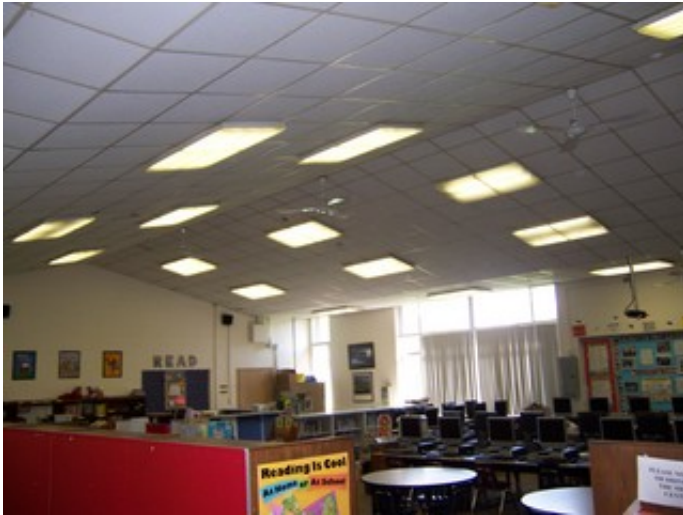
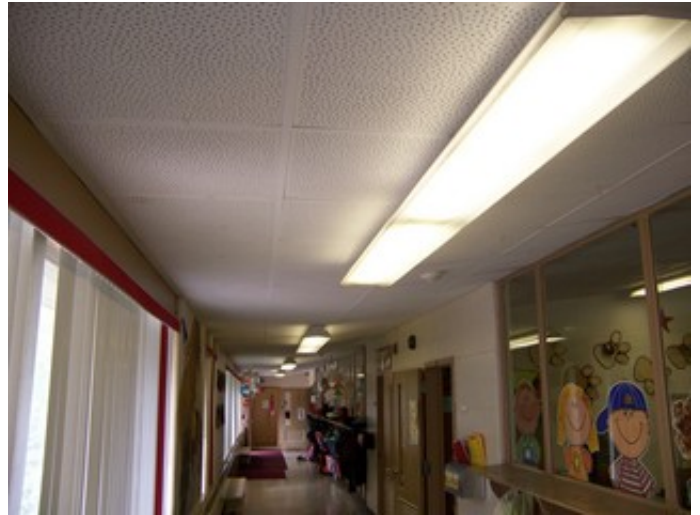
Rating: 3 Needs Replacement

Media Room Lighting

Recommendations: Provide complete replacement of lighting system due to age, condition of lighting fixtures and installation of a fire protection system.

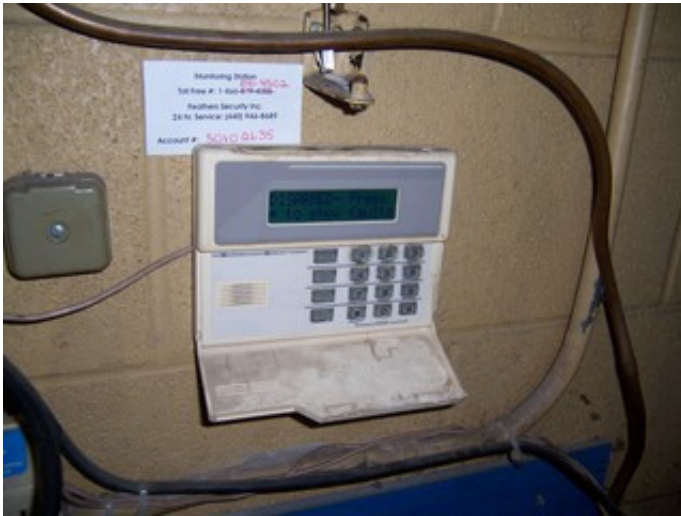
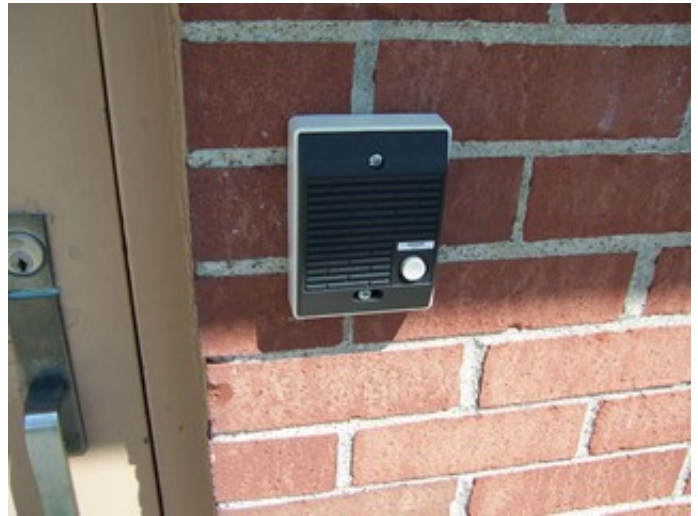
Rating: 3 Needs Replacement

Security Alarm Controls

Recommendations: Provide complete replacement of security system to meet Ohio School Design Manual guidelines. Provide complete replacement of exterior site lighting system to meet Ohio School Design Manual guidelines.

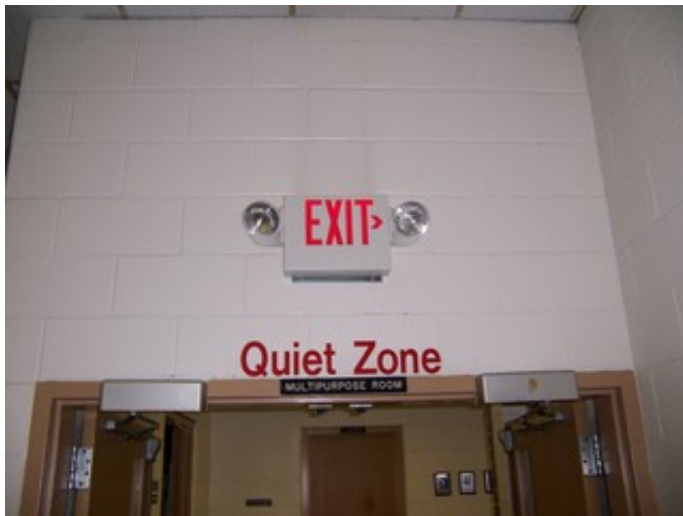
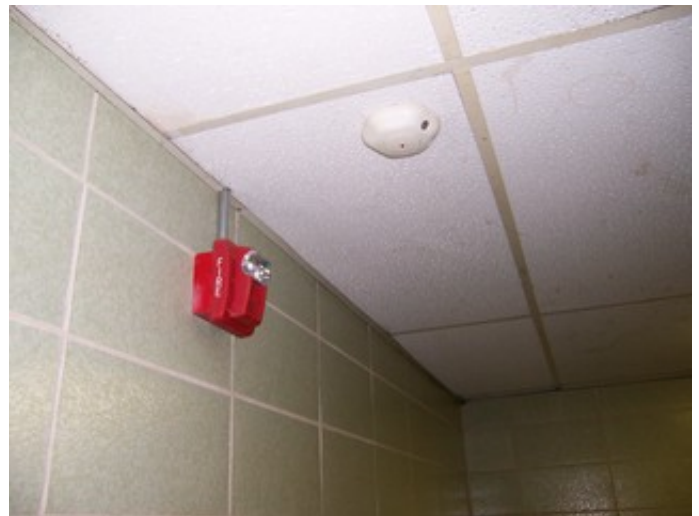
Rating: 3 Needs Replacement

Wall Mounted Exit Sign

Recommendations: Provide complete replacement of the emergency / egress lighting system throughout to meet the Ohio School Design Manual guidelines.

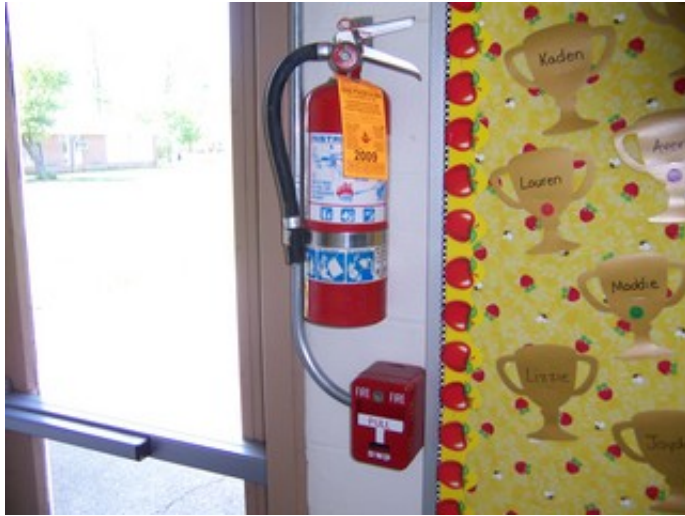
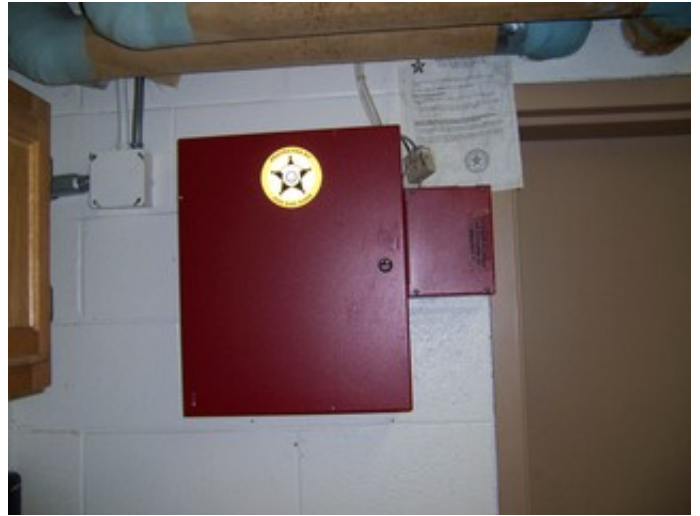
Rating: 3 Needs Replacement

Fire Alarm & Device

Recommendations: Recommend providing a complete new Fire Alarm System to meet the Ohio School Design Manual and the Ohio Building Code.

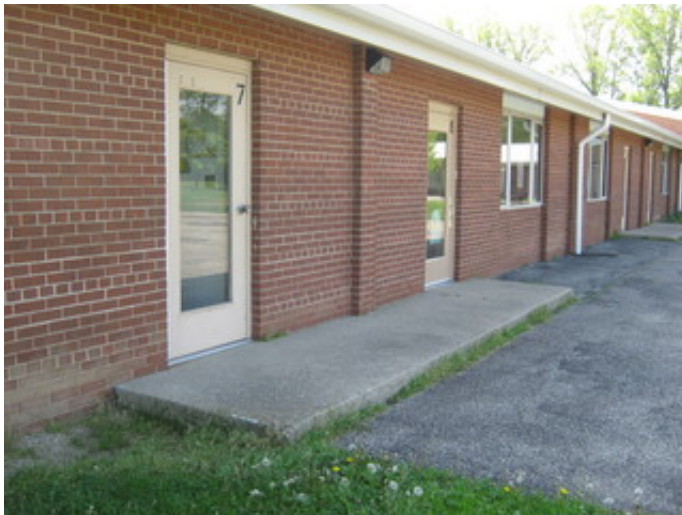
Rating: 2 Needs Repair

Stoop at classroom exits

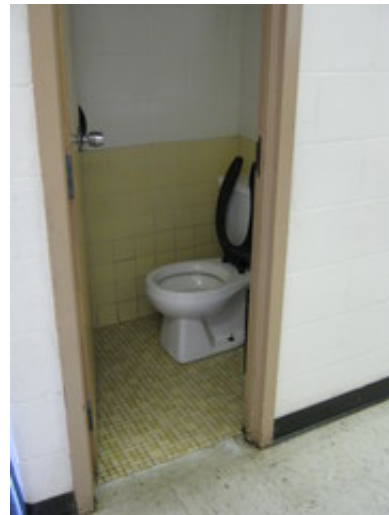
Non-compliant private toilet

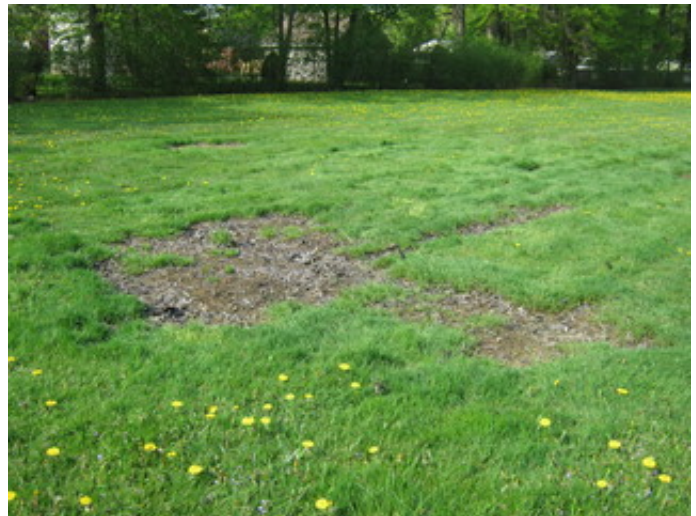
Rating: 2 Needs Repair

Evidence of ponding

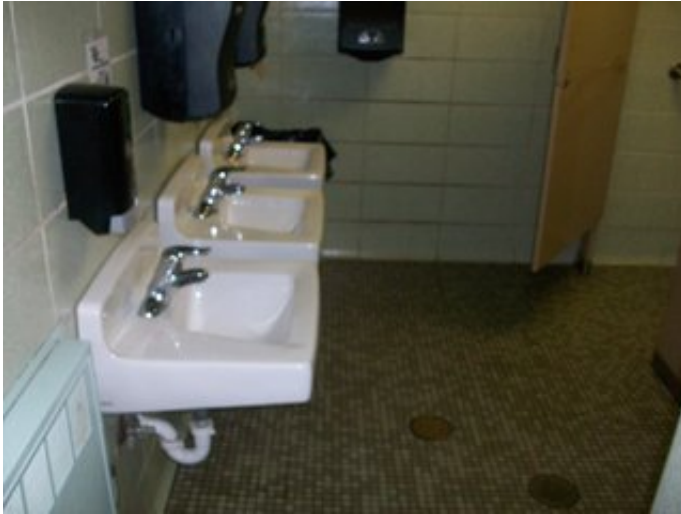
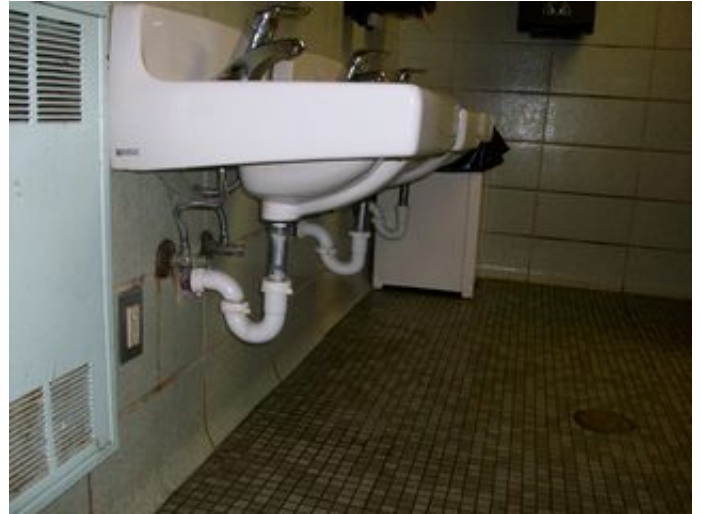
Sanitary drain below sink

Recommendations: The sanitary original drainage system is 49 years old. Recommend replacing with new sanitary and vent piping.

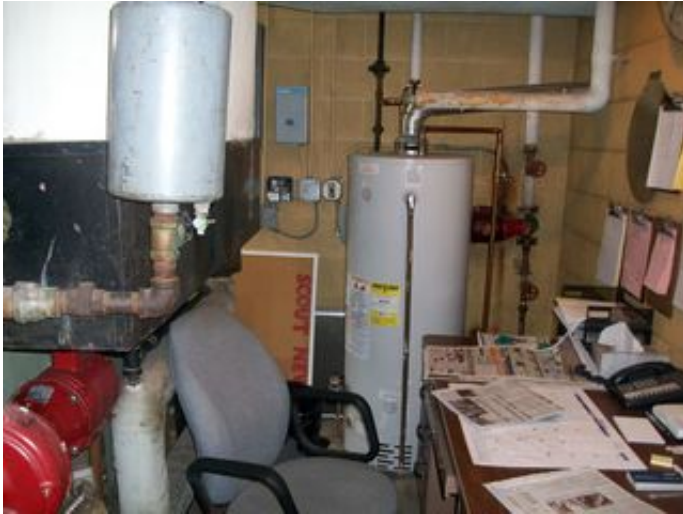
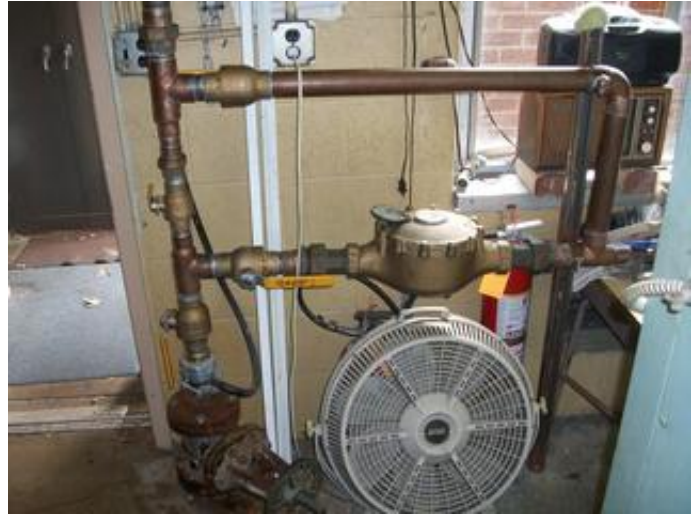
Domestic water piping

Recommendations: The original existing domestic water piping is 49 years old. Recommend replacing with new domestic water piping from the city site main.

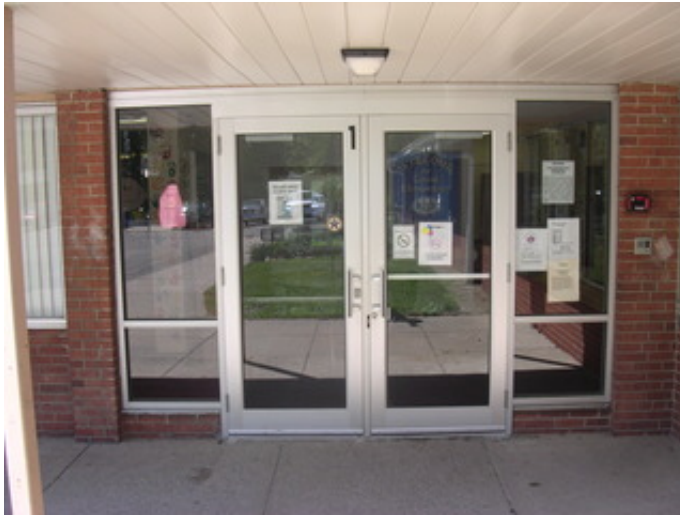
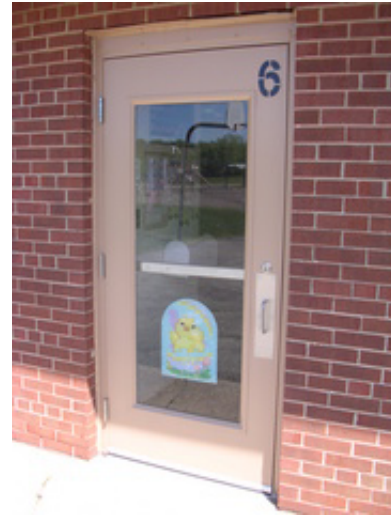
Typical aluminum entry system.

Recommendations: Replace exterior doors in the overall facility that are in poor condition to comply with Ohio Building Code, ADA, and Ohio School Design Manual guidelines.

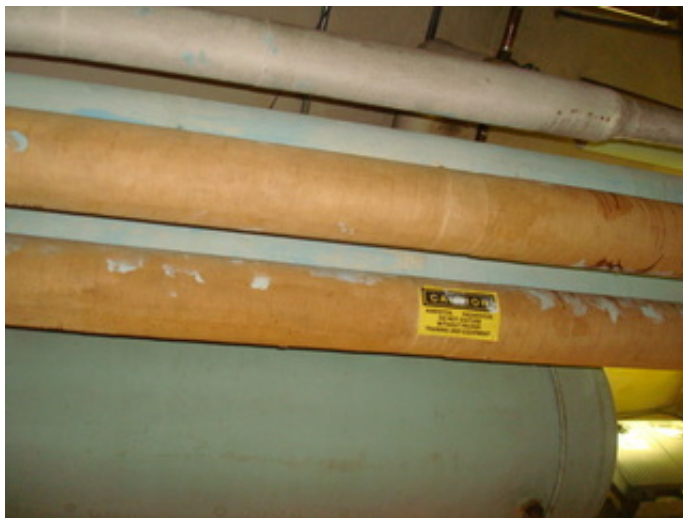
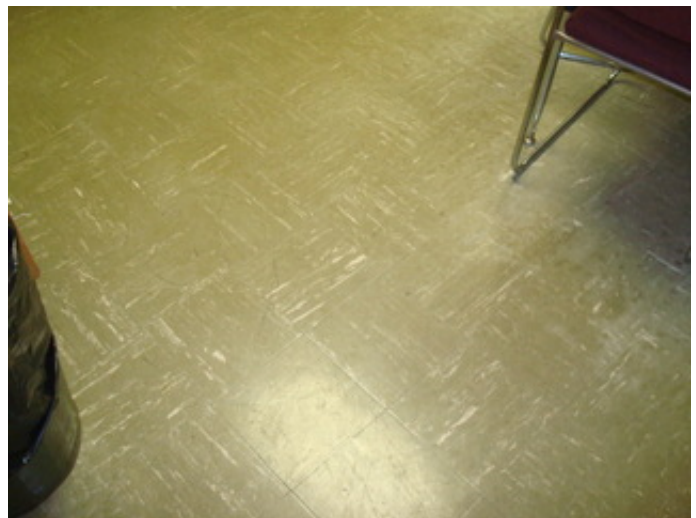
Pipe insulation

Recommendations: Remove all hazardous materials, inclusive of asbestos-containing materials in the overall facility, as noted in the attached Environmental Hazards Assessment.

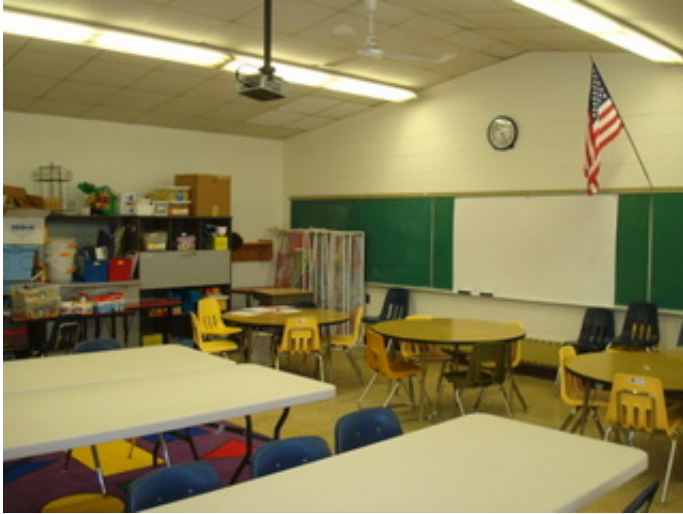
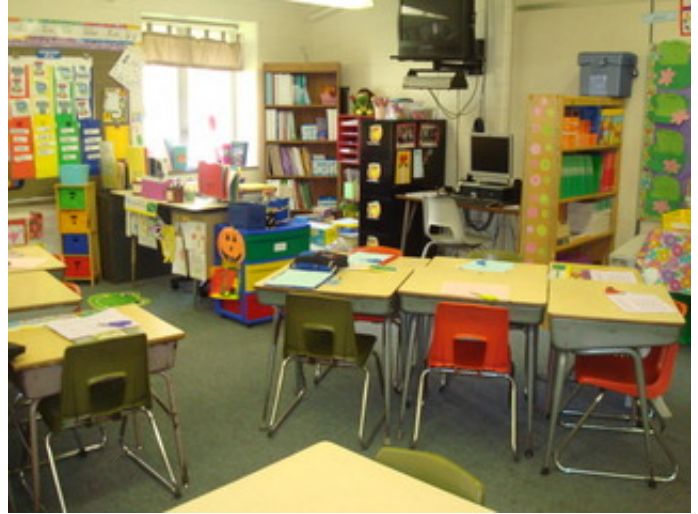
Classroom furniture

Recommendations: Provide for replacement of outdated or inadequate furniture.
