Building Information - Willoughby-Eastlake City SD (45104) - Jefferson Elementary

Program Type	Expedited Local Partnership Program (ELPP)
Setting	Suburban
Assessment Name	Jefferson E_2010_TCI
Assessment Date	2010-03-16
Cost Set:	2010
Building Name	Jefferson Elementary
Building IRN	18077
Building Address	35980 Lake Shore Blvd
Building City	Eastlake
Building Zipcode	44095
Building Phone	440/942-7244
Acreage	6.45
Current Grades	K-5
Teaching Stations	32
Number of Floors	2
Student Capacity	800
Current Enrollment	478
Enrollment Date	2010-04-01
Enrollment Date is the date in which the current enrollment was taken.	
Number of Classrooms	32
Historical Register	NO
Building's Principal	Ms. Barrie Alves
Building Type	Elementary

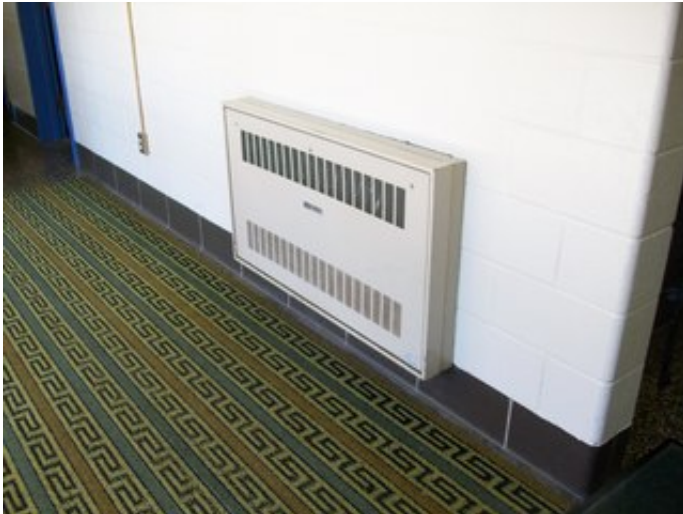
Description: The existing heating system for the overall facility is composed of three major hot water boilers centrally located in the main mechanical room of Eastlake MS where two of the boilers were installed in 1949 and the other one was installed 2008. These three boilers service both Eastlake MS and Jefferson ES. One of the original units is decommissioned and the other is in fair condition. The 2008 newly installed boiler unit is in excellent condition. The heating system in the overall facility is part of the Original Construction and is a 2-pipe system supplying hot water. With limited capacity for simultaneous heating and cooling operation, this system is not compliant with the OSDM requirements for basic system type. The forced draft hot water boilers, manufactured by Pacific and Campus were installed in 1949 and 2008 respectively and are in fair condition for the 1949's and excellent condition for the 2008 installation. Heating hot water is distributed to terminal units consisting of unit ventilators, cabinet heaters, unit heaters, and fin tubes. The terminal equipment was installed in 1951 and new with each addition and is in fair condition. The system does not comply with the 15 CFM per person fresh air requirements of the Ohio Building Code mechanical code and Ohio School Design Manual. The non DDC type system temperature controls were installed in 1949 and are in working condition. The system does feature individual heating temperature controls in all spaces required by the OSDM. The overall system does not feature any central energy recovery systems. The facility is equipped with louvered interior doors in storage and utility rooms to facilitate Corridor utilization as return air plenums while the classrooms have a return air systems. The existing system is not ducted, and floor to structural deck heights will not accommodate the installation of properly sized ductwork for a future Ohio School Design Manual approved system. The overall heating system is evaluated as being not in safe and efficient working order, though long term life expectancy of the existing system is anticipated. The structure is not equipped with central air conditioning. The site does not contain underground fuel tanks that are currently in use.

Rating: 3 Needs Replacement

Typical Electric Unit Heater

Recommendations: Provide new overall heating, ventilating, and air conditioning system to achieve compliance with Ohio Building Code and Ohio School Design Manual standards. Convert to ducted system to facilitate efficient exchange of conditioned air.

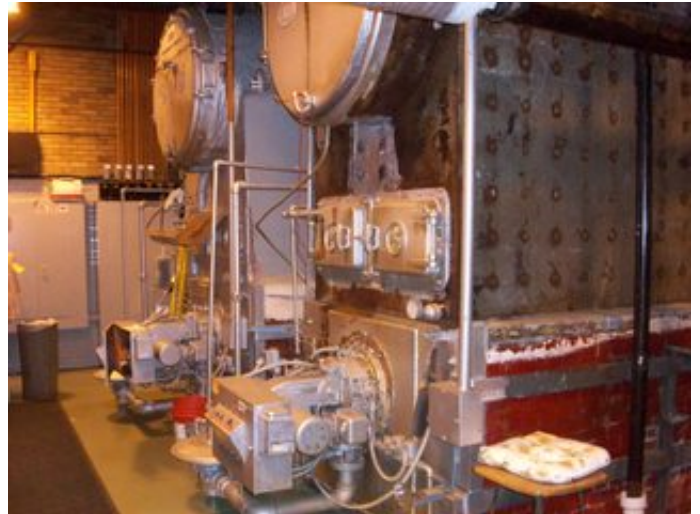
Gas Fired Boilers (At Eastlake)

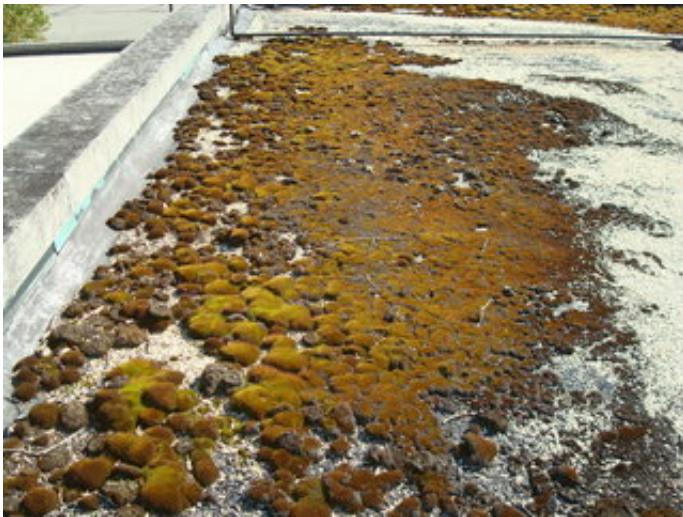
Description: The roof over the 1951 Original Construction is a built-up system that was installed greater than 20 years ago and is in poor condition. The roof over the 1957 Addition is a built-up system that was installed in 2003 and is in fair condition. The roof over the 1970 Addition except the gymnasium is a built-up system that was installed in 2002 (west half) and 2007 (east half) and is in fair condition, and the roof of the 1970 Addition gymnasium is a built-up system that was installed in 2006 and is in poor condition. There are District reports of current leaking over the 1970 Addition gymnasium. Signs of past leaking were observed during the physical assessment in the 1970 Addition gymnasium and in the stairway near the main entry to the 1951 Original Construction. Access to the roof was gained by access hatch and access ladder which are in fair condition. An access ladder is required between the lower and higher roof surfaces of the 1970 Addition. Fall safety protection cages are not required on this roof. Standing water was observed on the roof, particularly over the main entry to the 1951 Original Construction. Significant moss growth was observed on the roof of the 1951 Original Construction. Stone copings are in fair condition but most require removal and re-setting with new caulk joints as addressed in Item H. Part of the metal flashing on the 1970 Addition on the west side of the gymnasium is in poor condition. Roof storm drainage is addressed through a system of roof drains, which are properly located, and vary in condition from fair to poor depending on the condition of the roof surface. The roof is not equipped with overflow roof drains though they are needed on this building. The entrance canopy at the east side of the 1957 Addition does not have a gutter and downspout although one is required. The conditions of roof penetrations were consistent with the condition of the roof. There are not any covered walkways attached to this structure.

Rating: 3 Needs Replacement

Significant moss growth on 1951 Original Construction

Recommendations: The roof over the 1951 Original Construction and 1970 Addition require replacement and tapered insulation to meet Ohio School Design Manual Guidelines for age of system and due to condition. The metal flashing on part of the 1951 Addition requires replacement due to condition. Due to existing conditions, eight roof drains need to be replaced on the 1951 Original Construction, one roof drain needs to be replaced on the 1957 Addition, and seven roof drains need to be replaced on the 1970 Addition. A gutter and downspout need to be added to the entrance canopy at the east side of the 1957 Addition. Provide gutters and downspouts. Provide roof ladder to 1970 Addition.

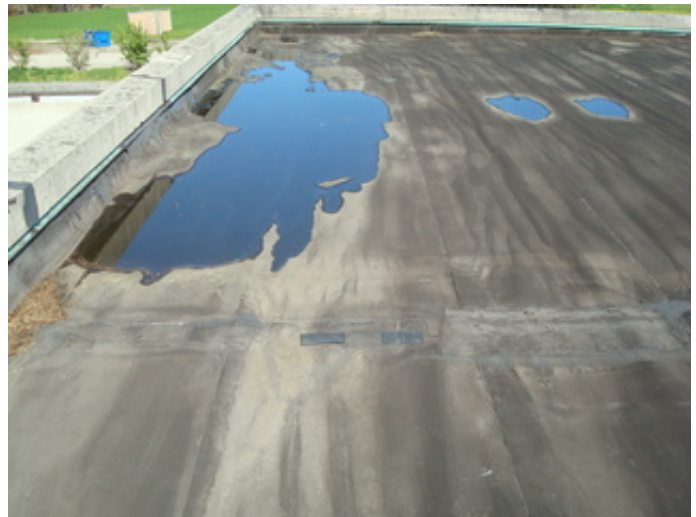
Patched area and standing water on 1970 Addition gymnasium

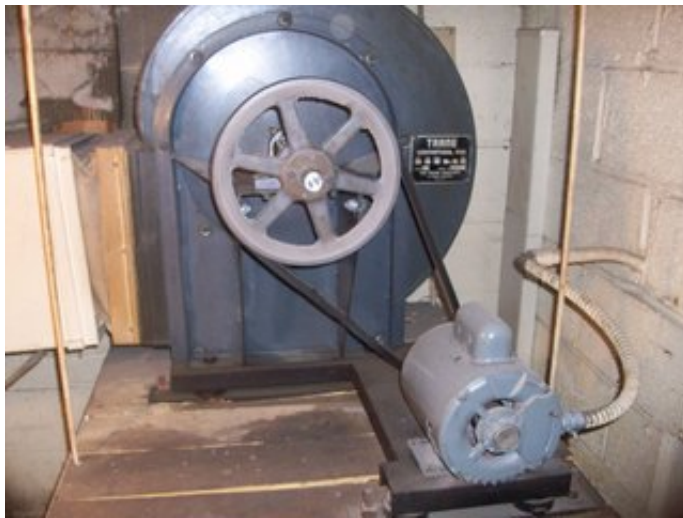
Description: The overall facility is not equipped with a central air conditioning system. Window units are provided in miscellaneous locations such as offices, library, and media center. The ventilation system in the overall facility consists of unit ventilators and ducted air handlers installed initially in 1951 and new with each addition and are in fair condition, providing fresh air to classrooms and other miscellaneous spaces such as Gymnasiums, Student Dining, Media Center etc. Relief air venting is provided by relief fans and roof vents. The ventilation system does not meet the Ohio Building Code 15 CFM per occupant fresh air requirement. The overall system is not compliant with Ohio Building Code and Ohio School Design Manual requirements. Dust collection systems are not required in this facility and no system is provided. The Art program is non-existent. Exhaust systems for Restrooms, Locker Rooms, Kitchen, Gymnasiums, Storage Rooms, Custodial Closets and specialized areas are adequately placed, and in working condition.

Ventilation Fan

Recommendations: Provide an air conditioning system to meet with Ohio Building Code and Ohio School Design Manual requirements. Pricing included in Item A. Provide kiln exhaust system for kiln listed in item J.

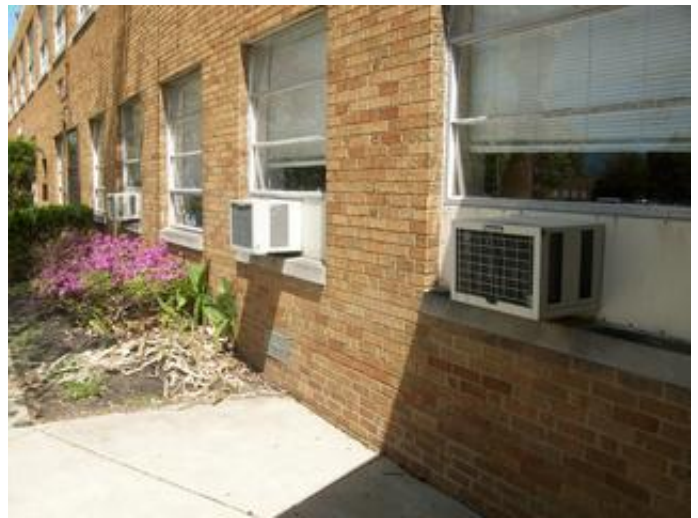
Window Air Conditioner Unit

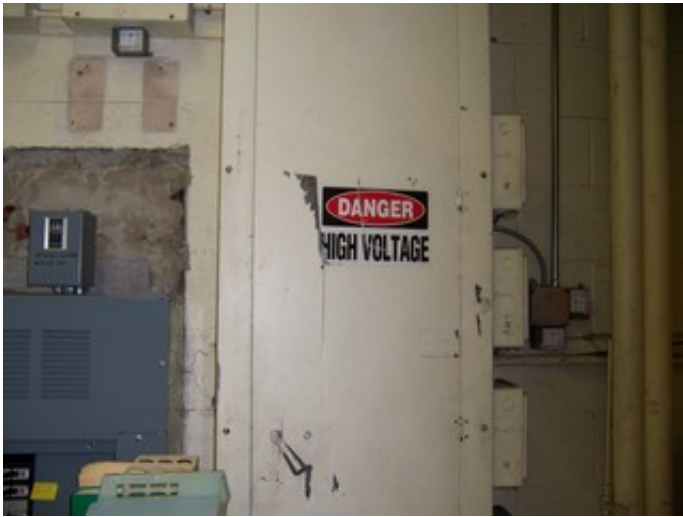
Description: Two electrical systems are provided to the overall facility; one is a 400 amp 120/240 volt, 1 phase, 3 wire original system from the year 1950, and is in fair condition. The second electrical system added under a later building addition is a 400 amp 120/208 volt, 3 phase, 4 wire system. Power is provided to the school from an original feeder from Eastlake Middle School in a campus electrical scheme system. The main distribution panels cannot be expanded to add additional capacity that would be required by the OSDM air conditioning requirements. The Classrooms are not equipped with adequate electrical outlets in some of the original areas per OSFC recommendations. The typical Classroom contains usually 2 to 3 general purpose outlets with certain classrooms having added outlets used for Classroom computers, and television. There are some spaces that have no electrical outlets such as storage areas and Janitor Closets. Some Corridors are not equipped with adequate electrical outlets for electrical servicing. Adequate GFI protected exterior outlets are not provided around the perimeter of the building. The facility is not equipped with an emergency generator. There is a 30 amp disconnect switch which feeds the Fire Alarm panel. Adequate building lightning protection safeguards are not provided. The original overall electrical system does not meet Ohio School Design Manual requirements, and both will be inadequate to meet the facility's future needs.

Rating: 3 Needs Replacement

Original Building Main Electrical Panel

Recommendations: The entire electrical systems requires replacement to meet Ohio School Design Manual guidelines and the Ohio Building Code for overall capacity due to lack of OSDM - required features and to accommodate the addition of an air conditioning system.

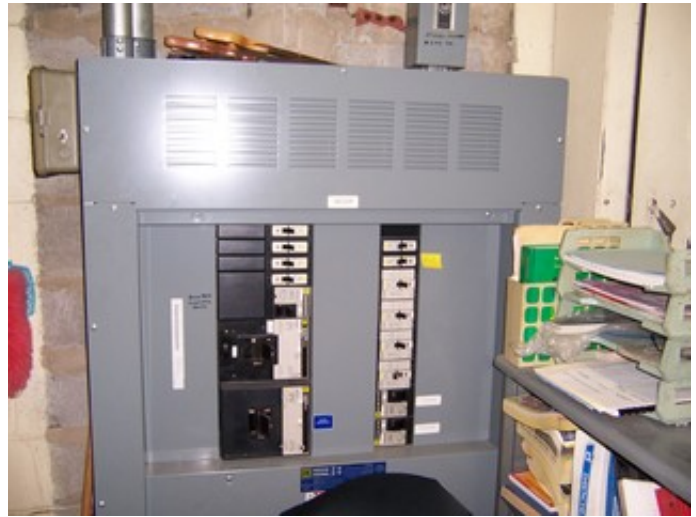
Electrical Distribution Panel

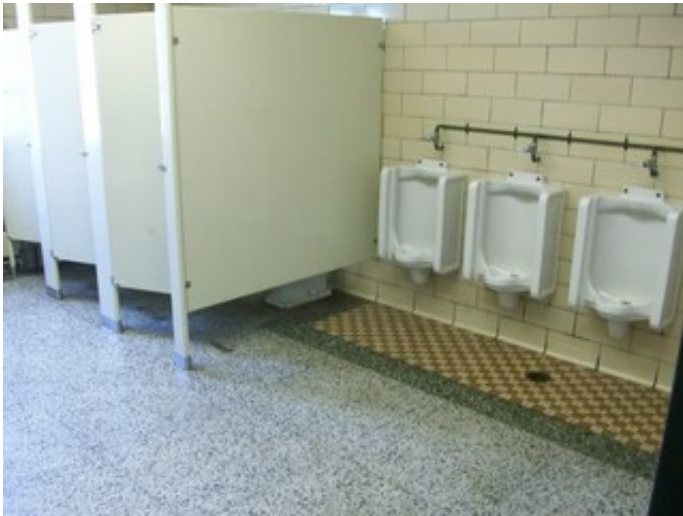
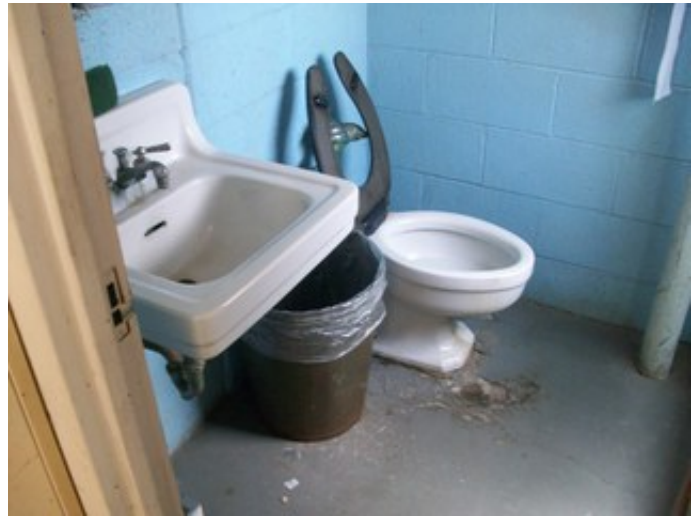
Description: This school has 30 water closets, 14 urinals, 22 lavatories, 3 wall hung electric water coolers, 23 sinks, 2 drinking fountains, 1 shower head, and 3 mop sinks. Most of the plumbing fixtures are in fair condition, but ADA requirements are not met for plumbing fixtures. A reduced principle backflow preventer is required. The water heater appears to be in very good condition. Domestic water piping is copper and appears to be in good condition. Sanitary drainage and vent piping is cast iron that appears to be in good condition.

Rating: 3 Needs Replacement

Toilet room fixtures

Recommendations: Provide all new plumbing fixtures, faucets and flush valves to replace the existing because of ADA requirements and condition of old plumbing fixtures. Refer to item O for the additional fixture replacements. Replace existing domestic water heater with new high efficient gas fired boilers. The recommendation for domestic water piping is in section R. The recommendation for sanitary drainage piping is in section Q.

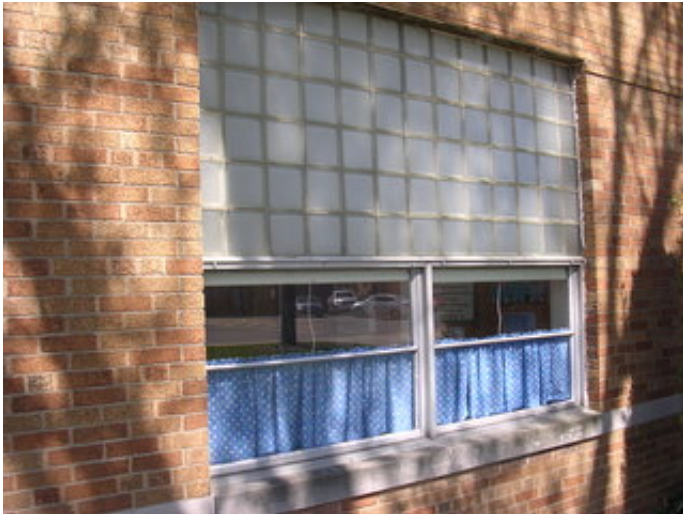
Description: The overall facility is equipped with non-thermally broken aluminum frame windows with single glazed non-insulated glazing type window system, which was installed in at the time of construction, and are in poor condition. Window system seals are in poor condition, with moderate water and frequent air infiltration being experienced. Window system hardware is in poor condition. The window system features surface mounted shades which are in moderate condition. The window system is equipped with insect screens on operable windows at the food preparation area only which are in fair condition. Hollow metal frame curtain wall systems are found in the 1970 Addition, in fair to poor condition that feature single glazed tempered glazing. There are glass block windows in the 1951 addition, in poor condition. The exterior entry doors in the 1951 original construction are equipped with non-thermally broken steel frame transoms with single glazed non-insulated glazing, in fair condition. Window security grilles are not provided for ground floor windows. There is not a Greenhouse associated with this school.

Rating: 3 Needs Replacement

Typical aluminum windows with glass block.

Recommendations: Provide a new insulated window system with integral blinds to meet with Ohio School Design Manual requirements for the overall facility. Replace storefront window system in the 1970 Addition to meet with Ohio School Design Manual requirements. Replace window transoms in exterior doors of the overall facility with approved safety glass.

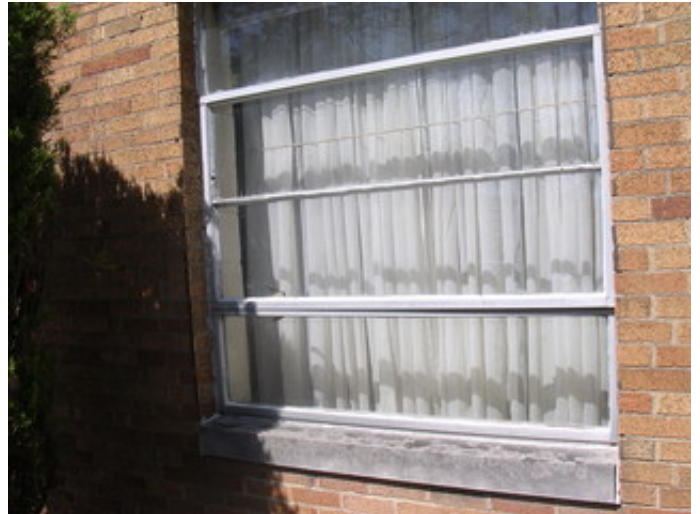
Typical aluminum windows.

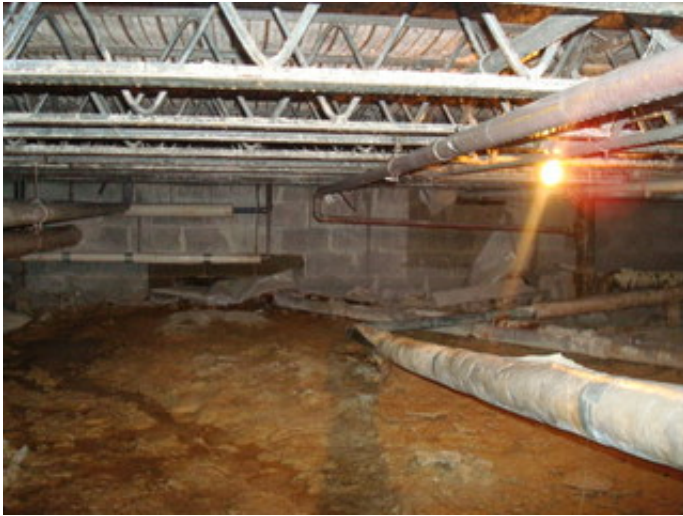
Description: The overall facility is equipped with concrete masonry unit foundation walls on concrete footings, which displayed no observed locations of significant differential settlement, cracking, or leaking, and are in fair condition. The District reports that there has been no past leaking. Minor grading or site drainage deficiencies were noted around the perimeter of the structure. Dampproofing is not called out, but drain tiles were included in the 1970 Addition.

Rating: 2 Needs Repair

Crawl wall.

Recommendations: Due to the structural wall damage observed in Item H from the earth quake damage that was reported in 1986, it is recommended that a structural engineer be retained to further assess the foundation's condition.

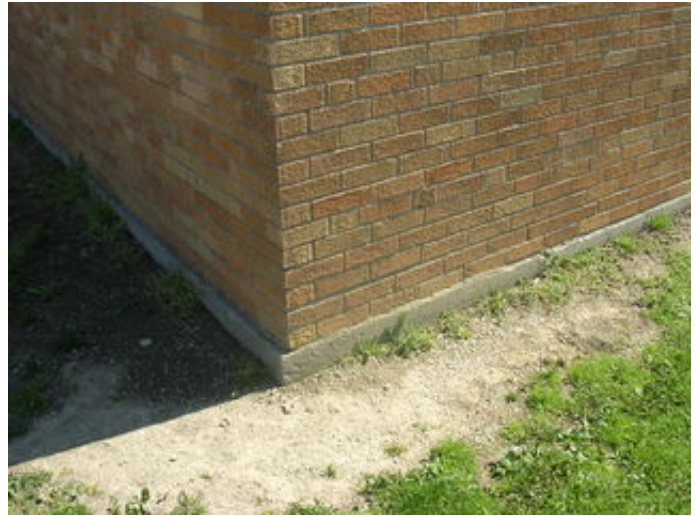
Typical exterior footing condition.

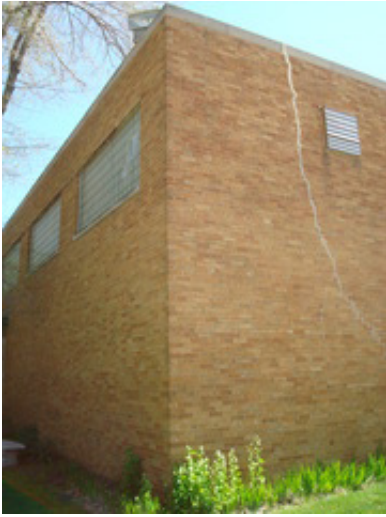
The 1951 Original Construction Student Dining space has visible signs of damage from an earthquake in 1986. A portion has been repaired and further evidence of cracking is ongoing. Foundation damage is suspected from the same earthquake. Structural evaluation is called for in items G and H. The 1951 Original Construction second floor Corridor walls have diagonal fissures both within the Corridor and occurring in several Classrooms. Similar fissures occur near the Kitchen and Workroom. Areas indicate being saw cut, patched and painted. The 1970 Addition has walls with substantial cracking near the south exit in the classroom and toilet room. Settlement from earthquake is suspected.

Description: The overall facility has a brick veneer on a masonry bearing wall system, which displayed locations of deterioration, and is in fair condition. The gymnasium in the 1951 Original Construction has visible damage from a 1980's earthquake that has been patched. The exterior masonry of the 1951 Original Construction and 1957 Addition has no caulked control joints. The 1970 Addition appears to have appropriately inappropriately spaced and adequately caulked control joints in fair condition, although some require re-caulking. Control joints are not provided at lintel locations at doors and windows. The school does not contain expansion joints, and none are needed as there is no indication of exterior masonry cracking or separation due to lack of expansion joints. The exterior masonry has not been cleaned and sealed in recent years, and shows evidence of mortar deterioration at the top of walls in the 1951 Original Construction. Architectural exterior accent materials consist of stone near the main entry to the 1951 Original Construction which is in fair condition. Interior walls are concrete masonry units, glazed block, concrete masonry units and plaster and are in fair condition. Interior masonry appears to have inadequately spaced and caulked control. The window sills are precast concrete, and are in fair condition although the window sills on the 1951 Original Building have caulk joints in poor condition. The exterior lintels are steel, and are in fair condition except at the 1951 Original Building gymnasium where the lintels are in poor condition. Chimneys are in fair condition.

Rating: 2 Needs Repair

Damaged wall at 1951 Original Construction gymnasium

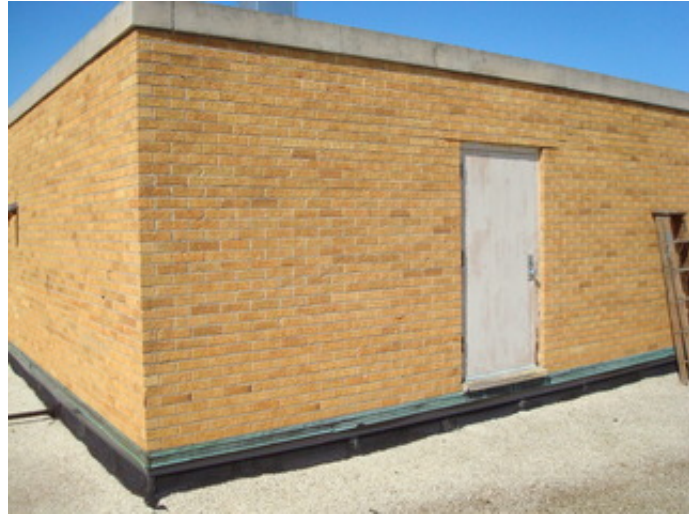
Damaged wall at 1970 Addition gymnasium

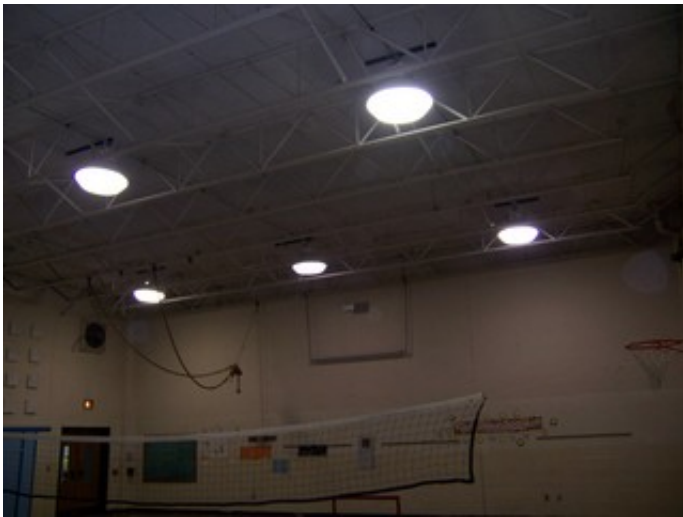
3 Needs Replacement

Gynasium Lighting

Provide complete replacement of lighting system due to age, of lighting fixtures and installation of a fire protection system.

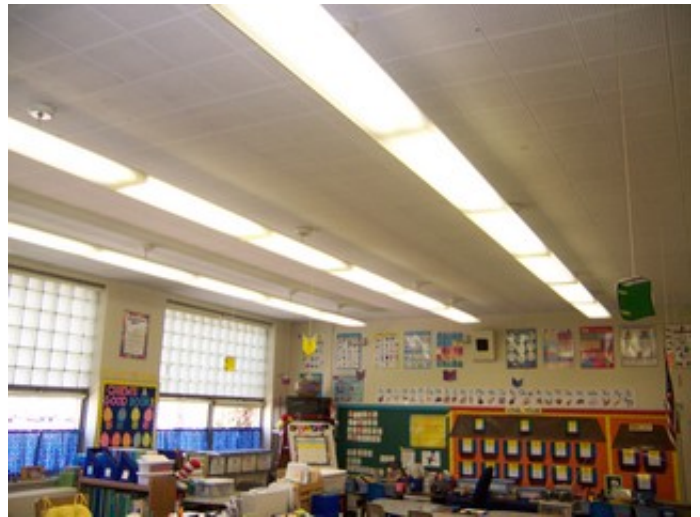
Typical Classroom Lighting

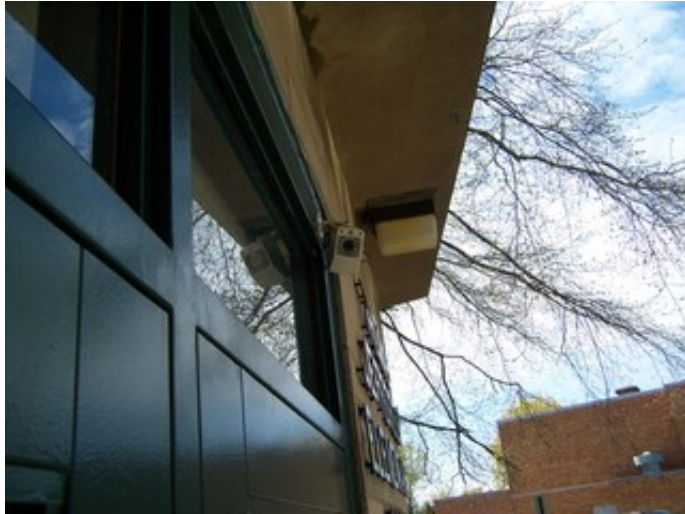
Rating: 3 Needs Replacement

Main Entrance CCTV

Recommendations: Provide complete replacement of security system to meet Ohio School Design Manual guidelines. Provide complete replacement of exterior site lighting system to meet Ohio School Design Manual guidelines.

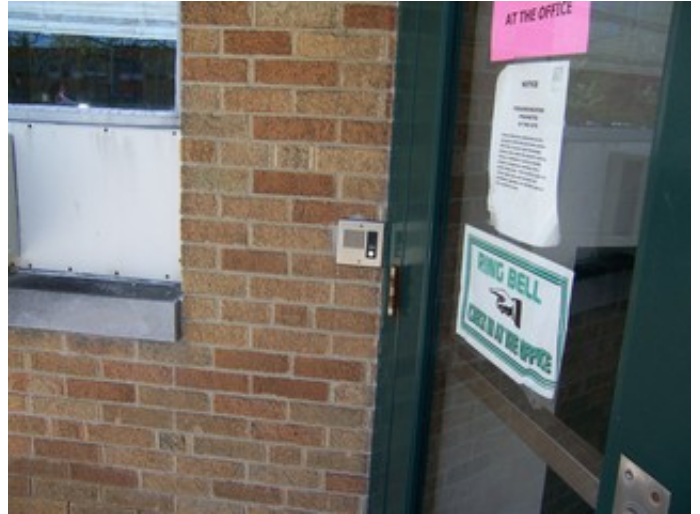
Entrance Security Buzzer

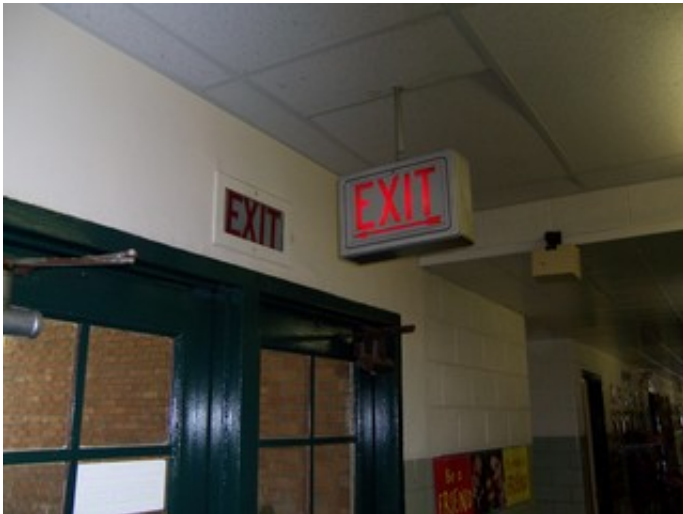
Rating: 3 Needs Replacement

Emergency Exit Signs

Recommendations: Provide complete replacement of the emergency / egress lighting system throughout to meet the Ohio School Design Manual guidelines.

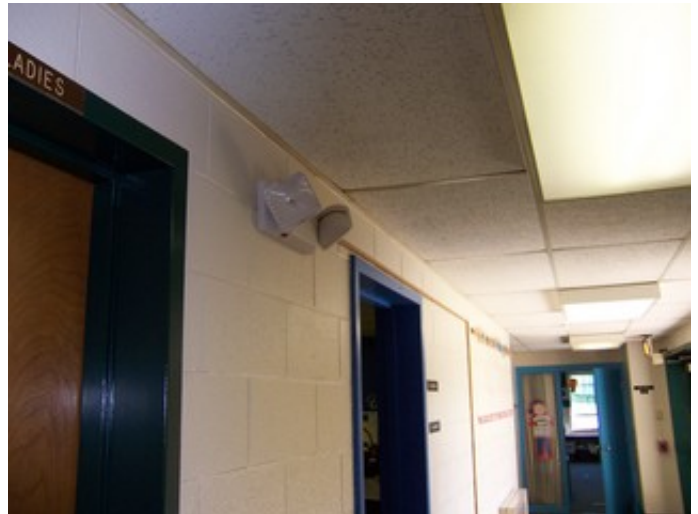
Wall Mounted Emergency Lighting

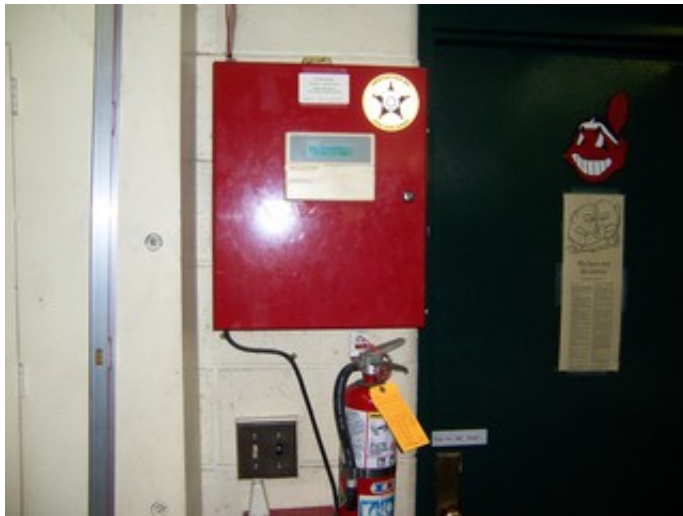
Fire Alarm Panel

Recommendations: Recommend providing a complete new Fire Alarm System to meet the Ohio School Design Manual and the Ohio Building Code.

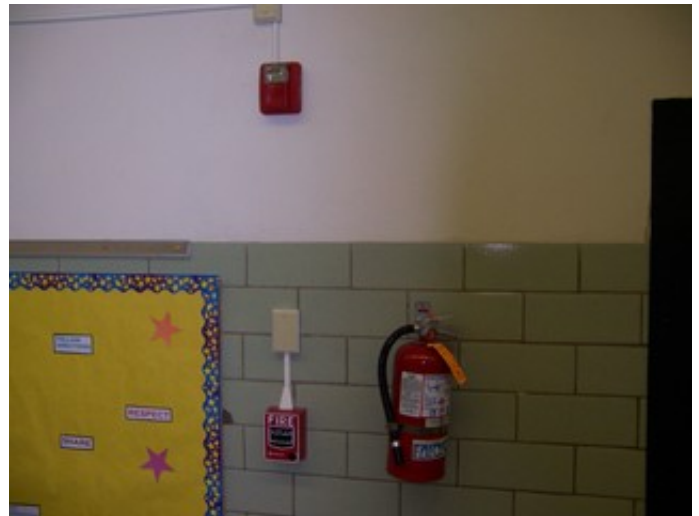
Typical Fire Alarm Devices

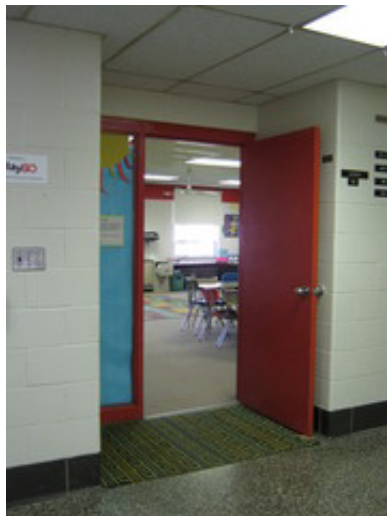
Typical recessed door

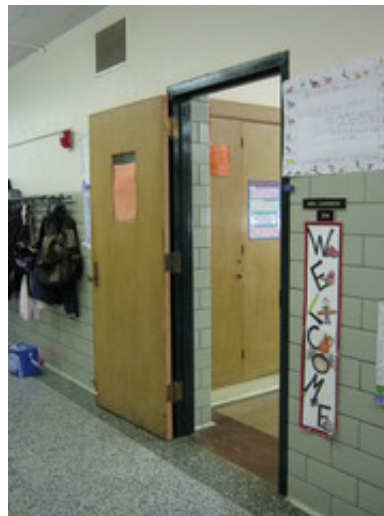
Typical un-recessed door

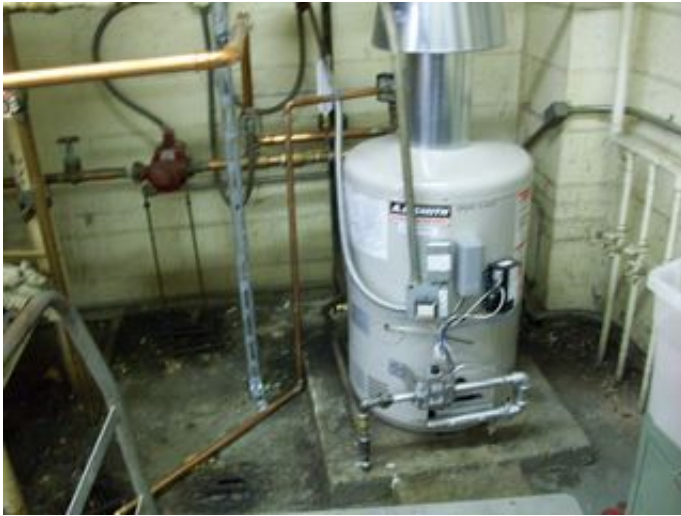
Domestic water heater

Recommendations: Recommend replacing with new domestic water piping from the city site main.

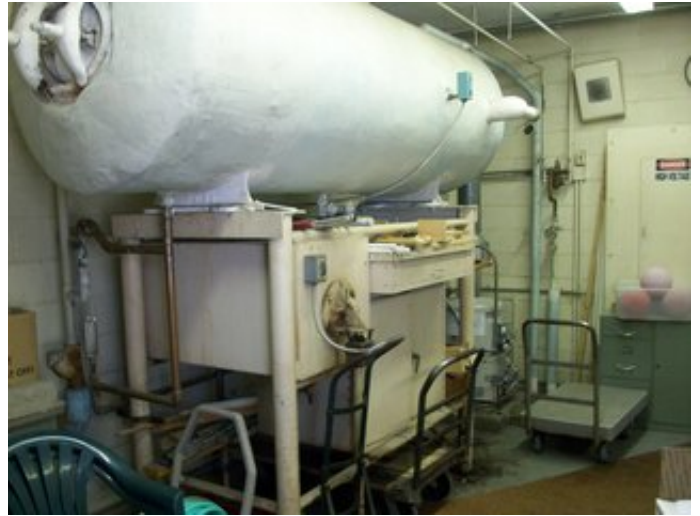
Storage tank and water piping

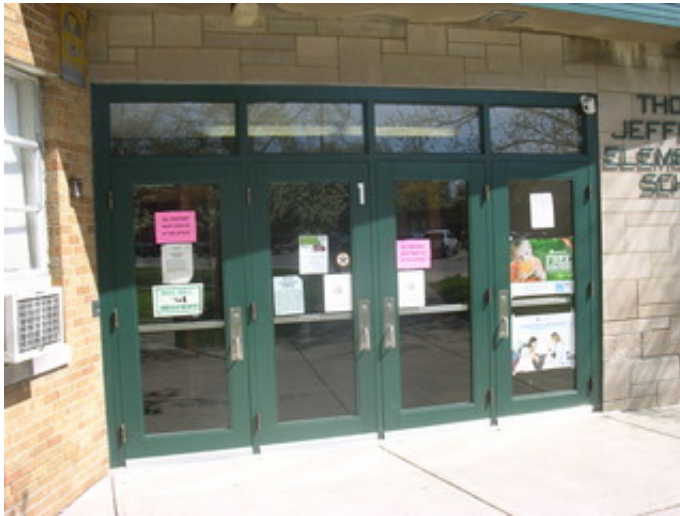
Typical hollow metal entry doors.

Recommendations: Replace exterior doors to comply with Ohio Building Code, ADA, and Ohio School Design Manual guidelines and due to condition.

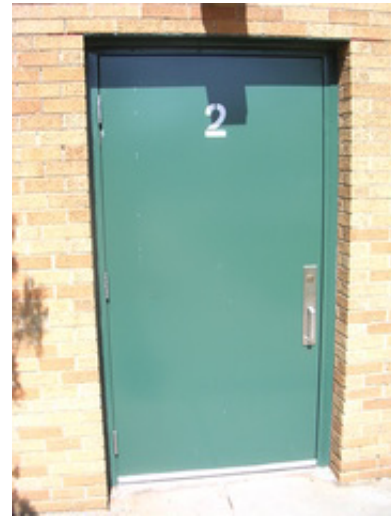
Typical hollow metal doors.

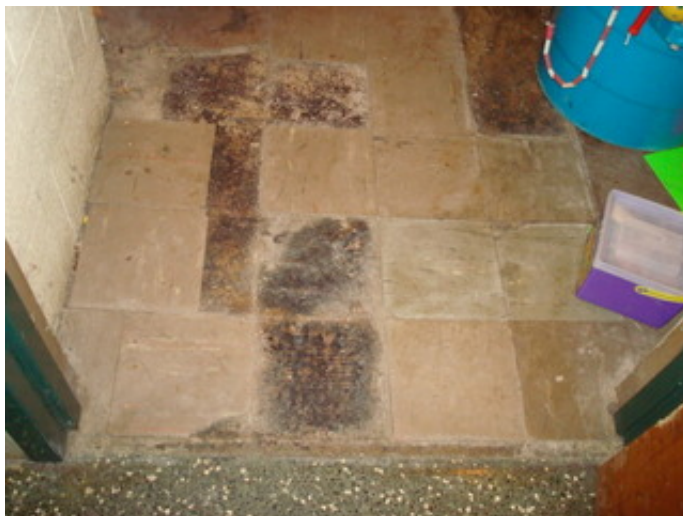
Vinyl tile in friable condition

Recommendations: Remove all hazardous materials, inclusive of asbestos-containing materials in the overall facility, as noted in the attached Environmental Hazards Assessment. Provide for the testing of paint that has the potential of being lead-based. Provide for disposal of fluorescent lighting.

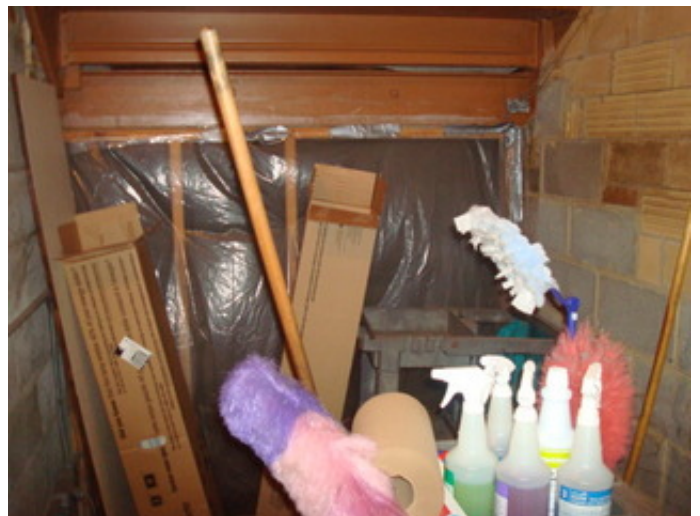
Encapsulated tunnel reported to contain asbestos

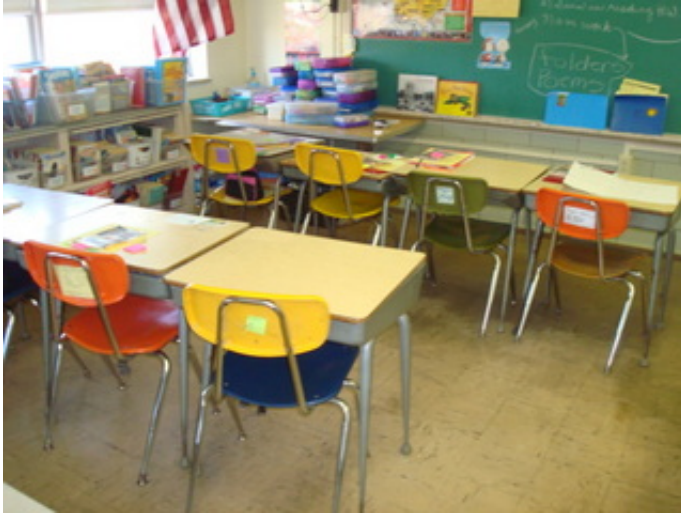
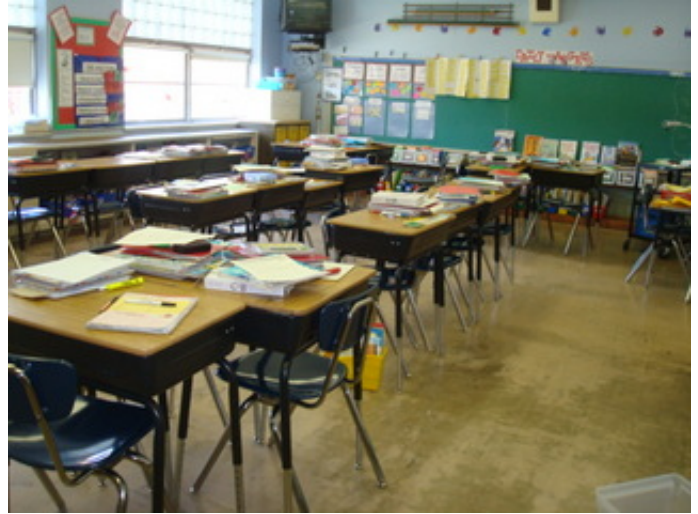
Classroom furniture

Recommendations: Provide for replacement of outdated or inadequate furniture.
