**Building Information - Willoughby-Eastlake City SD (45104) - McKinley Elementary School**

**Building Construction Information - Willoughby-Eastlake City SD (45104) - McKinley Elementary School (23754)**

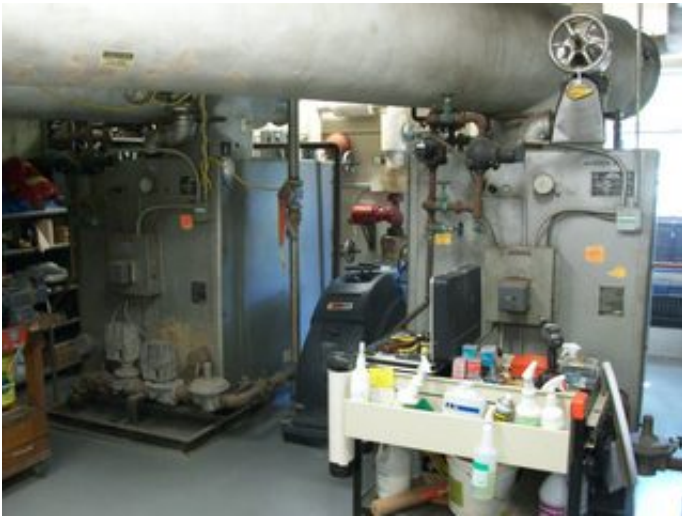
Gas Fired Hot Water Boilers

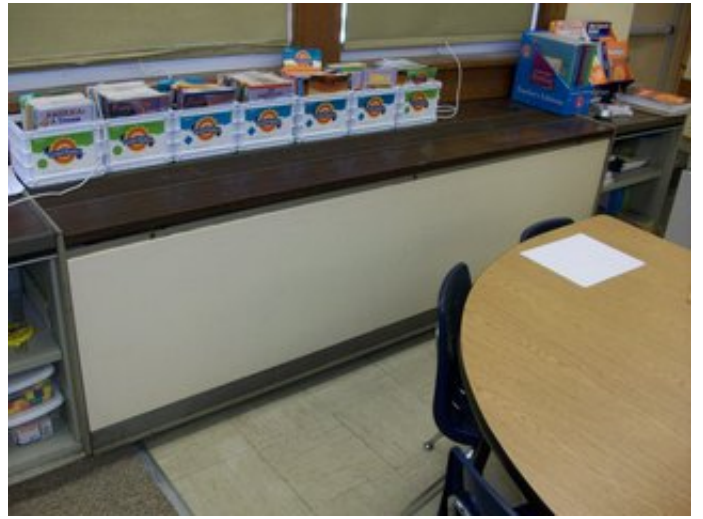
Unit Ventilator

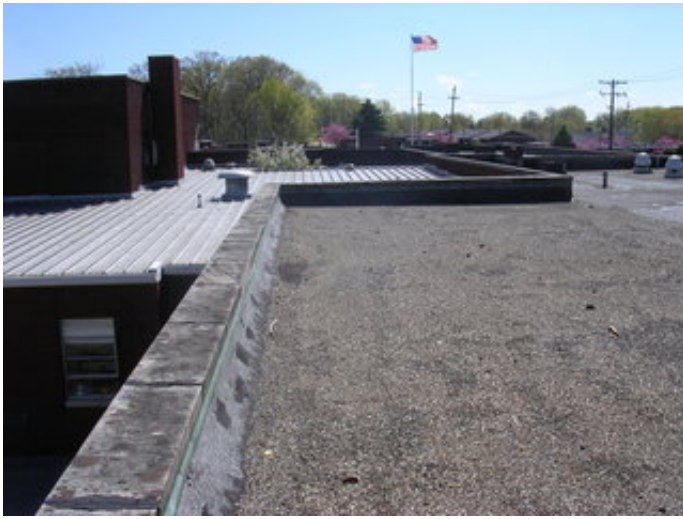
Typical roofing conditions,

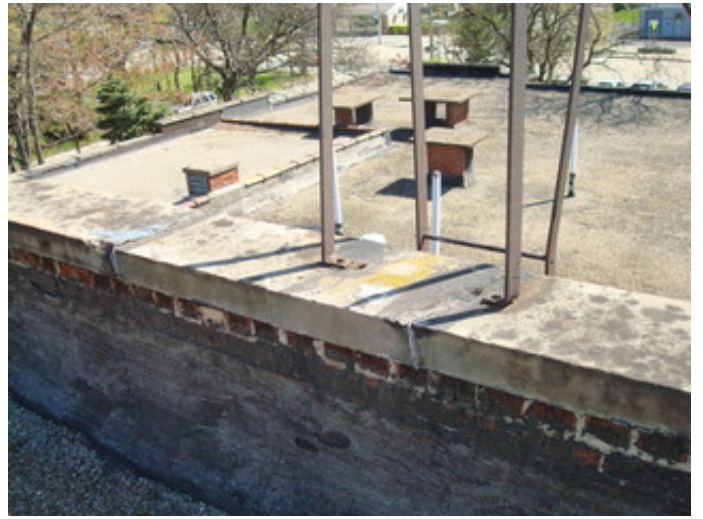
Typical flashing, coping, and roof ladder.

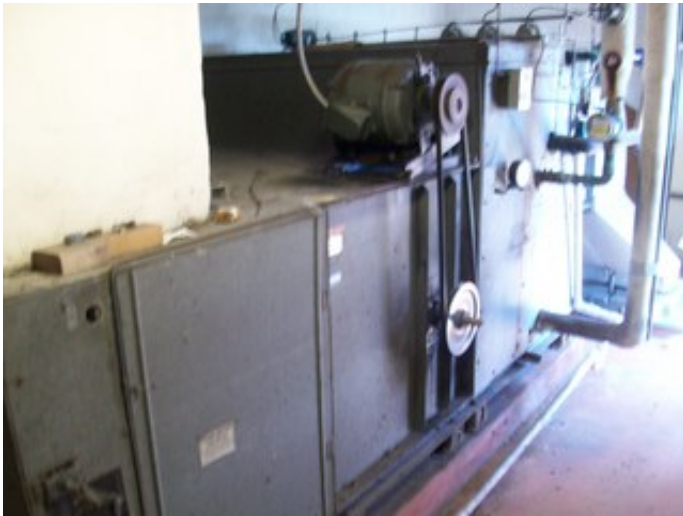
Air Handler Unit

**Recommendations:** Provide an air conditioning system to meet with Ohio Building Code and Ohio School Design Manual requirements. Pricing included in Item A. Provide kiln exhaust system for kiln listed in item J.

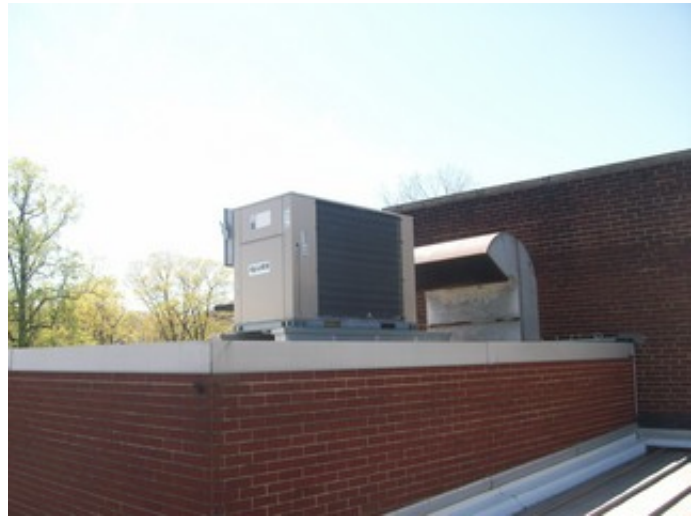
Rooftop Remote Air Conditioner Unit

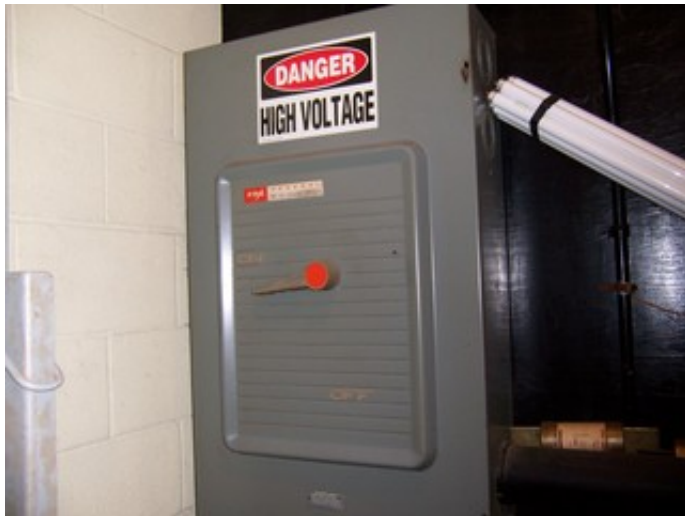
Main Electrical Utility Switch

**Recommendations:** The entire electrical systems requires replacement to meet Ohio School Design Manual guidelines and the Ohio Building Code for overall capacity due to lack of OSDM - required features and to accommodate the addition of an air conditioning system.

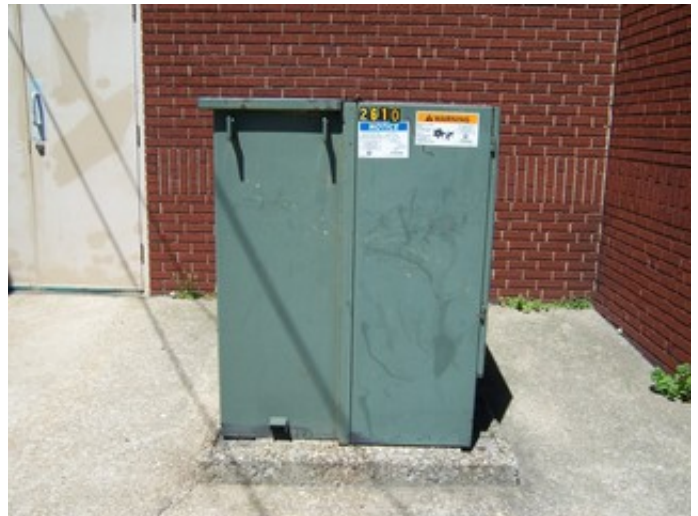
Main Electrical Transformer

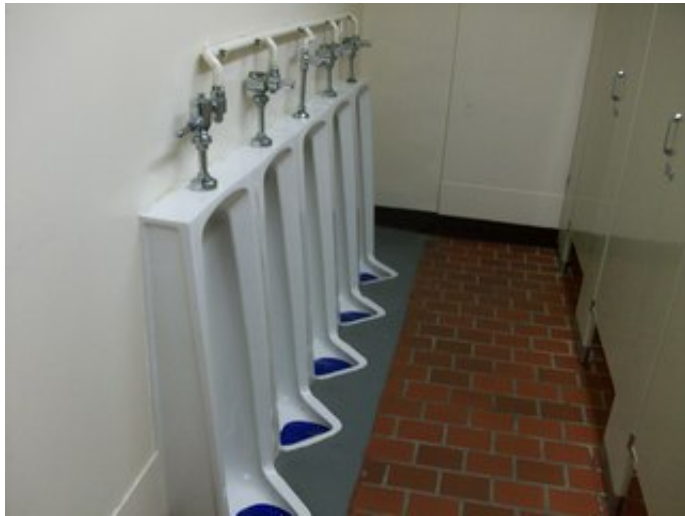
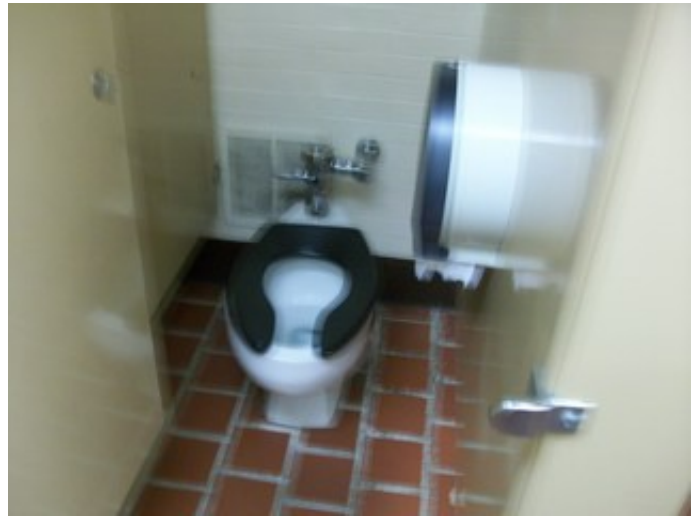
Toilet room fixtures

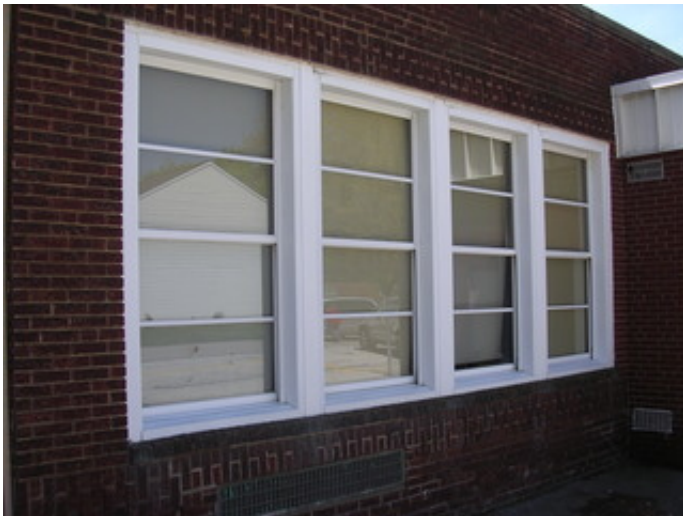
Typical replacement single glazed aluminum windows.

**Recommendations:** Provide a new insulated window system with integral blinds to meet with Ohio School Design Manual requirements. Replace storefront window system in the 1929 Addition with an aluminum storefront system to meet with Ohio School Design Manual requirements. Replace window transoms in exterior doors of the overall facility with approved safety glass to meet with Ohio School Design Manual requirements. Do not replace acrylic skylights at this time.

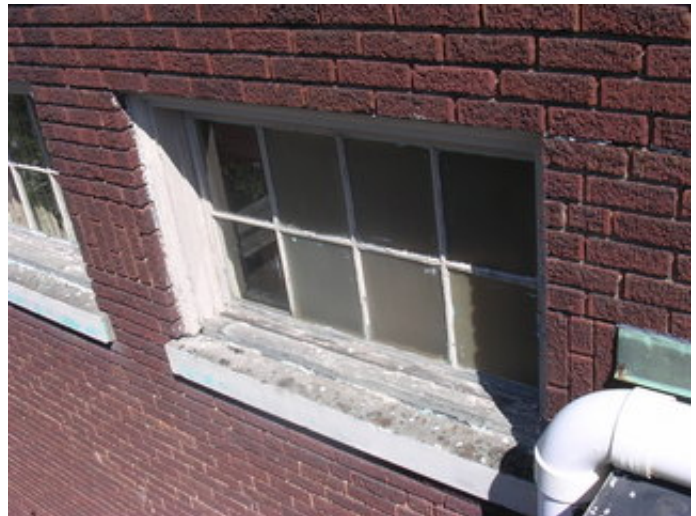
Typical wood windows.

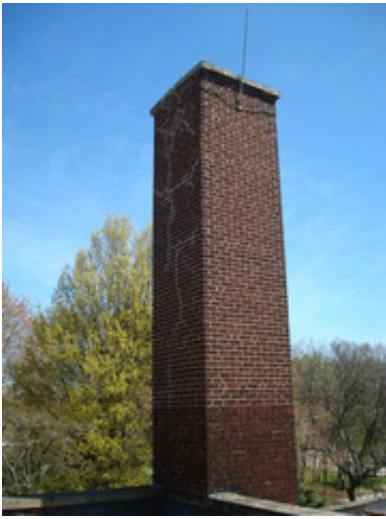
The west wall of the Gymnasium is visually out of plumb from the exterior. The interior wall has a subtle curve corresponding with the exterior anomaly. The chimney in the 1927 Addition exhibits structural problems. Access to one air handler unit is within a space that appeared structurally deficient.

Chimney showing extensive deterioration

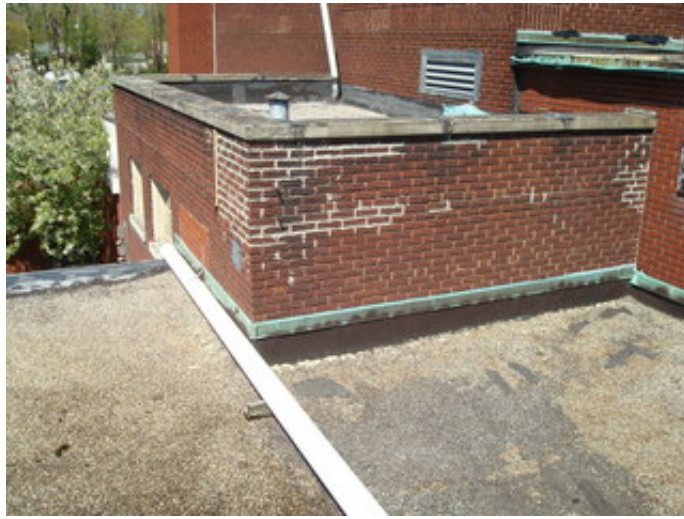
Deteriorated brick near courtyard

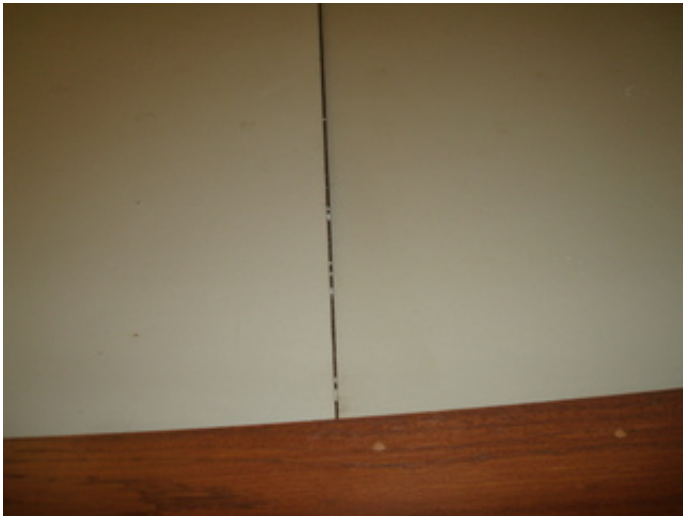
Vinyl wall covering

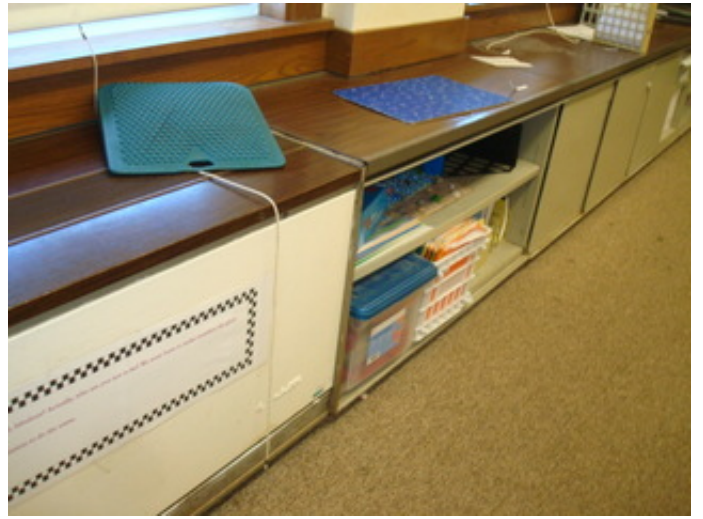
Classroom casework and heating unit

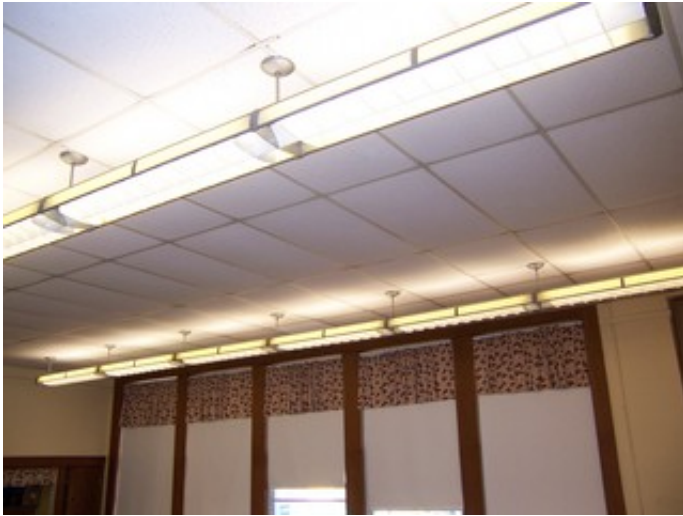
Classroom Lighting Fixtures

**Recommendations:** Provide complete replacement of lighting system due to age, condition of lighting fixtures and installation of a fire protection system.

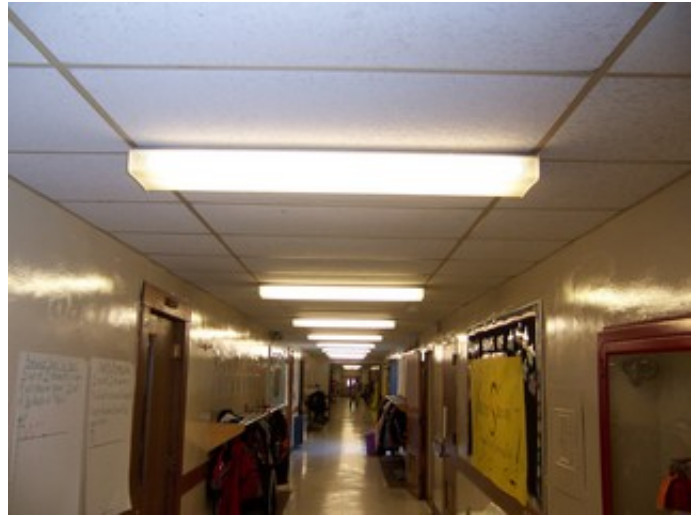
Surface Mounted Hallway Lights

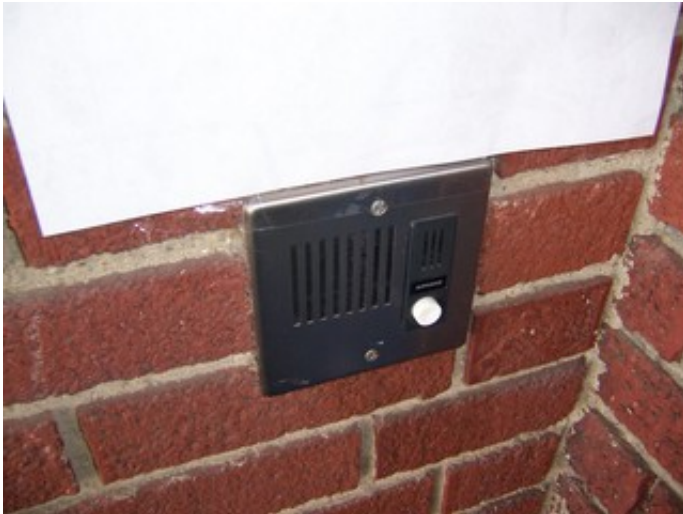
Front Door Wall Mounted Intercom

**Recommendations:** Provide complete replacement of security system to meet Ohio School Design Manual guidelines. Provide complete replacement of exterior site lighting system to meet Ohio School Design Manual guidelines.

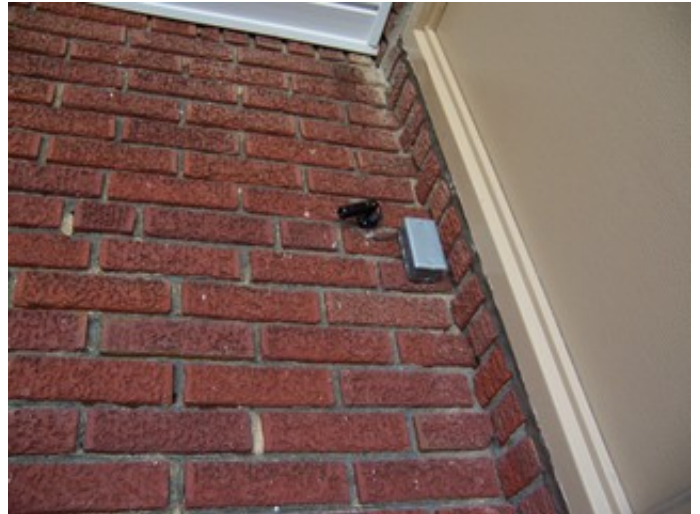
Front Door CCTV

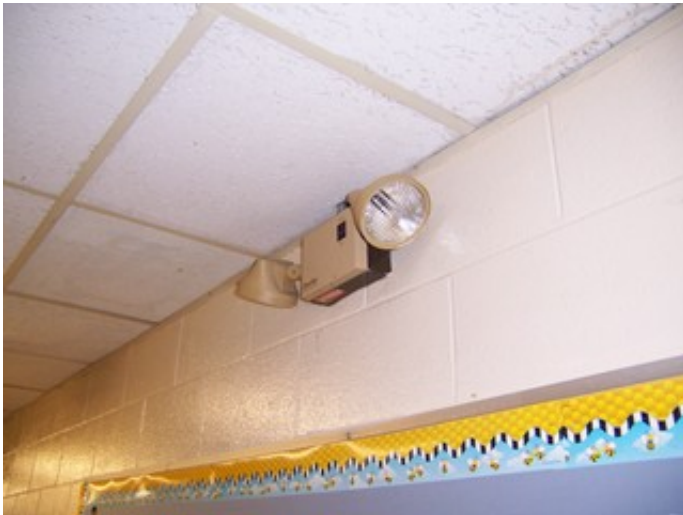
Hallway Egress Lighting

**Recommendations:** Provide complete replacement of the emergency / egress lighting system throughout to meet the Ohio School Design Manual guidelines.

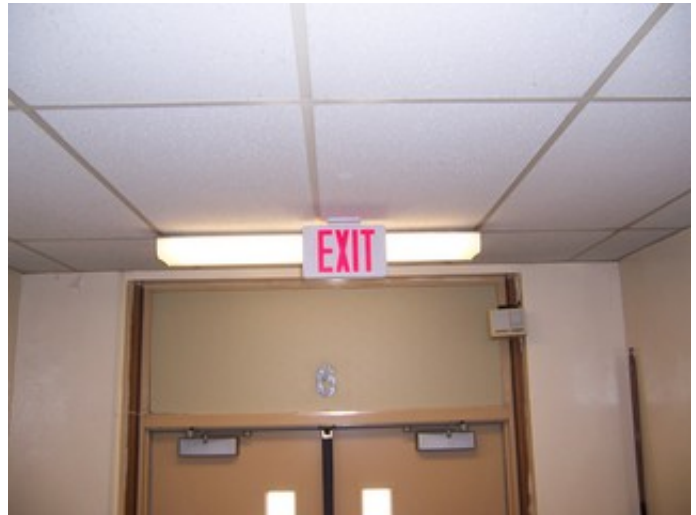
Typical Exit Sign

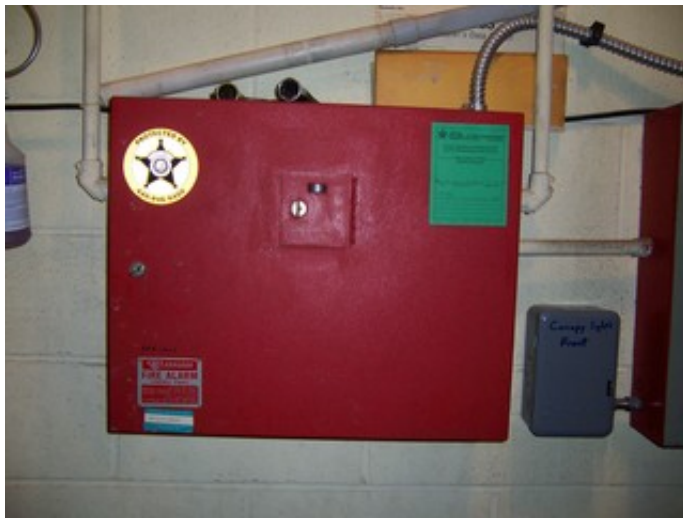
Main Fire Alarm Panel

Recommendations: Recommend providing a complete new Fire Alarm System to meet the Ohio School Design Manual and the Ohio Building Code.

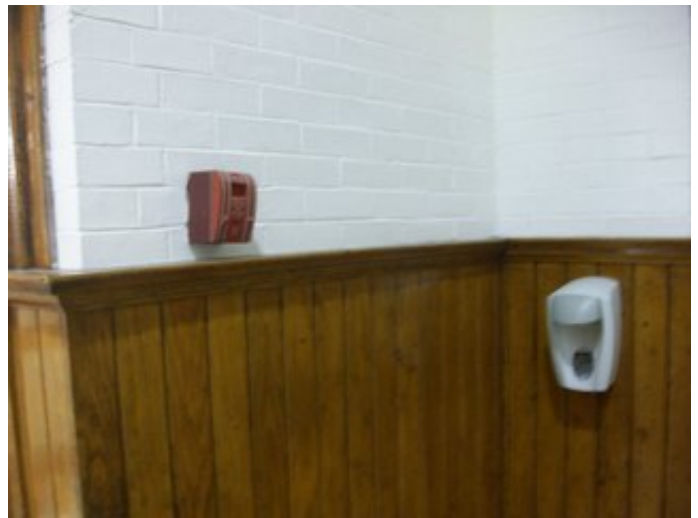
Typical Manual Pull Station

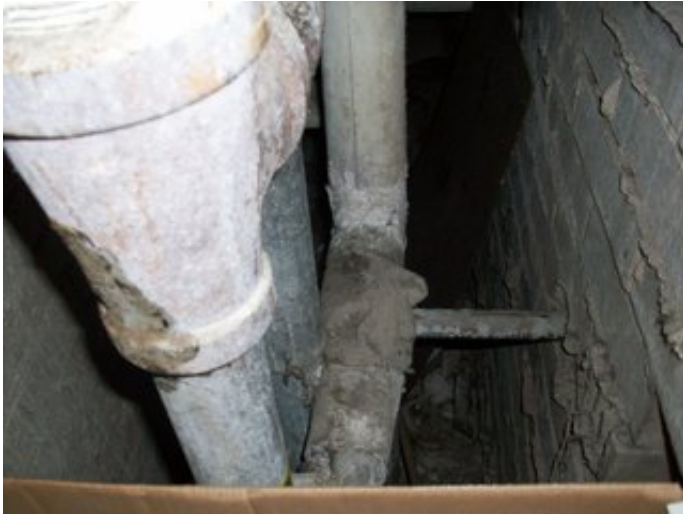
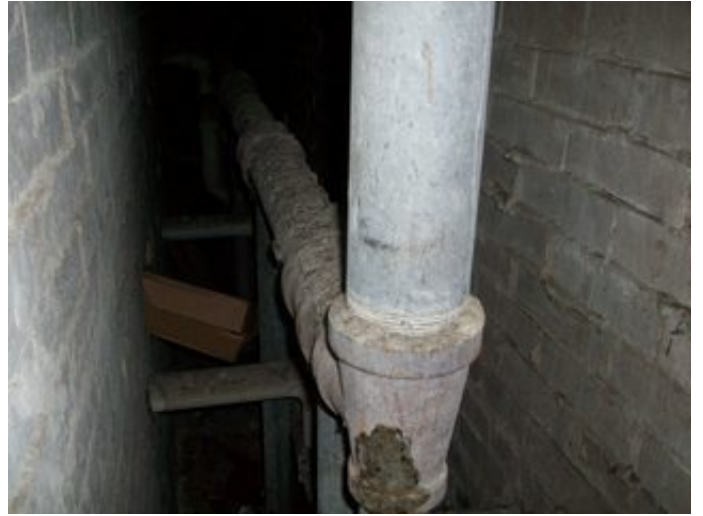
Sanitary drainage Piping

Recommendations: The original building sanitary drainage system is 88 years old with updates with each new addition. Recommend replacing with new sanitary and vent piping.

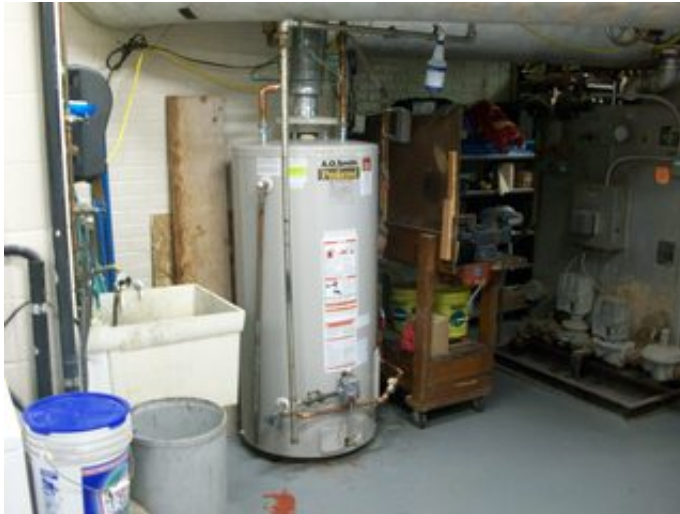
Domestic water heater

Recommendations: The existing domestic water piping original building is 88 years old with up dates in each new addition. Recommend replacing with new domestic water piping from the city site main.

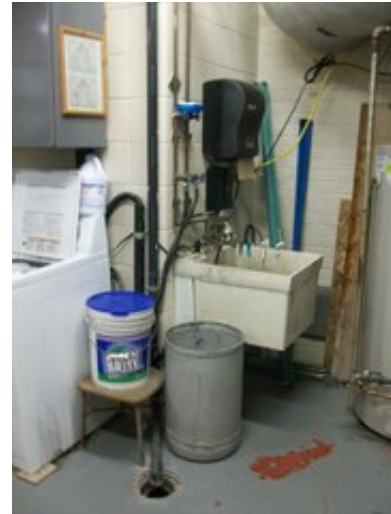
Domestic water piping

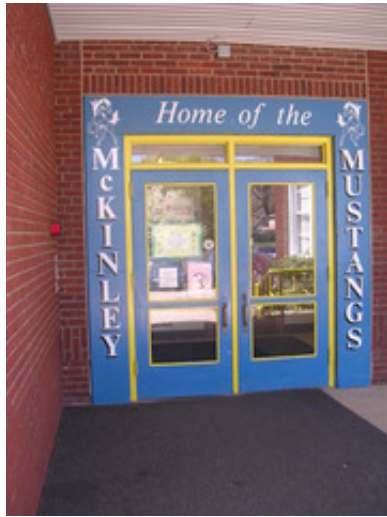
Typical hollow metal entry doors.

**Recommendations:** Replace all exterior doors to comply with Ohio Building Code, ADA, and Ohio School Design Manual guidelines and due to condition.

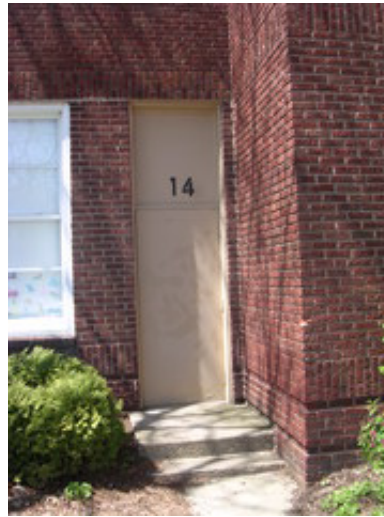
Typical classroom egress door.

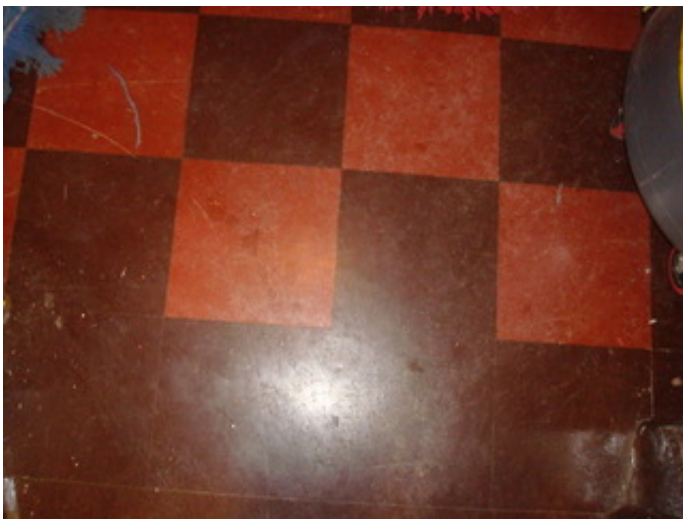
Vinyl tile

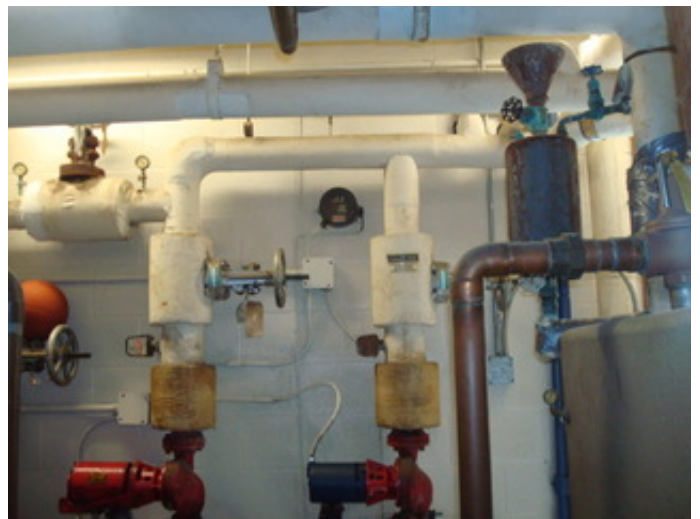
Pipe insulation
