Building Information - Willoughby-Eastlake City SD (45104) - Royalview Elementary School

Program Type	Expedited Local Partnership Program (ELPP)
Setting	Suburban
Assessment Name	Royalview E_2010_TCI
Assessment Date	2010-03-16
Cost Set:	2010
Building Name	Royalview Elementary School
Building IRN	32904
Building Address	31500 Royalview Dr
Building City	Willowick
Building Zipcode	44094
Building Phone	440/944-3130
Acreage	9.00
Current Grades	K-5
Teaching Stations	47
Number of Floors	2
Student Capacity	1175
Current Enrollment	829
Enrollment Date	2010-04-01
Enrollment Date is the date in which the current enrollment was taken.	
Number of Classrooms	47
Historical Register	NO
Building's Principal	Ms. Tamee Tucker
Building Type	Elementary

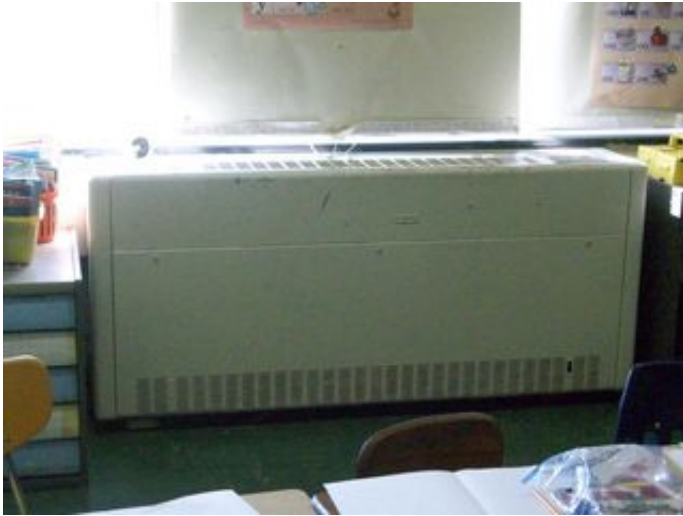
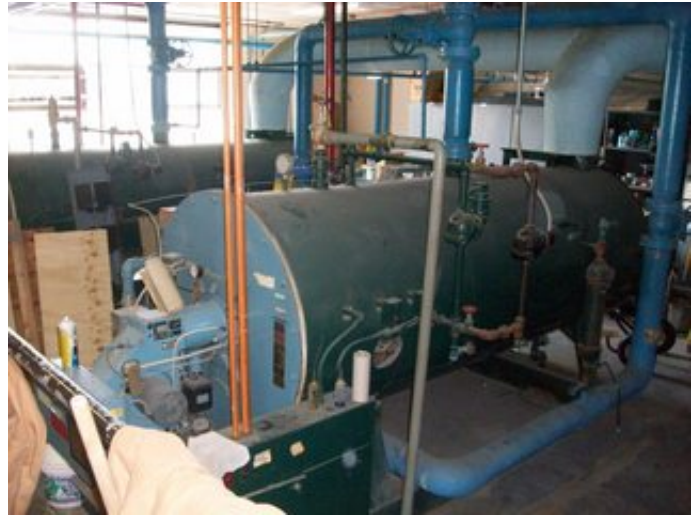
Description: The existing heating system for the overall facility is composed of two major hot water boilers centrally located in the main mechanical room which were installed in 1956. The units are in good condition. The heating system in the overall facility is part of the Original Construction and is a 2-pipe system supplying hot water heating. With very limited capacity for simultaneous heating and cooling operation, this system is not compliant with the OSDM requirements for basic system type. The forced draft hot water boilers, manufactured by Steampak were installed in 1956 and are in decent condition. Heating hot water is distributed to terminal units consisting of unit ventilators, cabinet heaters, unit heaters, and fin tubes. The terminal equipment was installed in 1956 and new with each addition and is in fair condition. The system does not comply with the 15 CFM per person fresh air requirements of the Ohio Building Code mechanical code and Ohio School Design Manual. The non DDC type system temperature controls were installed in 1956 and are in working condition. The system does feature individual heating temperature controls in all spaces required by the OSDM. The overall system does not feature any central energy recovery systems. The facility is equipped with louvered interior doors in classrooms, storage and utility rooms to facilitate Corridor utilization as return air plenums while the classrooms have a return air systems. The existing system is not ducted, and floor to structural deck heights will not accommodate the installation of properly sized ductwork for a future Ohio School Design Manual approved system. The overall heating system is evaluated as being not in safe and efficient working order, though long term life expectancy of the existing system is anticipated. The structure is not equipped with central air conditioning. The site does not contain underground fuel tanks that are currently in use.

Rating: 3 Needs Replacement

Typical Unit Ventilator

Gas Fired Hot Water Boilers

Recommendations: Provide new overall heating, ventilating, and air conditioning system to achieve compliance with Ohio Building Code and Ohio School Design Manual standards. Convert to ducted system to facilitate efficient exchange of conditioned air.

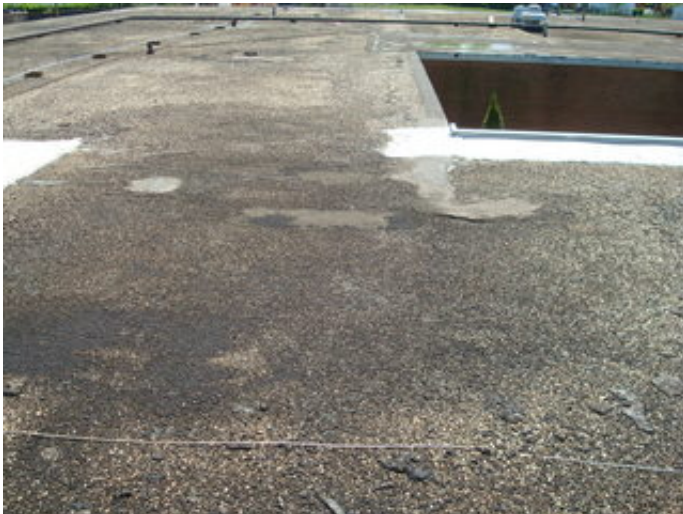
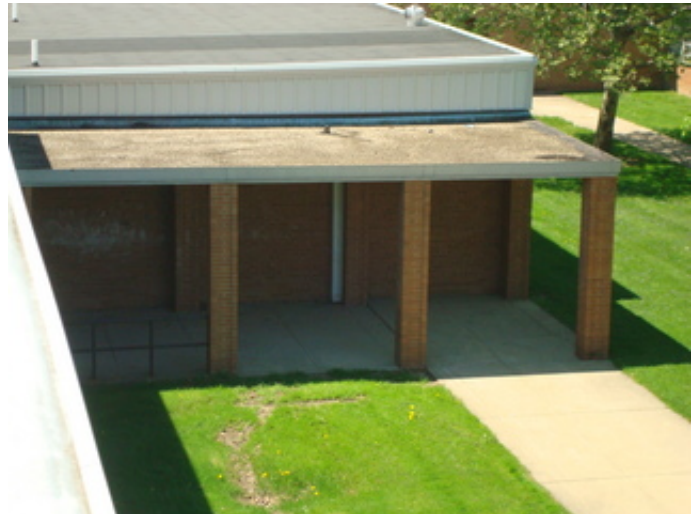
Description: The roof over the 1956 Original Construction, 1958 Addition, and 1962 Addition is a built-up system that are original to each area and are in poor condition. The roof over the 1962 Addition is a built-up system that was installed in 1989 and is in poor condition. There are District reports of current leaking in the 1966 Gymnasium, near the joint between the 1958 Addition, 1956 Original Construction and 1966 Addition, near the girls restroom in the 1956 Original Construction, in the area between the 1962 Addition and the 1958 Addition, and in several other locations. Signs of past leaking were observed during the physical assessment, including damage to the masonry walls due to water infiltration. The roof leaks extensively. Access to the roof was gained by access hatches that are in poor condition. Fall safety protection cages are not required. There were observations of standing water on the roof, particularly on the canopy of the 1966 Addition. Metal cap flashings are in poor condition. Roof storm drainage is addressed through a system of roof drains which are properly located, and in poor condition. The roof is not equipped with overflow roof drains though they are needed on this building. Roof penetrations are in poor condition consistent with the roofing materials. There are covered walkways attached to this structure. The covered walkway on the 1956 Original Construction is steel structure with built-up roof and are in poor condition.

Rating: 3 Needs Replacement

Patched roof over 1956 Original Construction

Covered walkway on 1966 Addition

Recommendations: The roof over the overall facility requires replacement to meet Ohio School Design Manual guidelines for age of system and due to condition. Include insulation in roof replacement. The flashing and coping on the overall facility require replacement due to condition. Due to existing conditions roof drains require replacement. Two roof hatches require replacement. Gutters and downspouts on the community room area of the 1956 Original Construction require replacement.

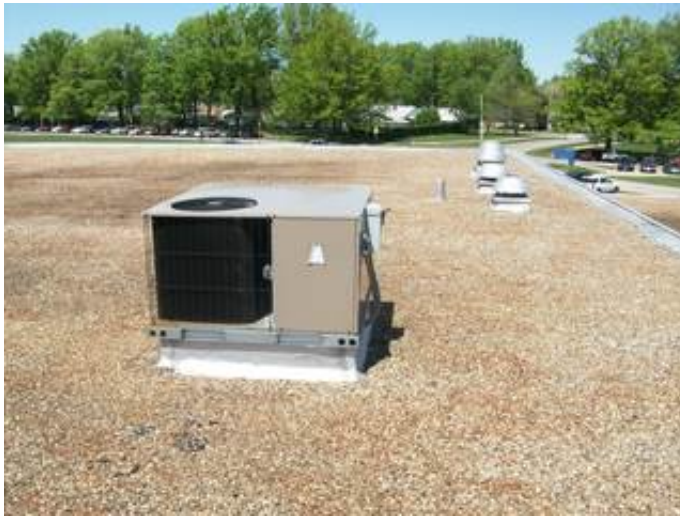
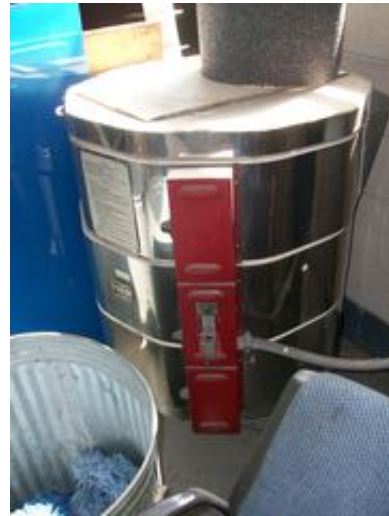
Description: The overall facility is not equipped with a central air conditioning system. Window units are provided in miscellaneous locations such as offices, library, and media center. The ventilation system in the overall facility consists of unit ventilators and ducted air handlers installed initially in 1956 and are in fair condition, providing fresh air to classrooms and other miscellaneous spaces such as Gymnasiums, Student Dining, Media Center etc. Relief air venting is provided by relief fans and roof vents. The ventilation system does not meet the Ohio Building Code 15 CFM per occupant fresh air requirement. The overall system is not compliant with Ohio Building Code and Ohio School Design Manual requirements. Dust collection systems are not required in this facility and no system is provided. The Art program is equipped with a kiln, and existing kiln ventilation is without a hood, and is in working condition. Exhaust systems for Restrooms, Locker Rooms, Kitchen, Gymnasiums, Storage Rooms, Custodial Closets and Career Tech specialized areas are adequately placed, and in working condition.

Split Air Condenser Unit & Exhaust Fans

Art Kiln Unit

Recommendations: Provide an air conditioning system to meet with Ohio Building Code and Ohio School Design Manual requirements. Pricing included in Item A. Provide kiln exhaust system for kiln listed in item J.

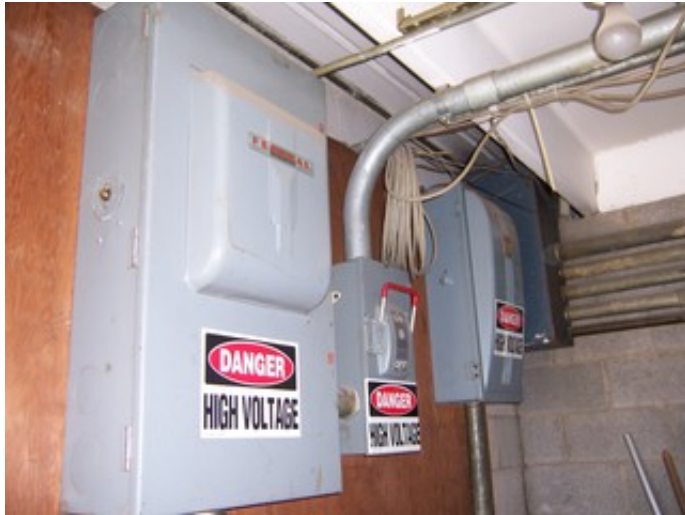
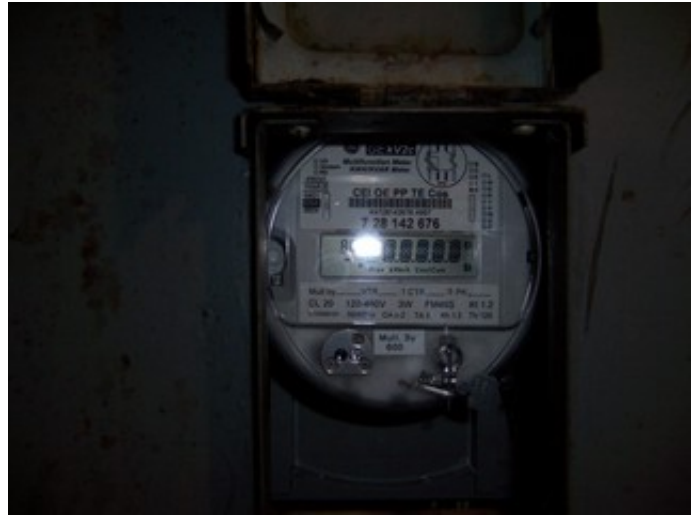
Description: The electrical systems provided to the overall facility is a dual voltage system of a 800 amp 120/240 volt, 1 phase, 3 wire original system from the year 1956, and is in fair condition. An up-graded second power system of 1200 amps at the voltage of 120/240 volt 3 phase 3 wire incorporated in the year 1966. Power is provided to the school by pole mounted utility owned transformers. The main distribution panel cannot be expanded to add additional capacity that would be required by the OSDM air conditioning requirements. The Classrooms are not equipped with adequate electrical outlets in some of the original areas per OSFC recommendations. The typical Classroom contains usually 2 to 3 general purpose outlets with certain classrooms having added outlets used for Classroom computers, and television. There are some spaces that have no electrical outlets such as storage areas and Janitor Closets. Most Corridors are equipped with adequate electrical outlets for electrical servicing. Adequate GFI protected exterior outlets are not provided around the perimeter of the building. The facility is not equipped with an emergency generator. There is a 100 amp emergency panel 'E', which feeds items such as exit lights, emergency lights and the Fire Alarm panel. Panel 'E' is fed directly from a 30 amp 240 V. disconnect switch. Adequate building lightning protection safeguards are not provided. The overall electrical system does not meet Ohio School Design Manual requirements, and will be inadequate to meet the facility's future needs.

Rating: 3 Needs Replacement

Main Utility Switch

Electric Utility Meter

Recommendations: The entire electrical system requires replacement to meet Ohio School Design Manual guidelines for overall capacity due to lack of OSDM - required features and to accommodate the addition of an air conditioning system.

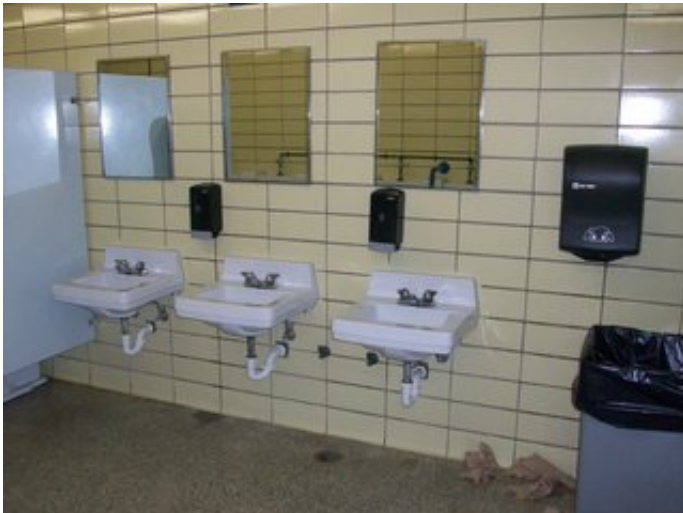
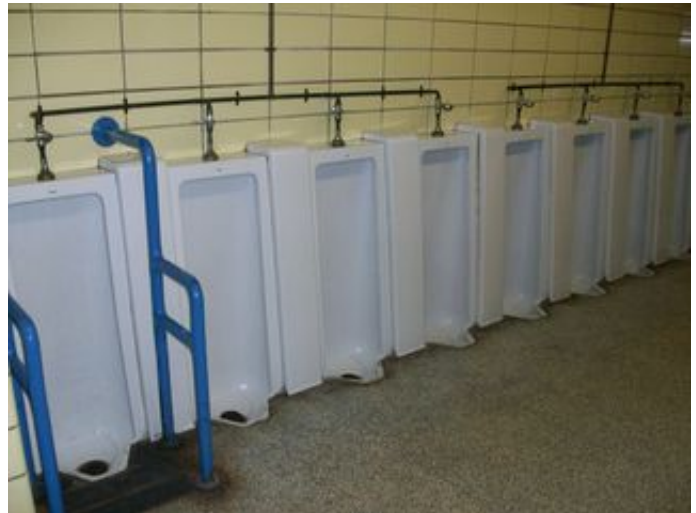
Rating: 3 Needs Replacement

Toilet room fixtures

Recommendations: Provide all new plumbing fixtures, faucets and flush valves to replace the existing because of ADA requirements and condition of old plumbing fixtures. Replace existing water heater with new high efficient gas fired water heaters. The recommendation for domestic water piping is in section R. The recommendation for sanitary drainage piping is in section Q.

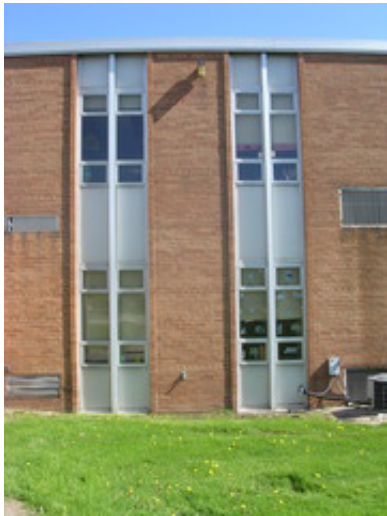
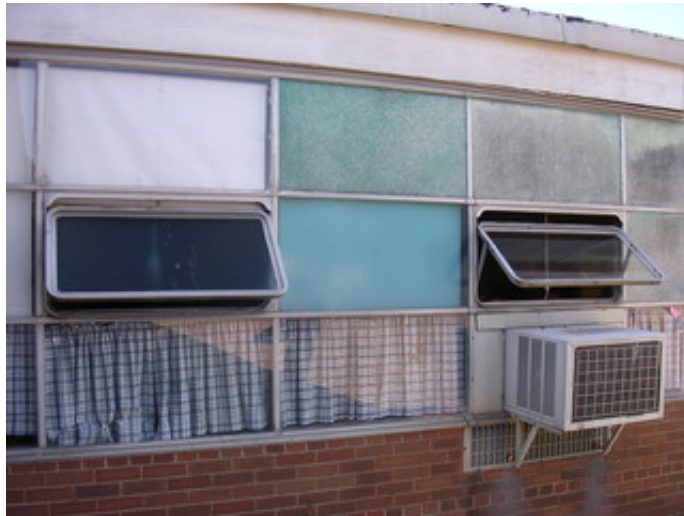
Description: The overall facility is equipped with non-thermally broken aluminum frame windows with single glazed non-insulated glazing type window system, which were installed at the dates of construction, and are in poor condition. Window system seals are in poor condition, with frequent air and water infiltration being experienced. Window system hardware is in poor condition. The window system features surface mounted blinds, which are in moderate condition. The window system is not equipped with insect screens on operable windows. Aluminum and hollow metal frame storefront window systems, with single tempered and non-tempered glazing are found in the overall facility and are in fair to poor condition. This facility does not feature any glass block windows. The school does not contain skylights. Window security grilles are not provided for ground floor windows. There is not a Greenhouse associated with this school.

Rating: 3 Needs Replacement

Typical aluminum windows.

Recommendations: Provide a new insulated window system with integral blinds to meet with Ohio School Design Manual requirements. Replace curtainwall/storefront system.

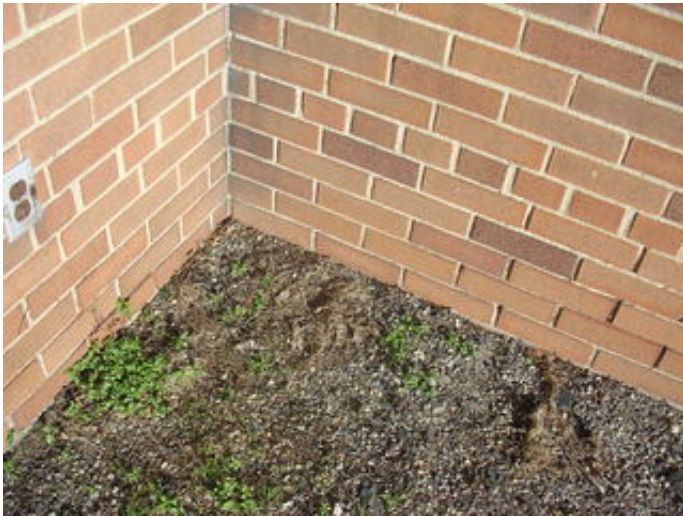
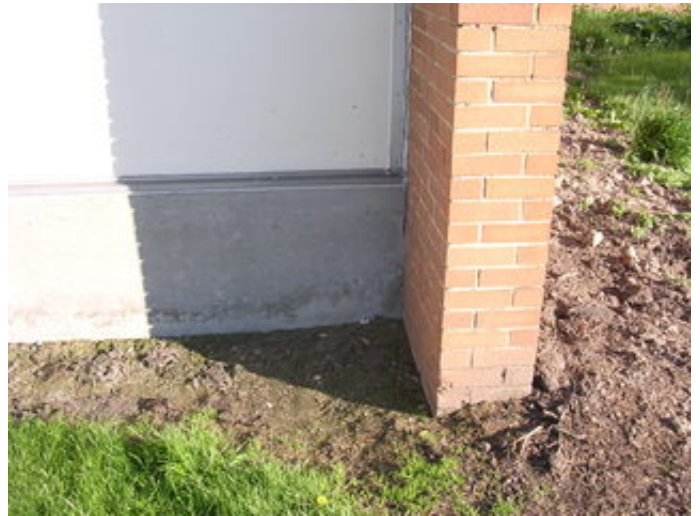
Description: The 1956 Original Construction foundation starter course masonry with trench concrete footings. Information for the 1958 Addition is not available. The 1962 and 1966 Additions are masonry with trench concrete footings. Dampproofing is not called out on the overall facility and perimeter insulation is minimal. Locations of significant differential settlement, and cracking, were observed at the 1966 entry canopy addition. The District reports that there has been no past leaking. Some grading / site drainage deficiencies were noted around the perimeter of the structure that could contribute to foundation / wall structural deterioration.

Rating: 2 Needs Repair

Typical foundation condition.

Recommendations: Provide foundation reinforcement at the entry canopy location of the 1966 addition.

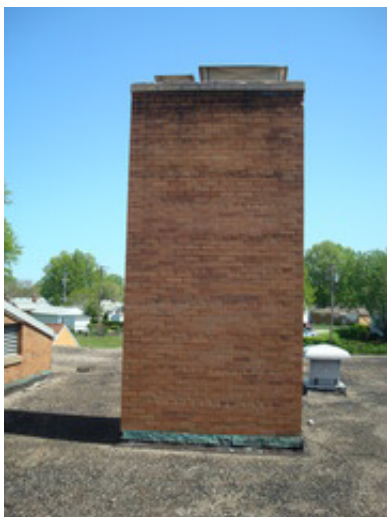
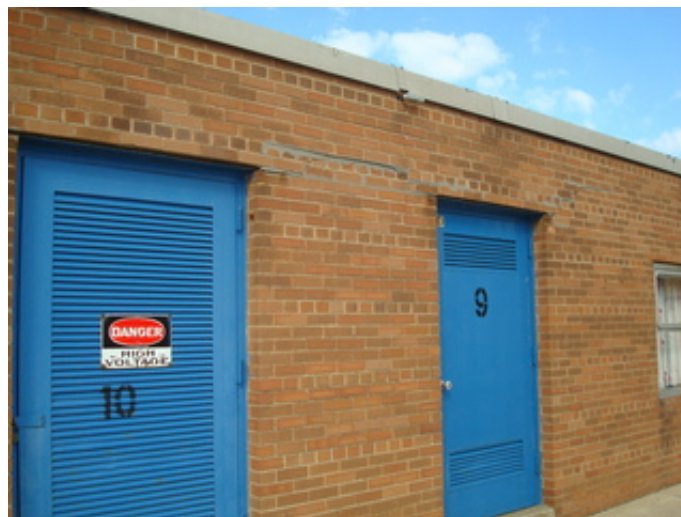
Description: The overall facility has a brick veneer on a masonry bearing wall system, which displayed locations of deterioration, and is in fair condition. The exterior masonry appears to have inappropriately spaced and adequately caulked control joints in poor condition. Control joints are not provided at lintel locations at doors and windows. The school has sufficient expansion joints, and they are in poor condition, particularly the expansion joint between the 1966 Addition and Willowick Middle School which is visibly separating beyond the width of the expansion joint. The exterior masonry has not been cleaned and sealed in recent years, and shows evidence of mortar deterioration on the South wall of the 1956 Original Construction particularly, on most of the piers of the 1956 Original Construction and the 1958 Addition, and the masonry piers of the canopies at the 1966 Addition. Interior walls are concrete masonry units and are in fair condition. Interior masonry appears to have no caulked control joints and cracking is apparent, possibly from water infiltration from the roof. Soffits are in poor condition. The window sills are an element of the aluminum window system, and are in poor condition. The exterior lintels are steel, and are rusting and in fair to poor condition. Chimneys are in poor condition with deteriorated grout throughout and a damaged precast coping. Canopies over entrances are cement board or asbestos panel type construction, and are in poor condition.

Rating: 2 Needs Repair

Chimney at 1956 Original Construction

Damaged lintels and brick at 1956 Original Construction

Recommendations: Provide tuckpointing in all areas of mortar deterioration as required through the overall facility. Replace brick damaged by water infiltration and rusting lintels as required in the 1956 Original Construction, 1958 Addition, and 1966 Addition. Provide masonry cleaning and sealing as required through the overall facility. Recaulk existing control joints. Replace masonry lintels as required in the 1956 Original Construction and the 1966 Addition. Scrape, prime and paint lintels as required through the overall facility. Re-build the top four feet of chimney and replace the precast coping. Install control joints. Cost for canopies and soffits included in item I.

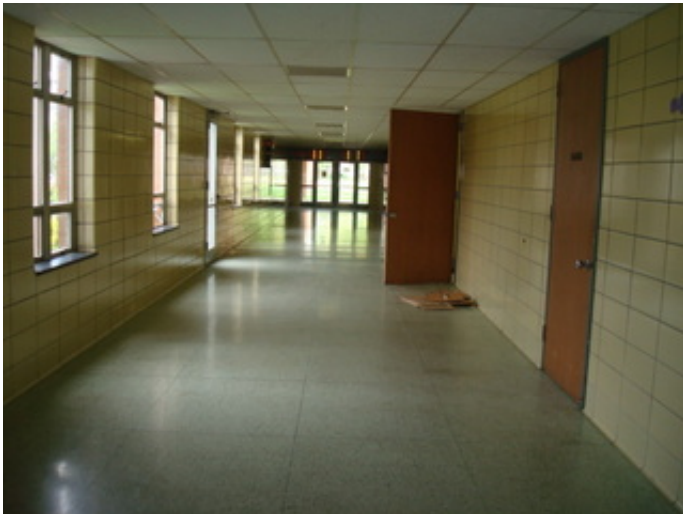
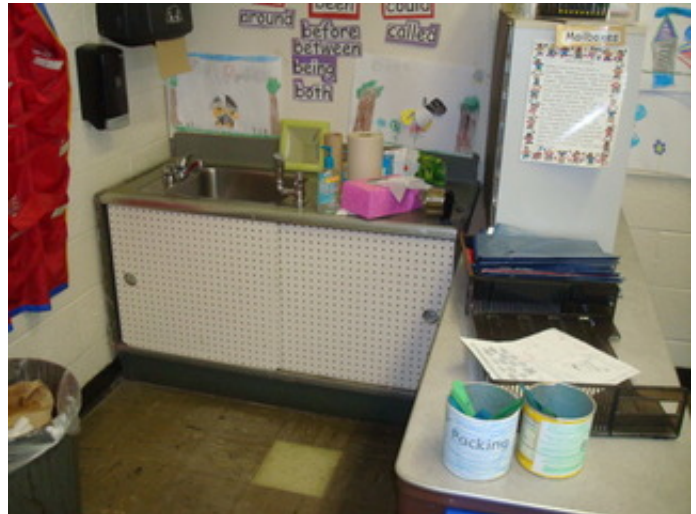
Rating: 3 Needs Replacement

Corridor

Classroom casework

Recommendations: Provide complete replacement of finishes and casework due to installation of systems outlined in Items A,C, D, E, K, L, M, N, T and U and non conformance with design manual. Funding for replacement of interior doors is provided in Item O, including doors here noted as being in poor condition. Provide a heat removal hood for the Art program kilns. Replace toilet partitions and toilet accessories. Rework walls addressed in item O.

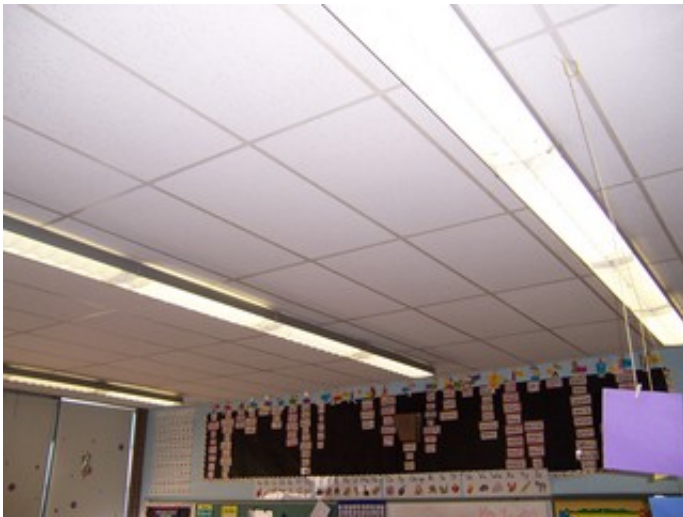
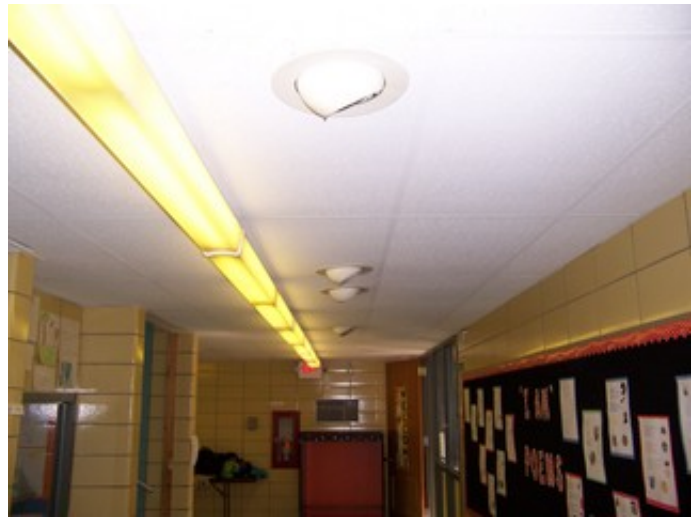
3 Needs Replacement

Typical Classroom Lighting

Hallway Lighting

Provide complete replacement of lighting system due to age, condition of lighting fixtures and installation of a fire protection system.

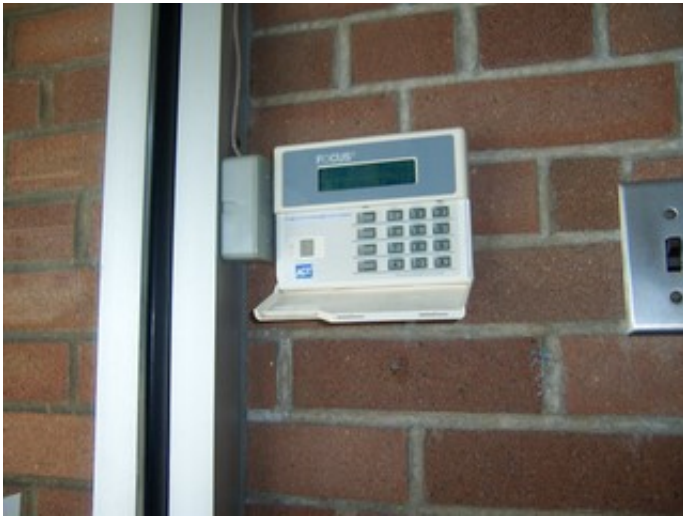
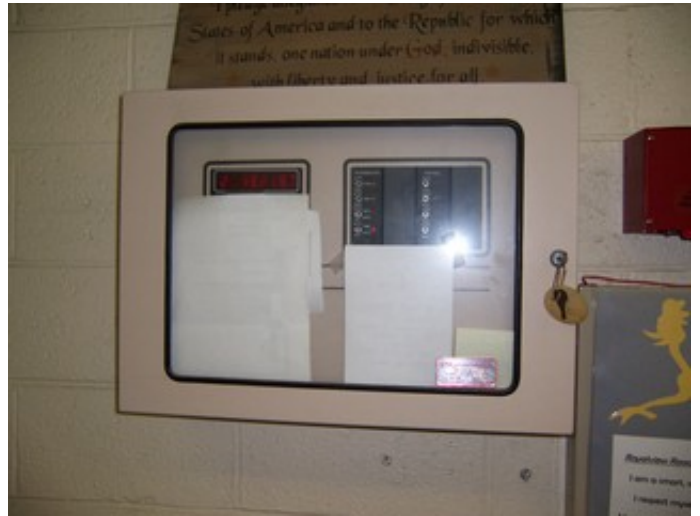
Rating: 3 Needs Replacement

Security Device

Security System Panel

Recommendations: Provide complete replacement of security system to meet Ohio School Design Manual guidelines. Provide complete replacement of exterior site lighting system to meet Ohio School Design Manual guidelines.

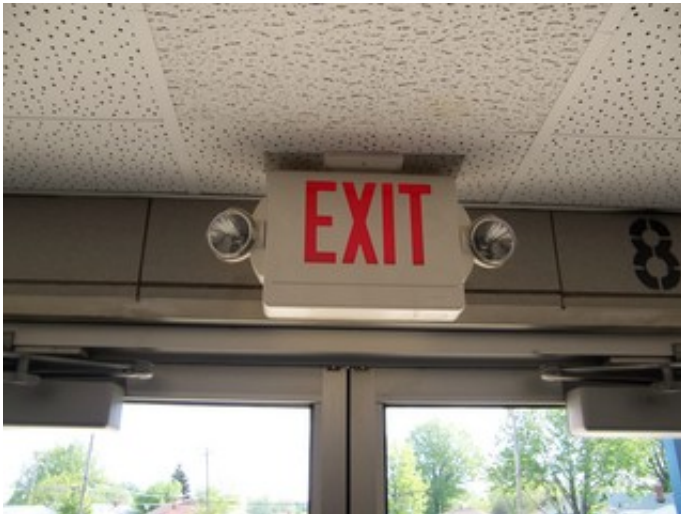
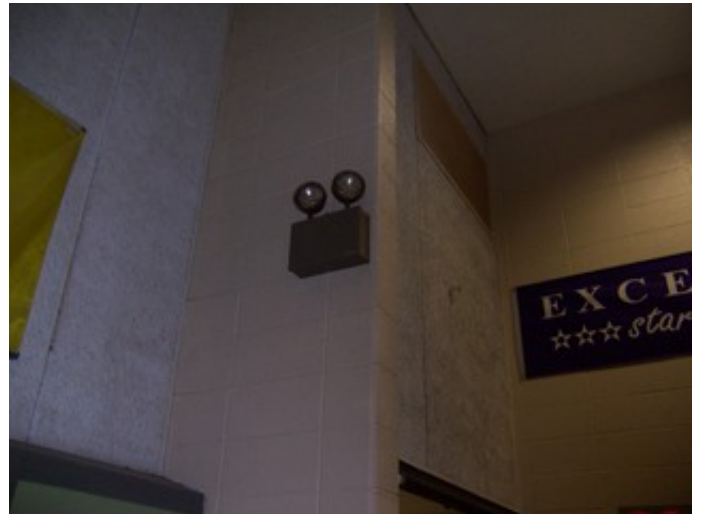
Rating: 3 Needs Replacement

Typical Exit Sign

Emergency Lighting

Recommendations: Provide complete replacement of the emergency / egress lighting system throughout to meet the Ohio School Design Manual guidelines.

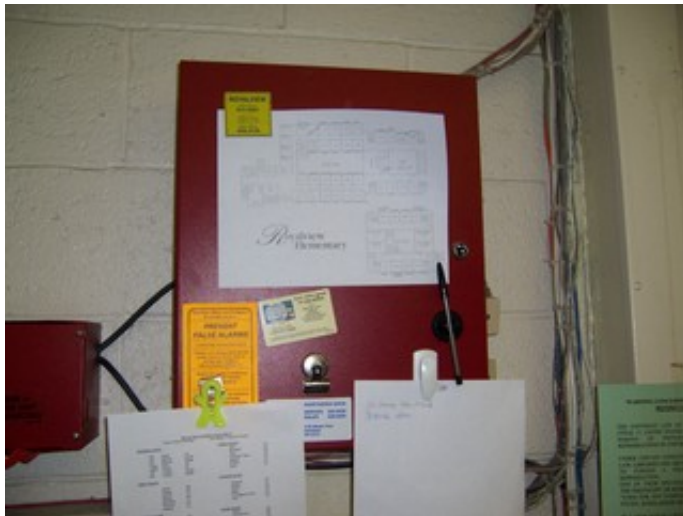
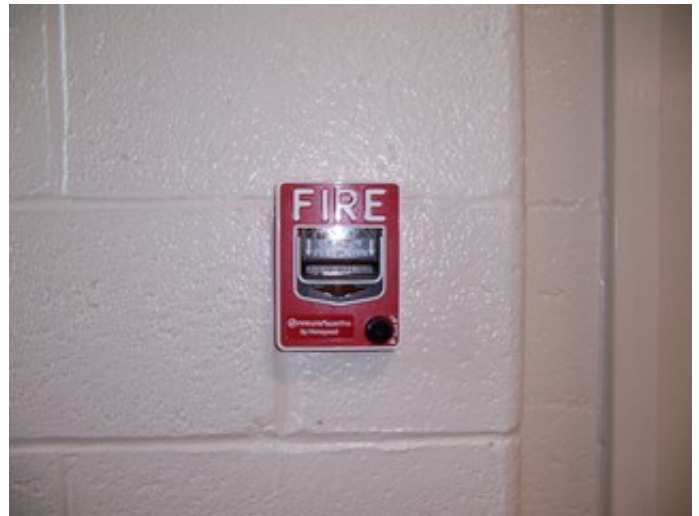
Rating: 3 Needs Replacement

Main Fire Alarm Panel

Typical Manual Pull Station

Recommendations: Recommend providing a complete new Fire Alarm System to meet the Ohio School Design Manual and the Ohio Building Code.

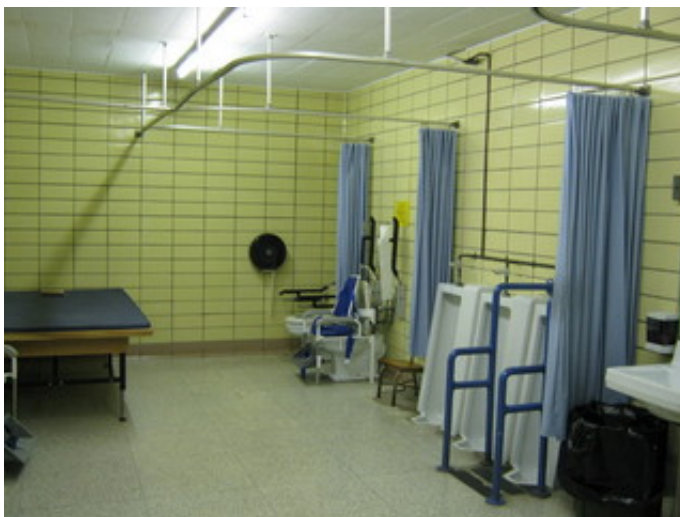
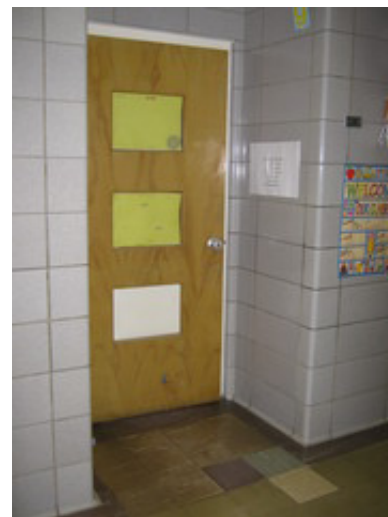
Rating: 2 Needs Repair

Multi-handicap accessible toilet room

Typical recessed classroom door

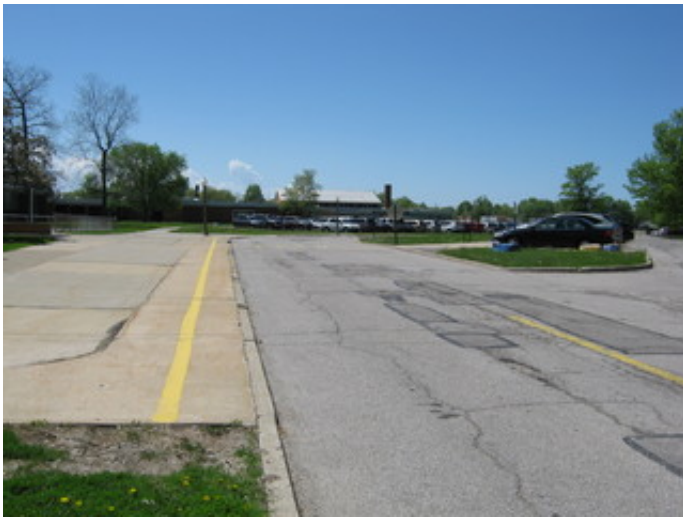
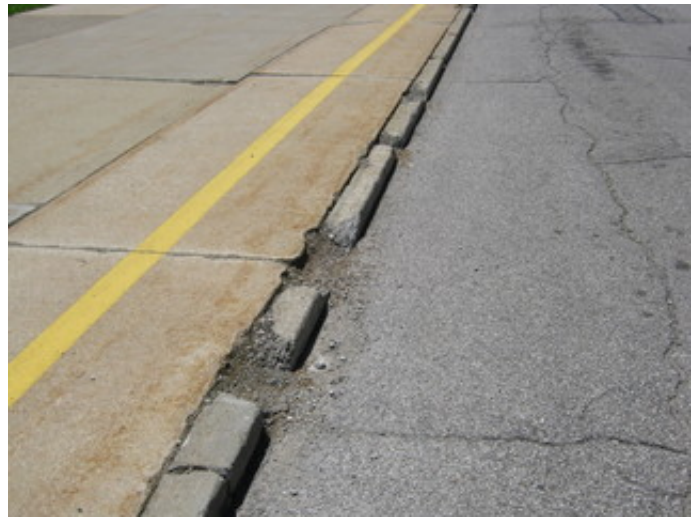
Rating: 2 Needs Repair

Bus loop

Curb in poor condition

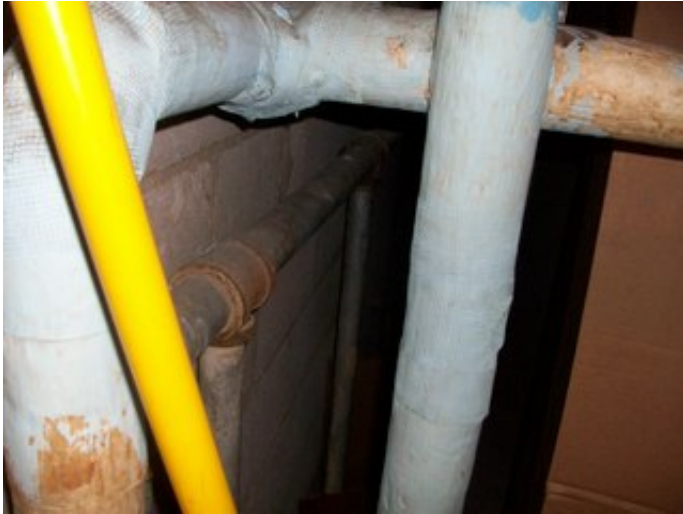
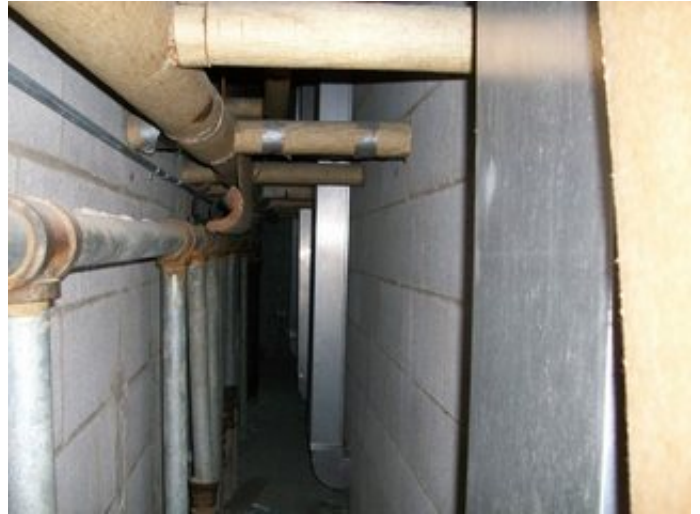
Sanitary drainage Piping

Recommendations: Replace existing system due to age of pipe.

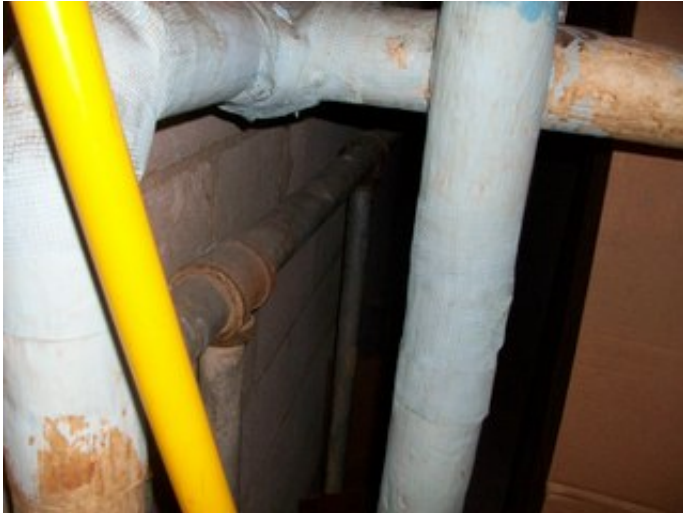
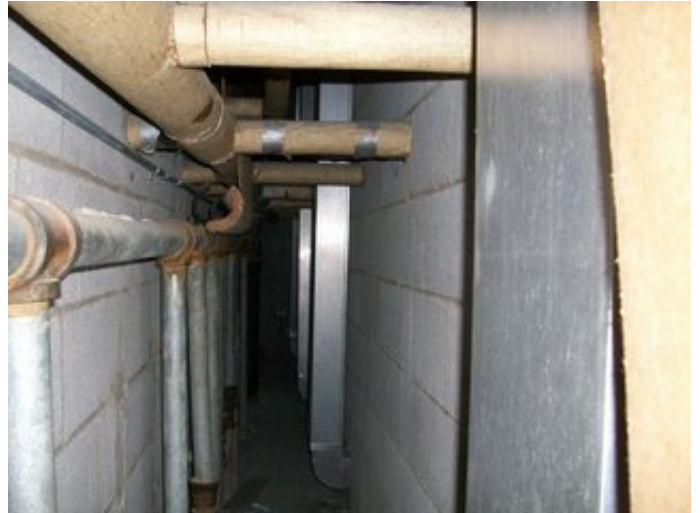
Domestic water in plumbing chase

Recommendations: The system does not provide adequate capacity for the future needs of the school.

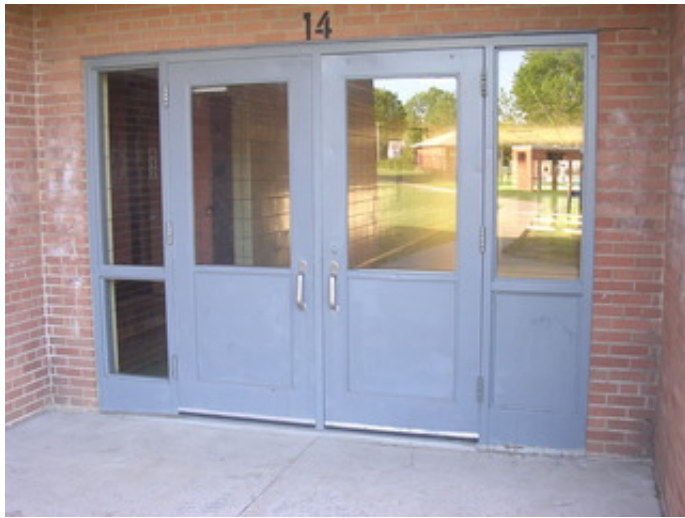
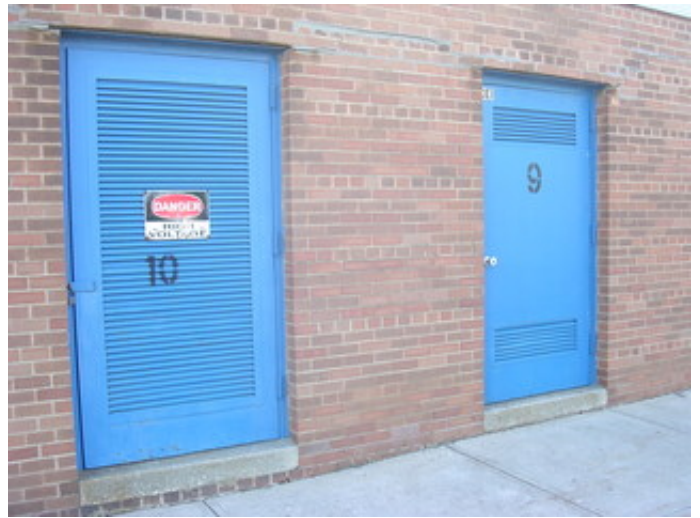
Typical hollow metal entry doors.

Typical hollow metal doors.

Recommendations: Replace all exterior doors to comply with Ohio Building Code, ADA, and Ohio School Design Manual guidelines.

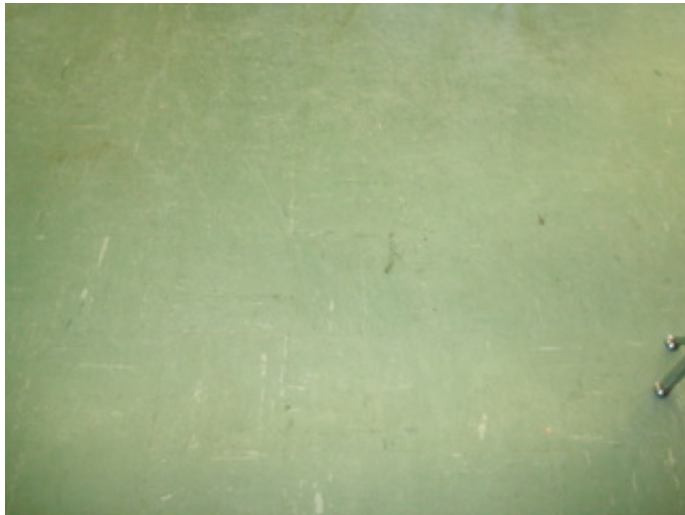
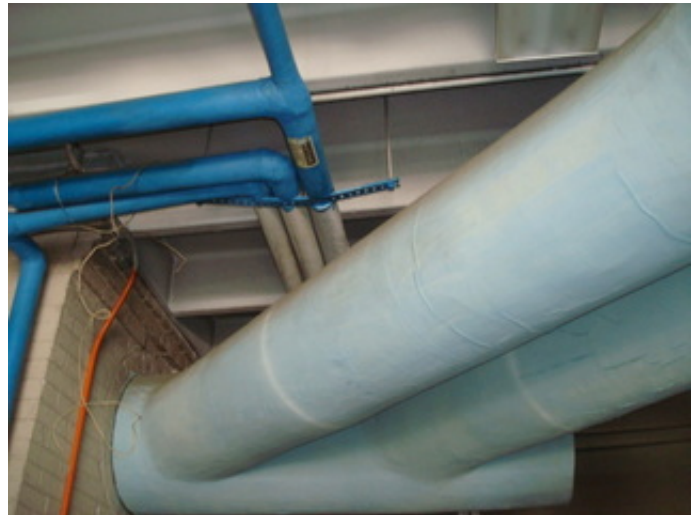
9x9 tile

Pipe insulation

Recommendations: Remove all hazardous materials, inclusive of asbestos-containing materials in the overall facility, as noted in the attached Environmental Hazards Assessment. Provide for the testing of paint that has the potential of being lead-based.

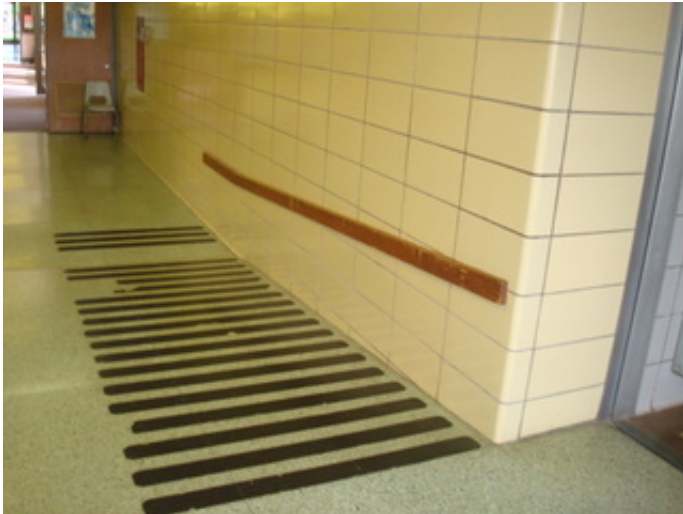
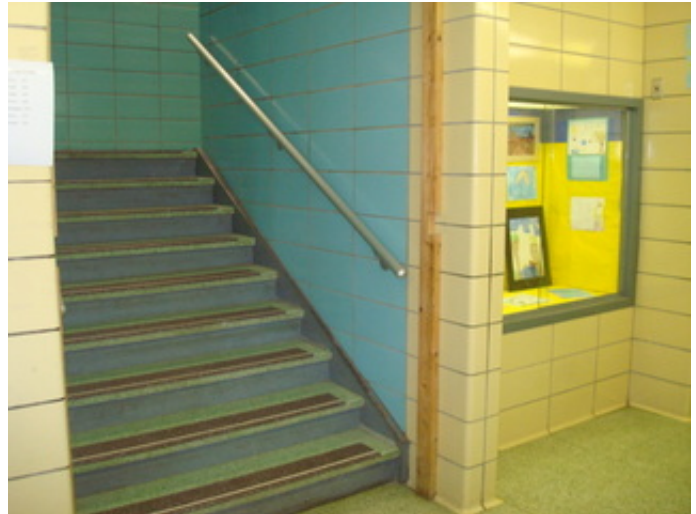
Ramp with non compliant handrail

Stair and non compliant handrail

Recommendations: Provide new automated fire suppression system to meet Ohio School Design Manual guidelines. Provide increased water service of a capacity sufficient to support the fire suppression system, funding included in fire suppression funding. Provide new handrails to meet the requirements of the Ohio Building Code. Stair tower enclosures are not recommended due to automatic fire suppression system.

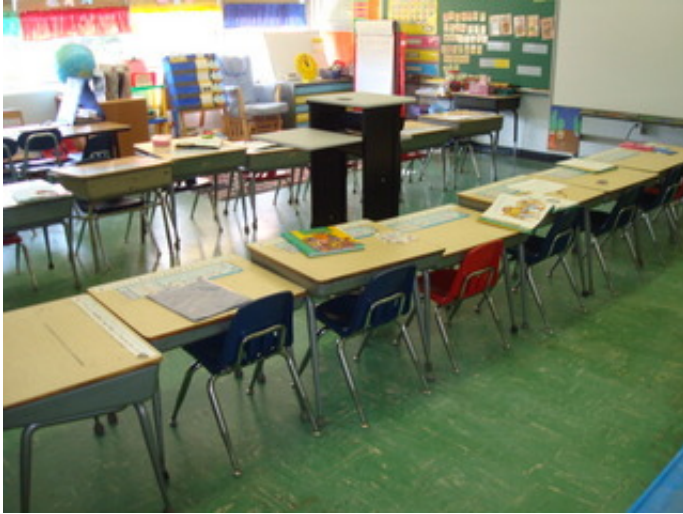
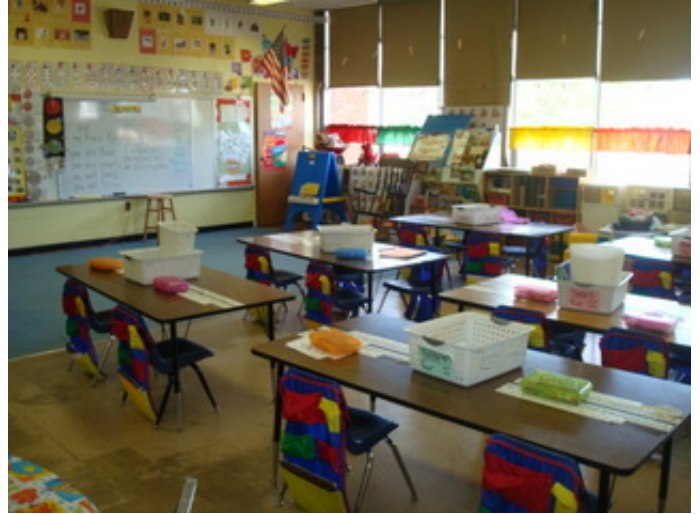
Classroom furniture

Recommendations: Provide for replacement of outdated or inadequate furniture.

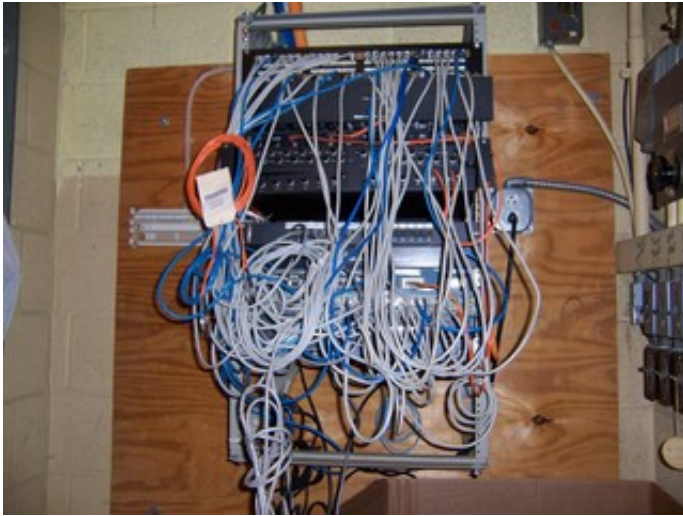
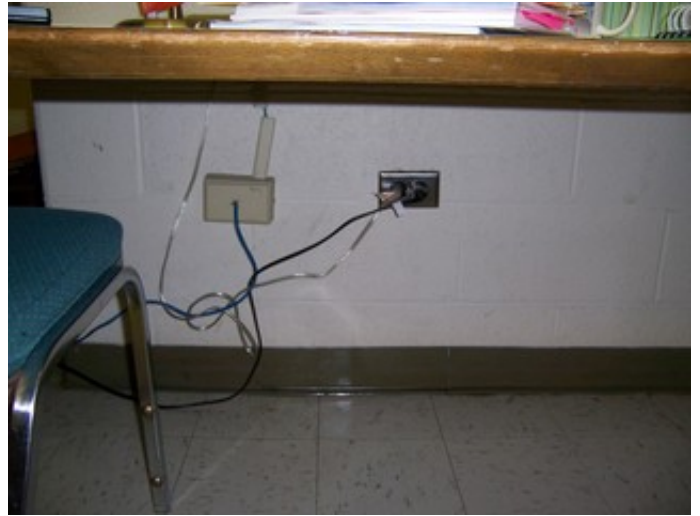
Technology Cabinet

Typical Technology Outlet

Recommendations: Provide complete replacement of technology systems to meet Ohio School Design Manual requirements for this facility.
