Building Information - Willoughby-Eastlake City SD (45104) - North High School

Program Type	Expedited Local Partnership Program (ELPP)
Setting	Suburban
Assessment Name	North H_2010_TCI
Assessment Date	2010-03-16
Cost Set:	2010
Building Name	North High School
Building IRN	27573
Building Address	34041 Stevens Blvd
Building City	Eastlake
Building Zipcode	44094
Building Phone	440/975-3692
Acreage	47.18
Current Grades	9-12
Teaching Stations	79
Number of Floors	2
Student Capacity	1850
Current Enrollment	1482
Enrollment Date	2010-04-01
Enrollment Date is the date in which the current enrollment was taken.	
Number of Classrooms	74
Historical Register	NO
Building's Principal	Ms. Jen Chauby
Building Type	High

North High School, which is not on the National Register of Historic Buildings, and originally constructed in 1955, is a 2 story, 218,817 square foot brick school building located in a suburban residential setting. The existing facility features a conventionally partitioned design, and does not utilize modular buildings. The structure of the overall facility contains concrete frame exterior wall construction, with block wall construction in the interior. The floor system consists of s

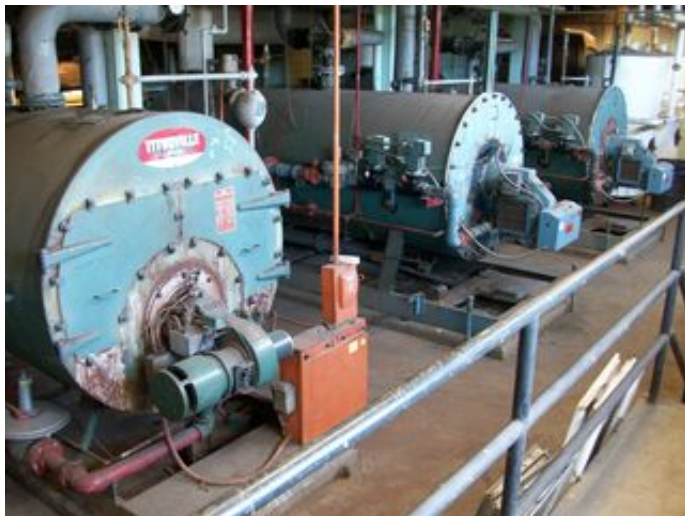
Rating: 3 Needs Replacement

Gas Fire Hot Water Boilers

Recommendations: Provide new overall heating, ventilating, and air conditioning system to achieve compliance with Ohio Building Code and Ohio School Design Manual standards. Convert to ducted system to facilitate efficient exchange of conditioned air.

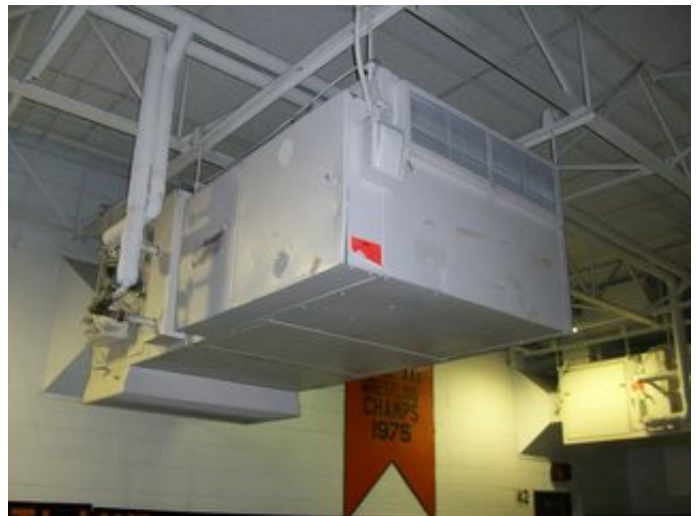
Forced Air Heating Unit

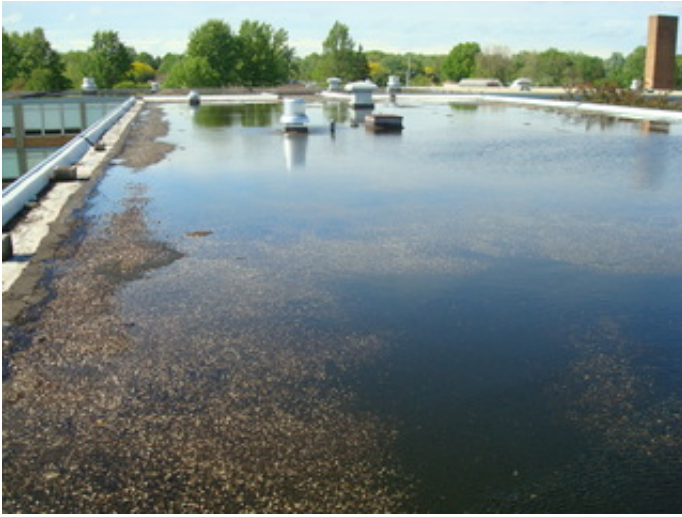
Standing water on 1962 Addition

Roof Insulation:	\$4.50	sq.ft. (Qty)		47,938 Required				28,478 Required		17,961 Required	4,347 Required	\$444,258.00	(tapered insulation for limited area use to correct ponding)
Roof Access Hatch:	\$2,000.00	each		2 Required						1 Required		\$6,000.00	(remove and replace)
Roof Access Ladder with Fall Protection Cage:	\$100.00	in.ft.		12 Required								\$1,200.00	(remove and replace)
Sum:			\$1,459,192.85	\$713,810.76	\$0.00	\$0.00	\$0.00	\$402,236.56	\$0.00	\$266,165.28	\$76,980.25

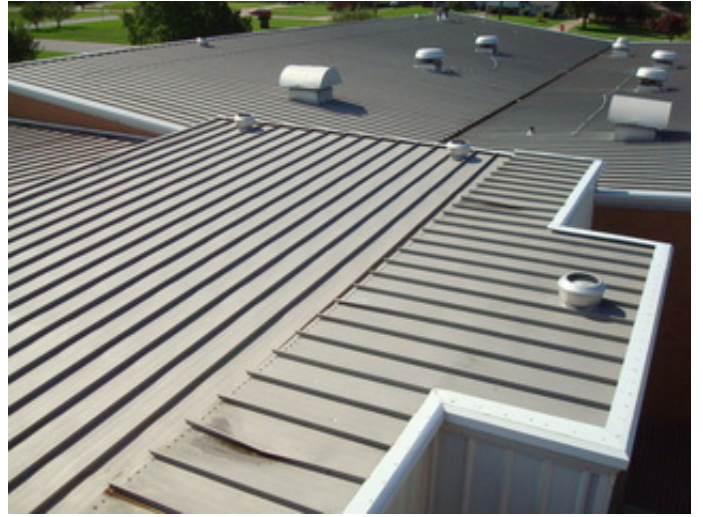
Metal roofing retrofit surfaces on the 1955 Original Construction

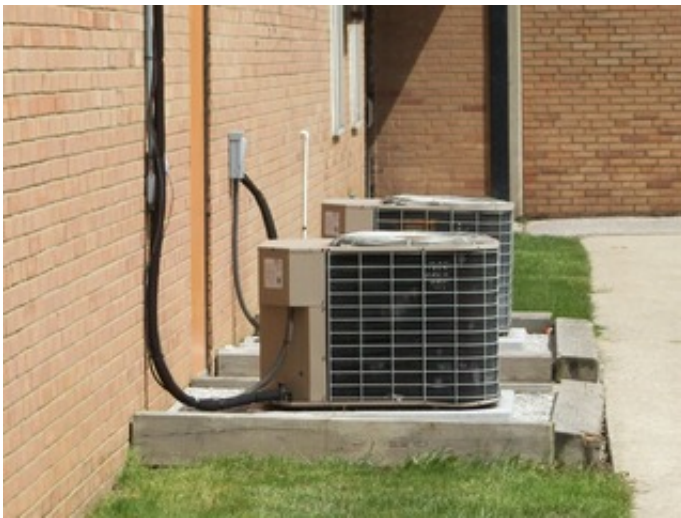
Condenser Units

Recommendations: Provide an air conditioning system to meet with Ohio Building Code and Ohio School Design Manual requirements. Pricing included in Item A.

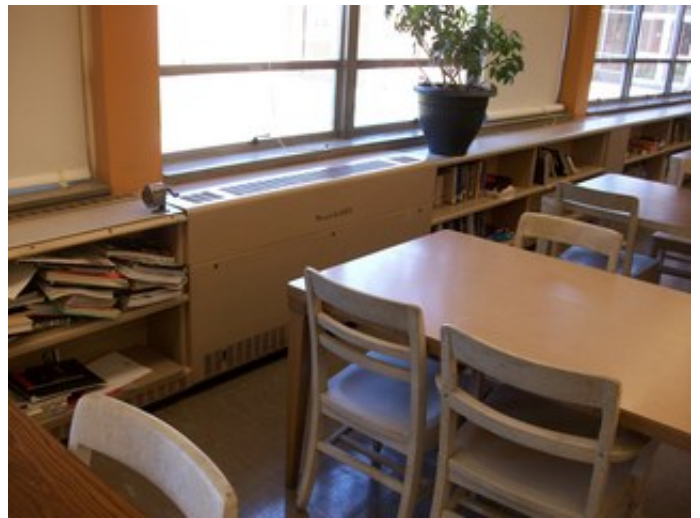
Unit Ventilator

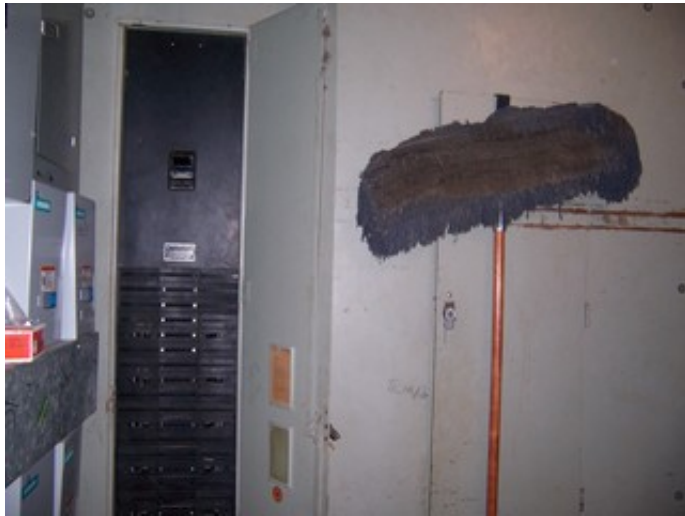
Secondary Electrical Panels

Recommendations: The entire electrical systems requires replacement to meet Ohio School Design Manual guidelines and the Ohio Building Code for overall capacity due to lack of OSDM - required features and to accommodate the addition of an air conditioning system.

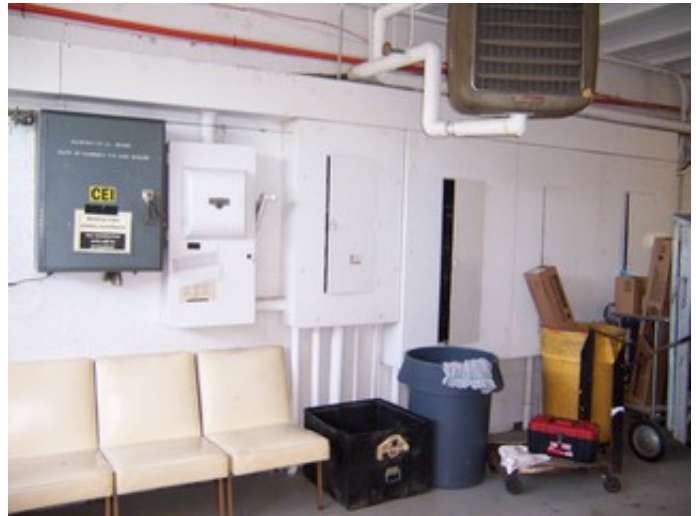
Main Electrical Switch and Panels

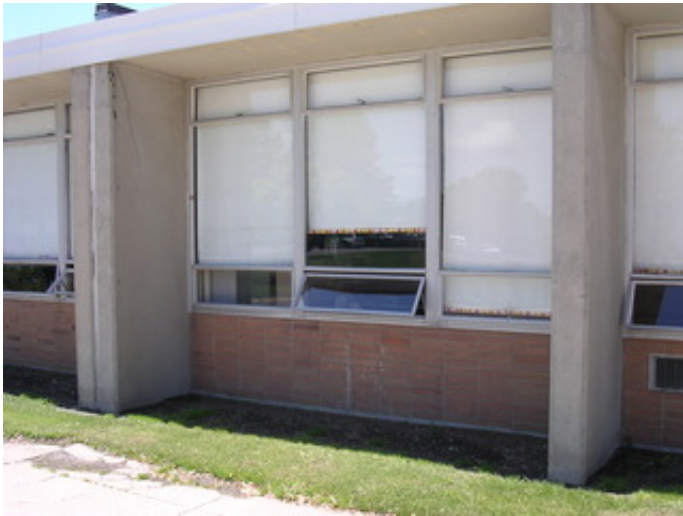
Typical aluminum windows.

Recommendations: Provide a new insulated window system with integral blinds to meet with Ohio School Design Manual requirements. Replace curtain wall system in the overall facility to meet with Ohio School Design Manual requirements. Replace window transoms / sidelights in exterior doors of the overall facility due to condition to meet with Ohio School Design Manual requirements. Replace greenhouse in poor condition.

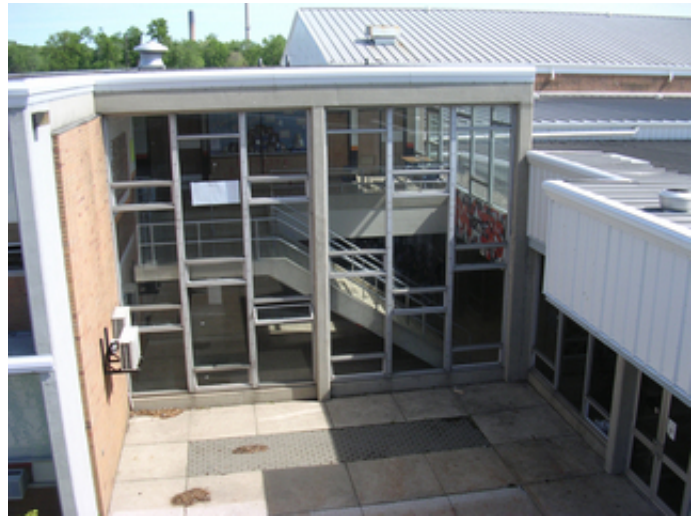
Typical aluminum curtain wall system.

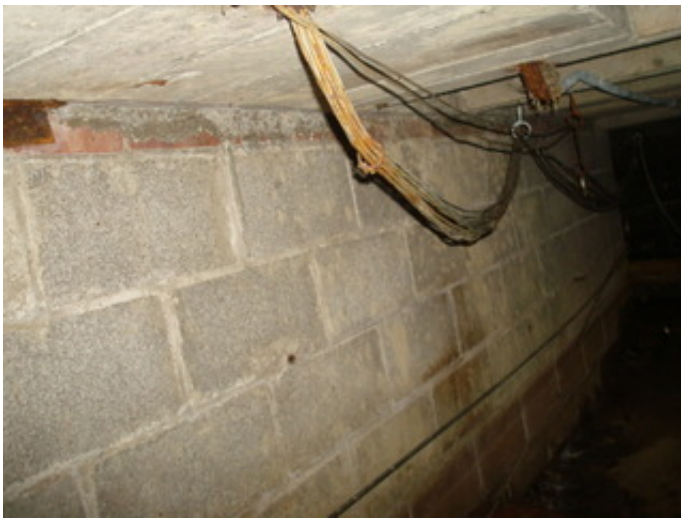
Crawl foundation wall

Recommendations: Provide drainage tile system at north face of the 1955 original construction to correct erosion caused by open down pipes.

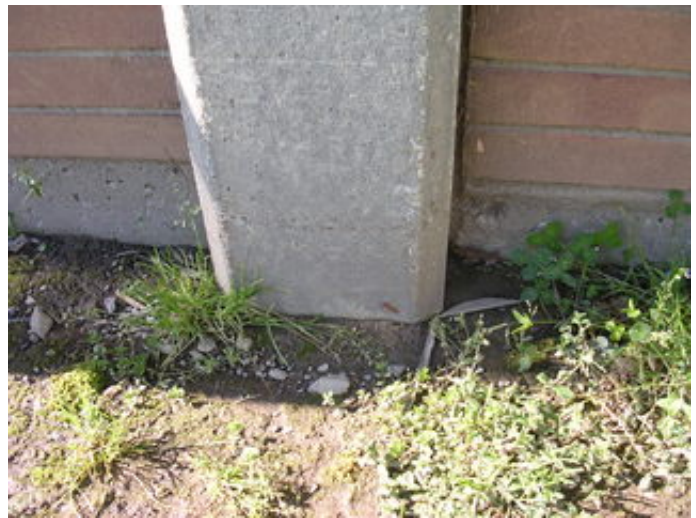
Typical foundation condition.

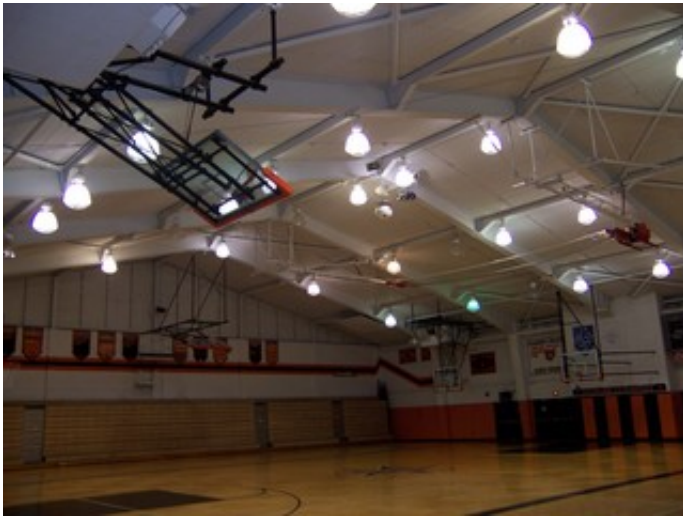
Gymnasium Lighting

Recommendations: Provide complete replacement of lighting system due to condition, utilization of T12 fixtures and installation of fire protection system.

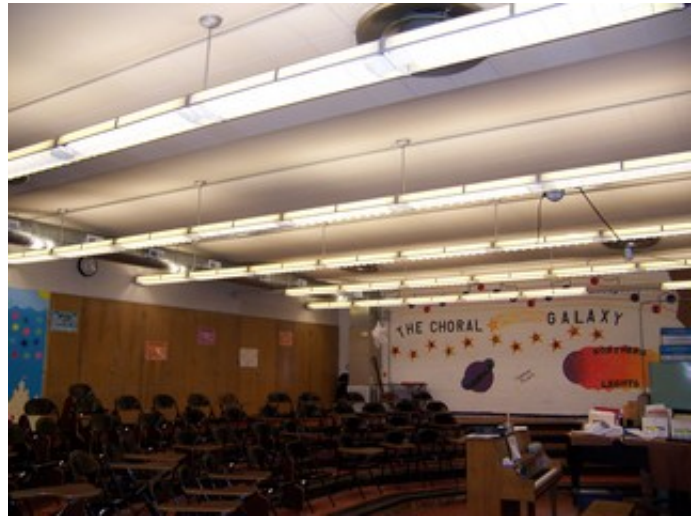
Choir Room Lighting

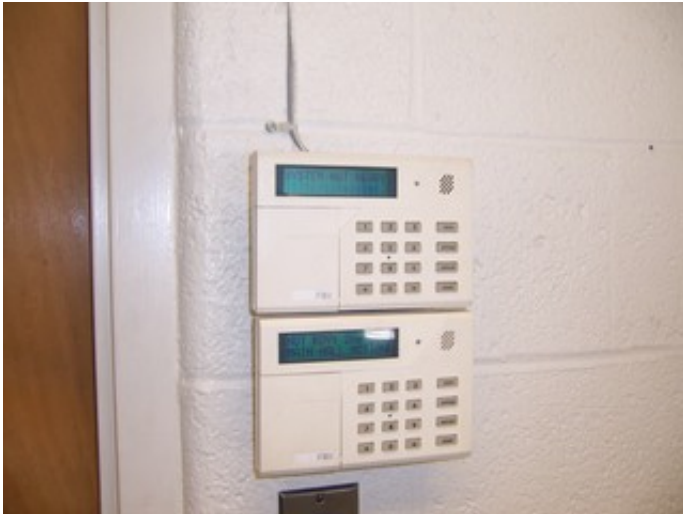
Security Alarm Panels

Recommendations: Provide complete replacement of security system to meet Ohio School Design Manual guidelines

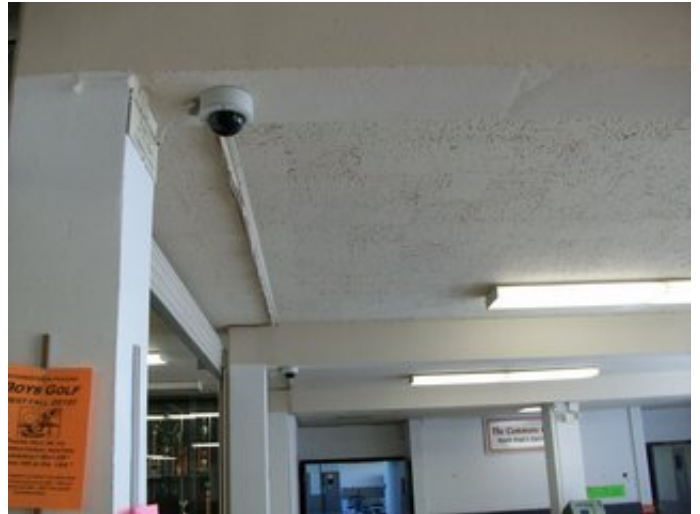
Ceiling Mounted Surveillance Camera

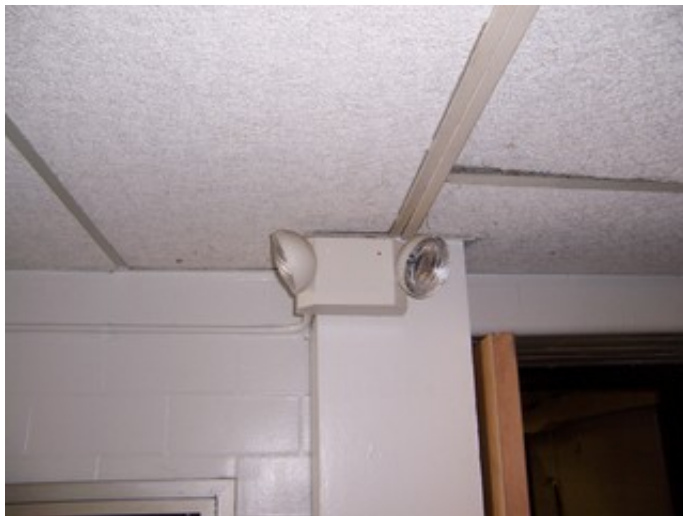
Emergency Lighting

Recommendations: Provide complete replacement of emergency / egress lighting system to meet Ohio School Design Manual guidelines.

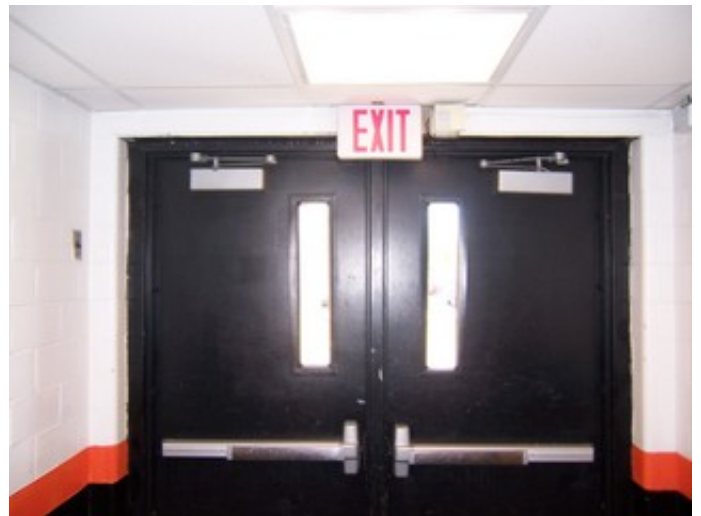
Ceiling Mounted Exit Sign

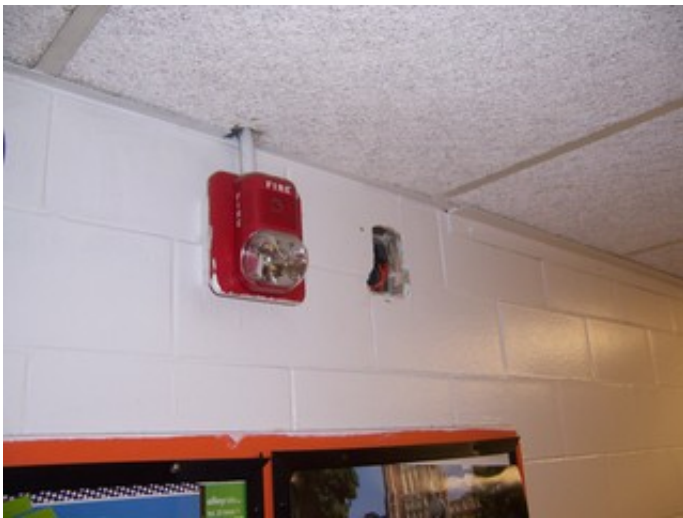
Wall Mounted Fire Alarm Strobe

Recommendations: Provide complete replacement of fire alarm system to meet OBC, NFPA, and Ohio School Design Manual guidelines.

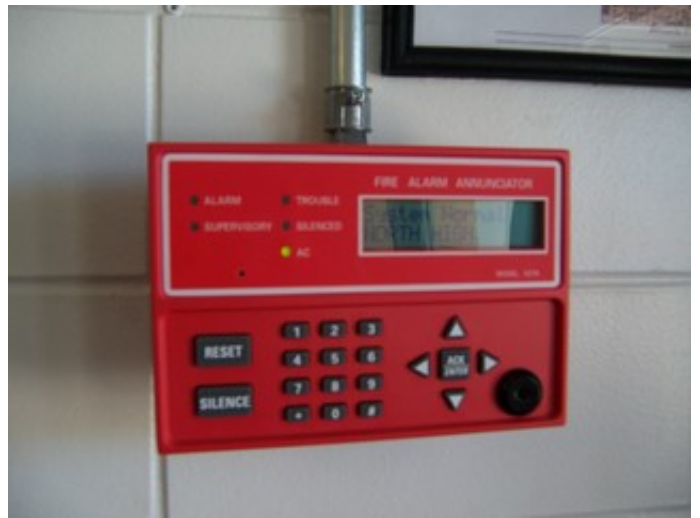
Fire Alarm Control Device

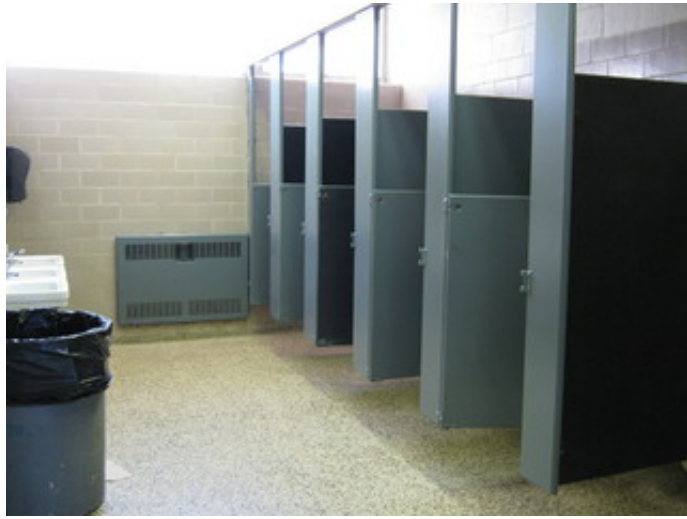
Non accessible group toilet room

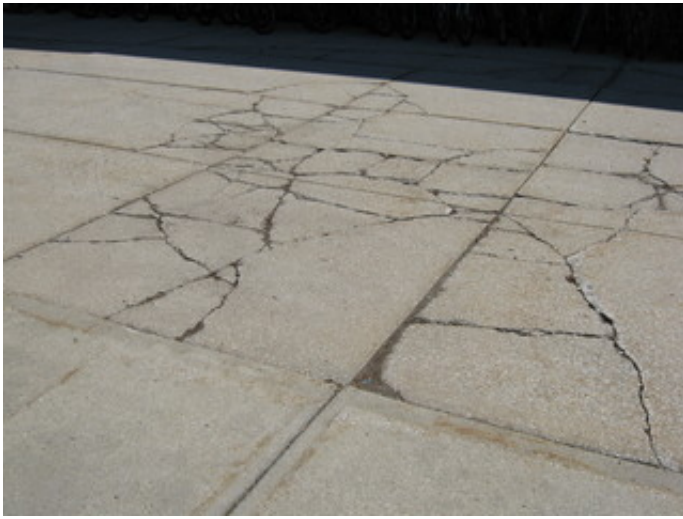
Sidewalk in poor condition

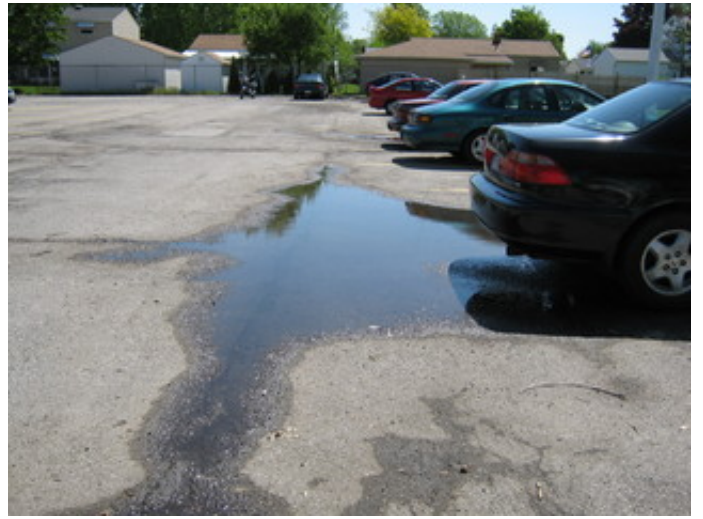
Parking lot ponding

Provide Exterior Parking Lot Catch Basin:	\$2,500.00	each		400 Required								\$1,000.00	(includes stripping and re-grading)
Base Sitework Allowance for Unforeseen Circumstances	\$50,000.00	allowance		6 Required								\$15,000.00	
Sitework Allowance for Unforeseen Circumstances for buildings 100,000 SF or larger	\$150,000.00	allowance		Required								\$50,000.00	Include this and one of the next two. (Applies for whole building, so only one addition should have this item)
Sum:				\$817,748.05	\$817,748.05	\$0.00	\$0.00	\$0.00	\$0.00	\$0.00	\$0.00	\$150,000.00	Include this one <u>or</u> the previous. (Applies for whole building, so only one addition should have this item)

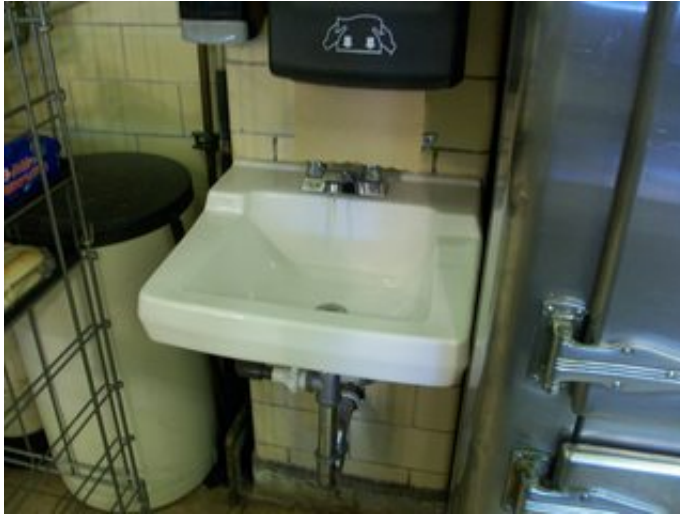
Sanitary drain below sink

Recommendations: Replace existing system due to age of pipe.

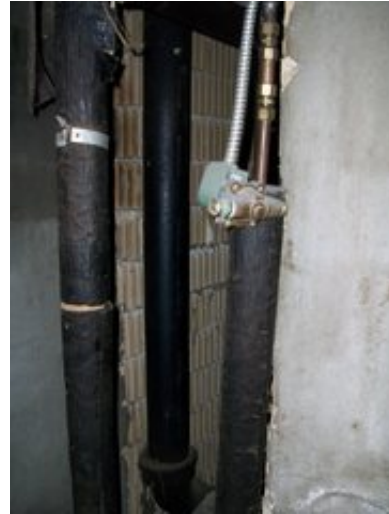
Sanitary drainage Piping

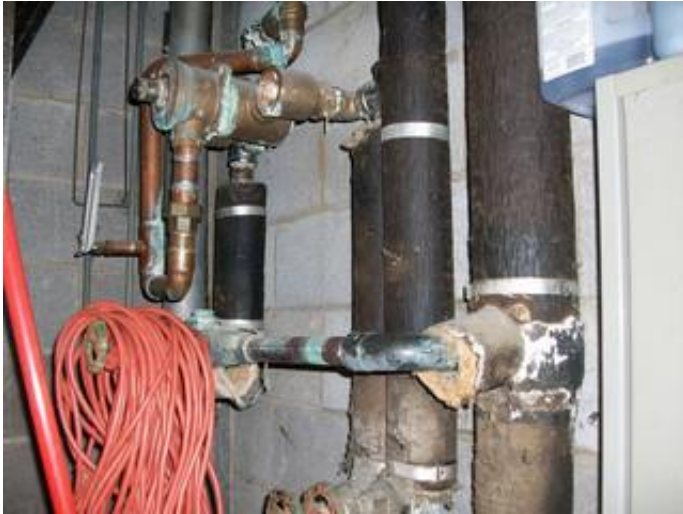
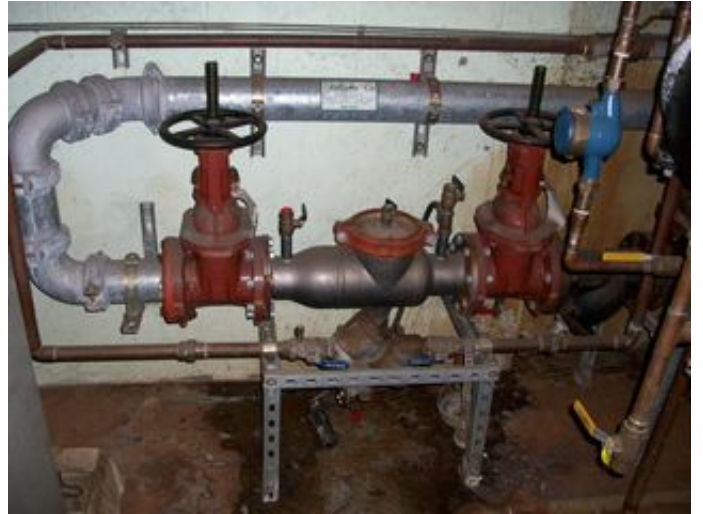
Domestic Water Piping

Domestic water piping

Recommendations: The facility is not equipped with an automated fire suppression system, and the existing water supply will not provide adequate support for a future system.

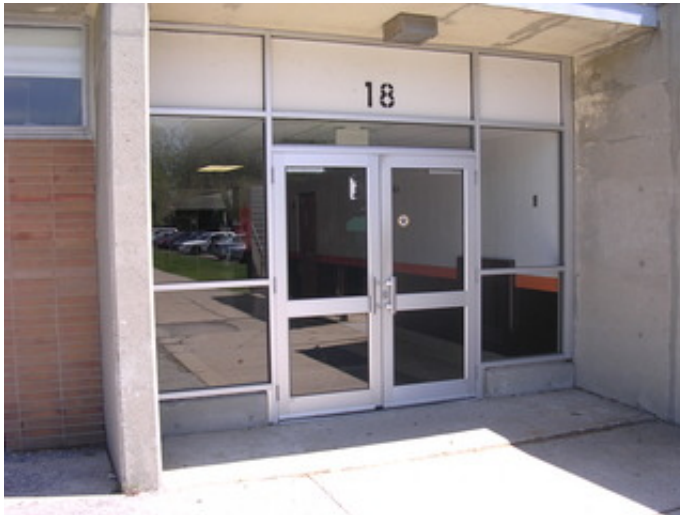
Typical aluminum entry doors.

Recommendations: Replace exterior doors, due to poor condition to comply with Ohio Building Code, ADA, and Ohio School Design Manual guidelines. . Replace overhead doors in the 1957 Addition due to poor condition. Sidelite replacement included in item F.

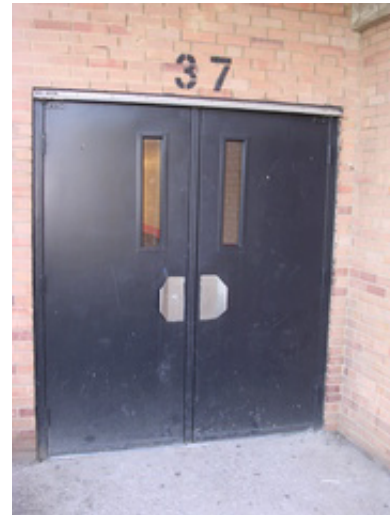
Typical hollow metal doors.

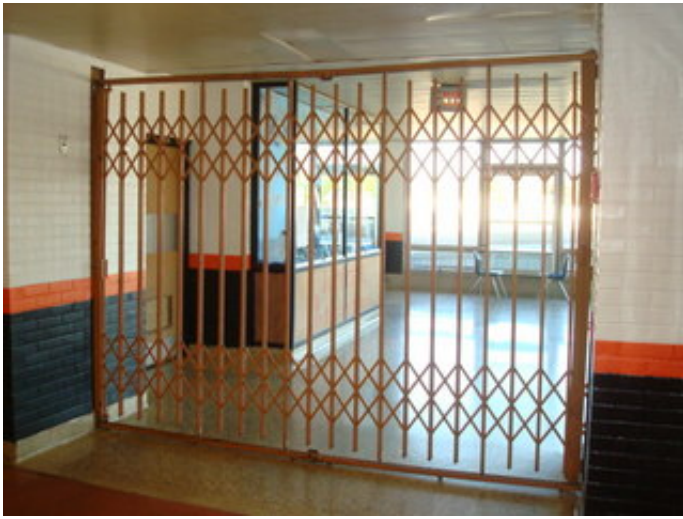
Gate for afterhours

Other: Replace gate with door	\$7,500.00	each		3 Required								\$22,500.00	Remove gate and replace with dual action double door to eliminate dead end corridor.
Other: Second egress door	\$3,000.00	each		4 Required				2 Required		2 Required		\$24,000.00	Provide second means of egress from room with more than 50 occupants
Sum:			\$821,702.00	\$501,970.50	\$2,297.75	\$14,903.75	\$0.00	\$97,360.75	\$9,711.00	\$121,059.25	\$74,399.00
