Building Information - Willoughby-Eastlake City SD (45104) - Kennedy Junior High School

Building Construction Information - Willoughby-Eastlake City SD (45104) - Kennedy Junior High School (94510401)

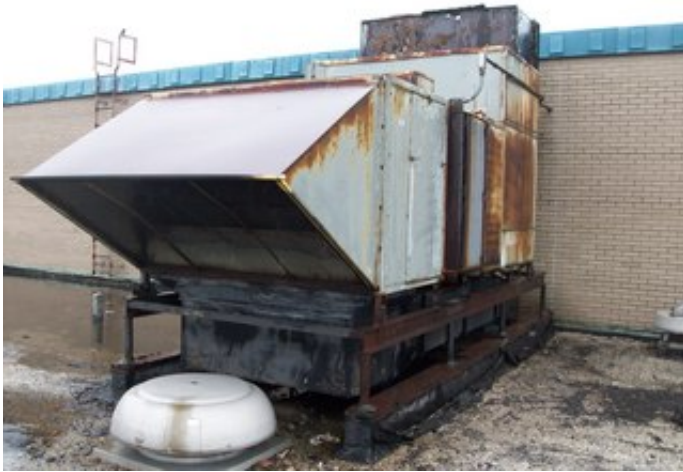
Description: The existing heating system for the overall facility is composed of an electric heating forced air system remotely dispersed throughout the facility in the form of package air handlers and unit heaters installed new in 1964. The units are in fair condition. The heating system in the overall facility is part of the Original Construction and newly updated with each addition. With very limited capacity for simultaneous heating and cooling operation, this system is not compliant with the OSDM requirements for basic system type. The air handler units, manufactured by various manufacturers were installed in 1964, and are in fair condition. Heating system is distributed to terminal units consisting of unit ventilators, cabinet heaters and unit heaters. The terminal equipment was installed in 1964 and new with each addition and is in fair condition. The system does (not) comply with the 15 CFM per person fresh air requirements of the Ohio Building Code mechanical code and Ohio School Design Manual. The non DDC type system temperature controls were installed in 1964 and are in working condition. The system does feature individual heating temperature controls in all spaces required by the OSDM. The overall system does not feature any central energy recovery systems. The facility is not equipped with louvered interior doors to facilitate Corridor utilization as return air plenums. However rooms do have a return air systems. The existing system is ducted, and floor to structural deck heights in majority of the areas will accommodate the installation of properly sized ductwork for a future Ohio School Design Manual approved system. The overall heating system is evaluated as being not in safe and efficient working order, due to age. The structure is equipped with central air conditioning except for in the gym. The site does not contain underground fuel tanks that are currently in use.

Rating: 3 Needs Replacement

Air Handler With Electrical Heating Strips

Recommendations: Provide new overall heating, ventilating, and air conditioning system to achieve compliance with Ohio Building Code and Ohio School Design Manual standards. Convert to ducted system to facilitate efficient exchange of conditioned air.

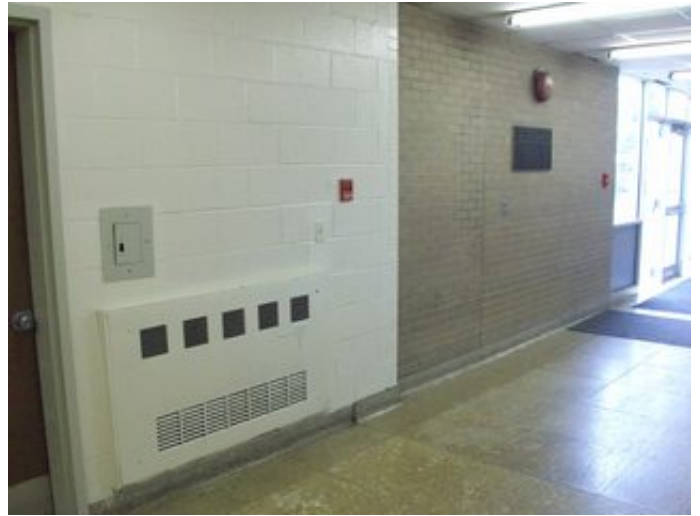
Electric Unit Heater

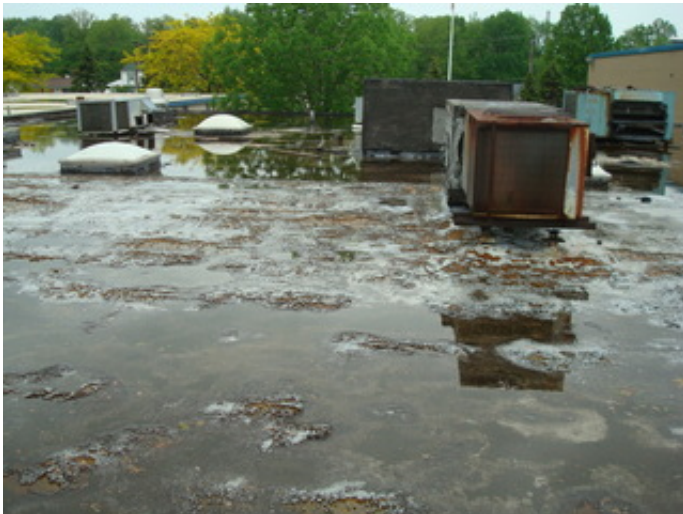
Description: The roof over the overall facility is a built-up roofing system that was installed with the original construction, and is in poor condition. Various patches of built-up roofing and spray-on roofing are in poor condition. There is severe current leaking throughout all areas of the facility, with the exception of the northwest classroom area of the 1964 Original Construction which was installed in approximately 2001 but is in poor condition. Current leaking was observed in most areas during the physical assessment. Access to the roof was gained by access hatch that is in poor condition and access ladders that are in fair condition. Fall safety protection cages are not required. There were observations of extensive standing water on all areas of the roof. Metal cap flashings are in poor condition. Roof storm drainage is addressed through a system of roof drains, which are properly located, and in poor condition. Approximately half of the roof drains are clogged, contributing to the standing water issues on this roof. The roof is not equipped with overflow roof drains though they are needed on this building. Roof penetrations were in poor condition in most locations, consistent with the roof condition. There are not any covered walkways attached to this structure.

Rating: 3 Needs Replacement

Spray-on roofing, standing water, and skylights

Recommendations: Replace roof with single-ply membrane to meet Ohio School Design Manual guidelines for age of system and due to condition. Provide tapered insulation for positive slope to drain. Replace flashing and coping due to condition. Replace roof drains, and install overflow drains. Replace roof hatch and ladder.

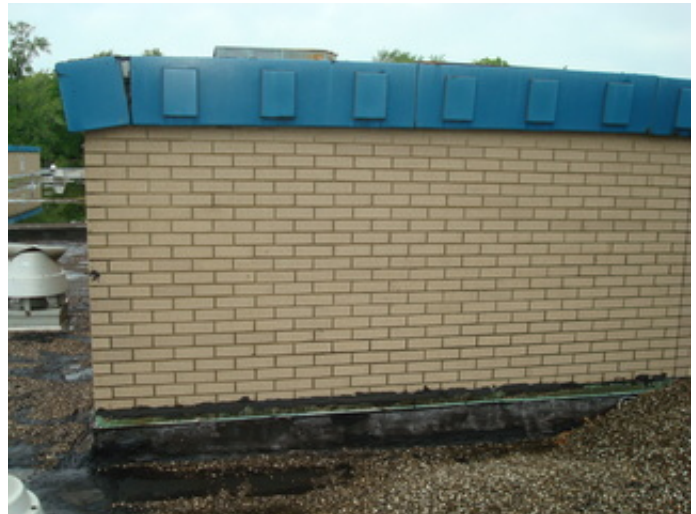
Deteriorated metal wall coping

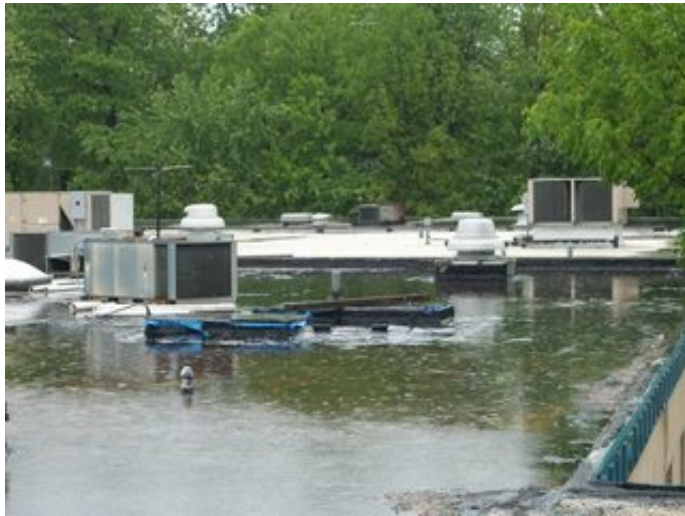
Description: The overall facility is equipped with rooftop central air conditioning systems except for in the gymnasium. The ventilation system in the overall facility consists of unit ventilators and ducted air handlers installed initially in 1964 and new with each addition and are in fair condition, providing fresh air to classrooms and other miscellaneous spaces such as Gymnasiums, Student Dining, Media Center etc. Relief air venting is provided by relief fans and roof vents. The ventilation system does not meet the Ohio Building Code 15 CFM per occupant fresh air requirement. The overall system is not compliant with Ohio Building Code and Ohio School Design Manual requirements. Dust collection systems are not provided or required. Exhaust systems for Restrooms, Locker Rooms, Kitchen, Gymnasiums, Storage Rooms, Custodial Closets and specialized areas are adequately placed, and in working condition.

Roof Top A/C And Exhaust Fans

Recommendations: Provide an air conditioning system to meet with Ohio Building Code and Ohio School Design Manual requirements. Pricing included in Item A. Provide kiln exhaust system for kiln listed in item J.

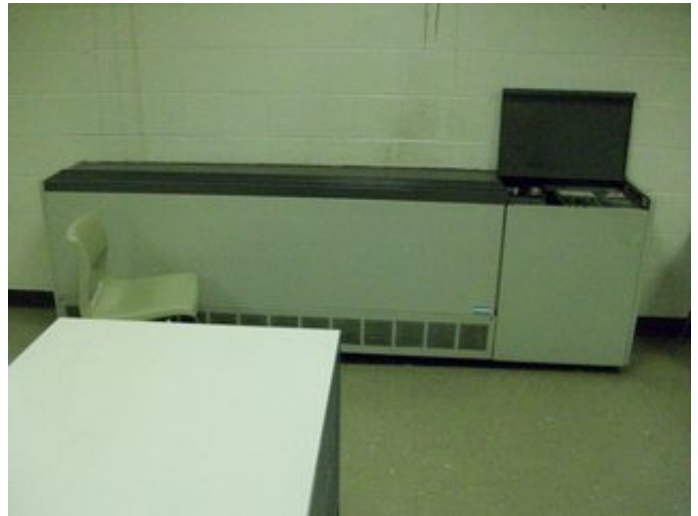
Unit Ventilator

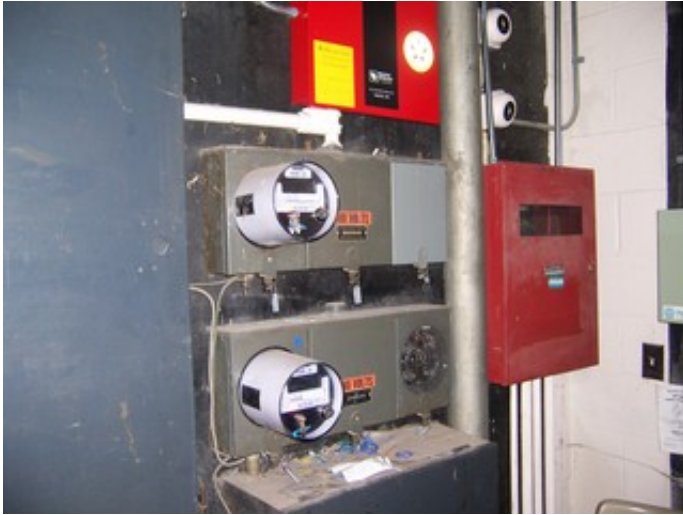
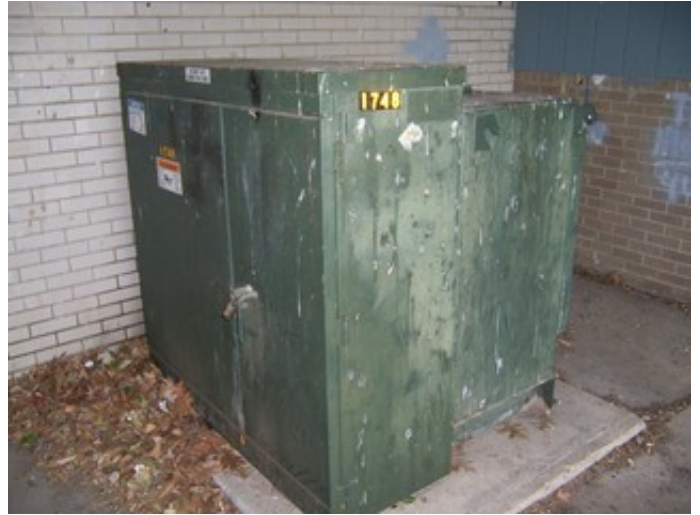
Rating: 3 Needs Replacement

Electric Utility Meters

Pad Mounted Transformer

Recommendations: The entire electrical systems requires replacement to meet Ohio School Design Manual guidelines due to age.

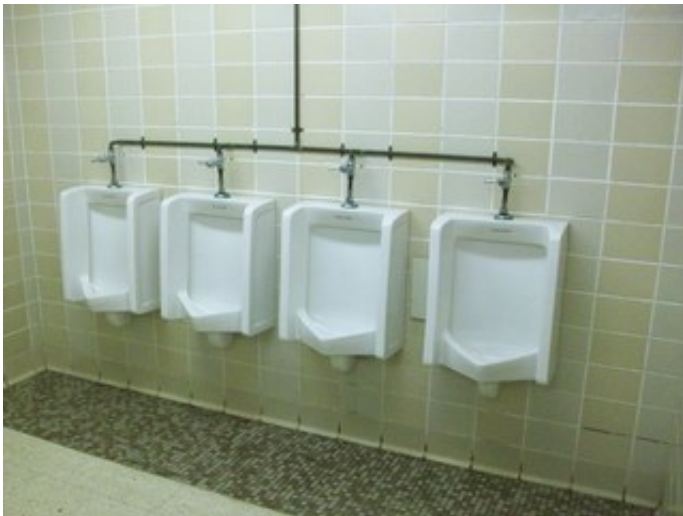
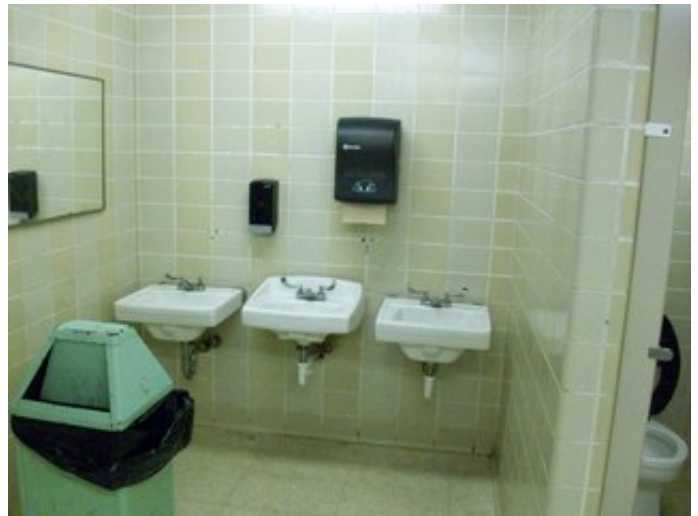
Rating: 3 Needs Replacement

Toilet room fixtures

Recommendations: The school does not meet the OBC requirements for fixtures. ADA requirements are not met for fixtures and drinking fountains see Item O.

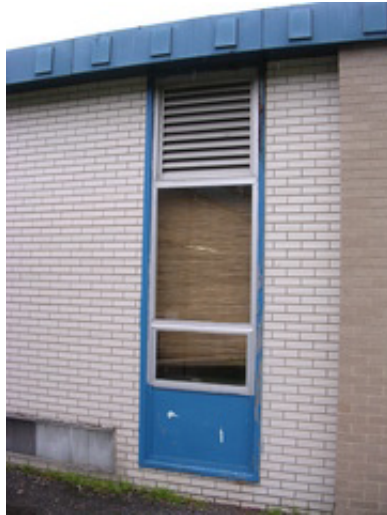
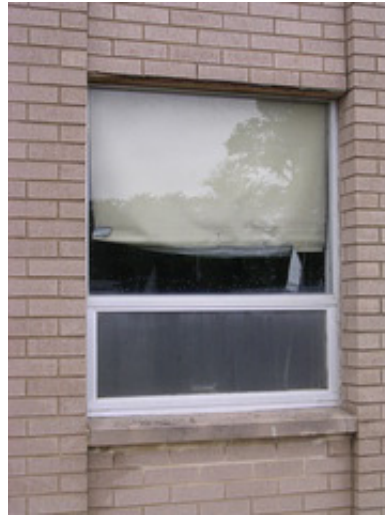
Description: The overall facility is equipped with non-thermally broken aluminum windows with single and double pane non-insulated glazing type window system, which was installed at the times of construction, and are in poor condition. Window frames are a combination of aluminum and hollow metal. Spandrel panels are mismatched and a combination of porcelain, metal, and fiberglass. Window system seals are in poor condition, with moderate air and water infiltration being experienced. Window system hardware is in poor condition. The window system features surface mounted blinds, which are in poor condition. The window system is not equipped with insect screens on operable windows. Hollow metal storefront window systems with single glazed, tempered and non-tempered glazing are in poor condition. An aluminum storefront window systems was found in the 1970 Addition, with single glazed, non-insulated, tempered glazing that is in fair condition. This facility does not feature any glass block windows. The school contains (8) acrylic bubble type skylights in poor condition. Window security grilles are not provided for ground floor windows. There is not a Greenhouse associated with this school.

Rating: 3 Needs Replacement

Typical aluminum window in hollow metal frame.

Typical aluminum window.

Recommendations: Provide a new insulated window system with integral blinds to meet with Ohio School Design Manual requirements. Replace storefront window system in the overall facility. Replace skylights in the overall facility.

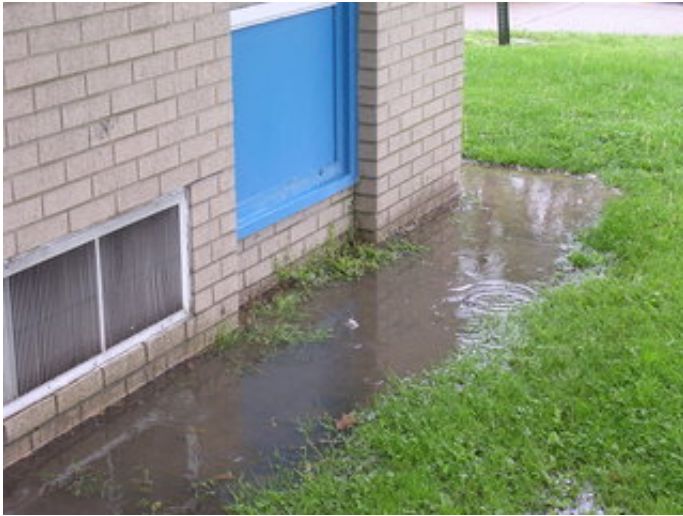
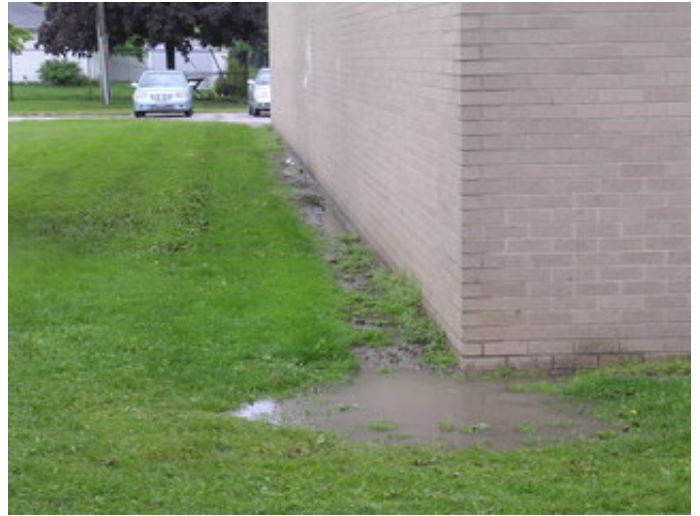
Description: The overall facility is equipped with concrete trench footings, which displayed no locations of significant differential settlement, cracking, or leaking, and are in good condition. The District reports that there has been no past leaking. Grading and site drainage deficiencies were noted around the perimeter of the structure that could contribute to foundation / wall structural deterioration.

Rating: 2 Needs Repair

Ponding at foundation.

Recommendations: Provide drainage tile system at 1,400 lineal feet of the overall facility to control ponding issues.

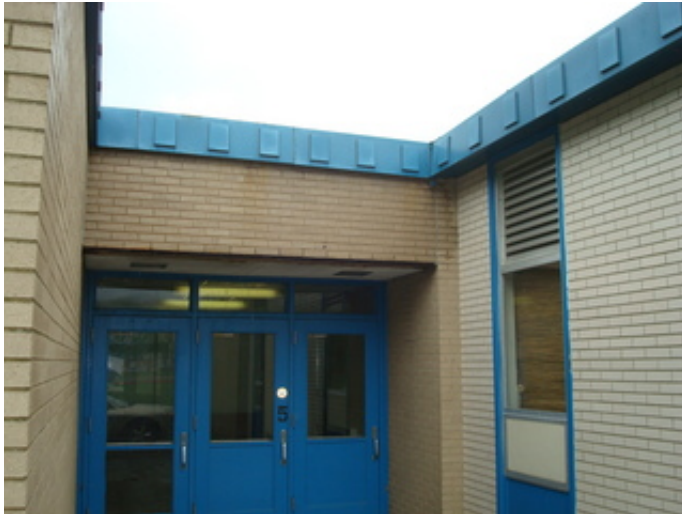
Description: The overall facility has a brick veneer on a masonry bearing wall system which displayed locations of minor deterioration, and is in fair condition. The exterior masonry appears to have appropriately spaced and inadequately caulked control joints in fair condition. Control joints are not provided at lintel locations at doors and windows. The school has sufficient expansion joints on the 1970 addition, and they are in fair condition. The school contains expansion joints. The exterior masonry has not been cleaned and sealed in recent years, and shows evidence of mortar deterioration in the 1970 addition exterior walls and at the glazed block on the west side of the 1964 Addition. Architectural exterior accent materials consist of glazed block, which is in fair condition. Interior walls are primarily concrete masonry units with some metal stud partitions with plaster and are in fair condition. Interior masonry appears to have adequately spaced and caulked control joints in fair condition. Soffits are in poor condition. The window sills are concrete, and are in fair condition. The exterior lintels are steel, and are rusting. Chimneys are in fair condition but mortar deterioration was observed and precast coping is in poor condition.

Rating: 2 Needs Repair

Rusted lintel and deteriorated control joint in 1970 Addition

Recommendations: Provide tuckpointing in all areas of mortar deterioration as required through the overall facility. Provide masonry cleaning and sealing as required through the overall facility. Recaulk existing control joints. Replace masonry lintels as required through the overall facility. Paint lintels as required throughout the overall facility.

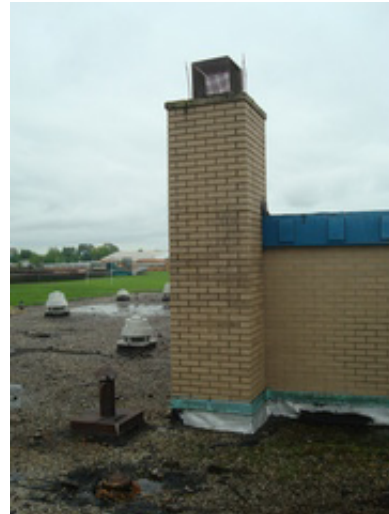
Chimney showing deteriorated mortar

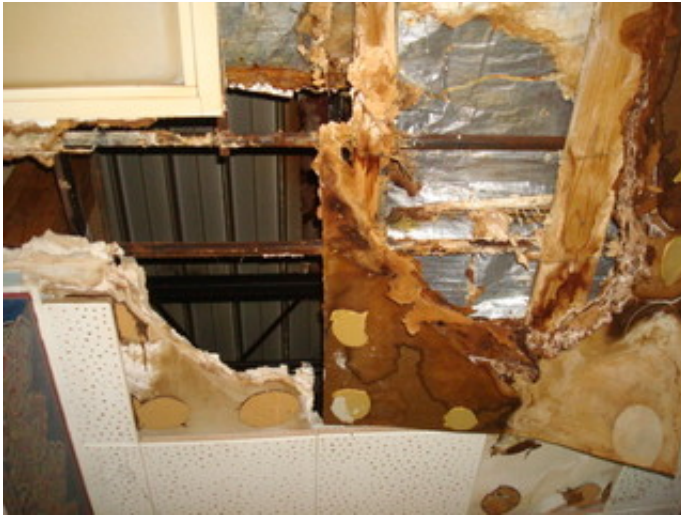
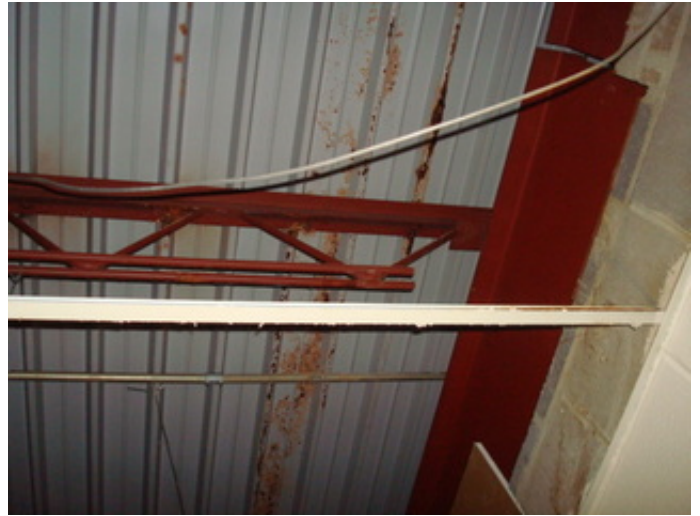
Description: The floor construction of the base floor of the overall facility is concrete slab on grade type construction, and is in fair condition. There is no crawl space. There are no intermediate floors in this single story structure. Ceiling to structural deck spaces are sufficient to accommodate HVAC, electrical, and plumbing scopes of work in required renovations. The roof construction of the overall facility is steel joist with metal decking type construction, and are in moderate condition. Areas of rust were observed due to extensive roof leaking. The gymnasium is steel bar joists with tectum panels and is in moderate condition. Plaster soffits show water damage from roof leaks.

Rating: 2 Needs Repair

Roof structure

Recommendations: Replace damaged soffits.

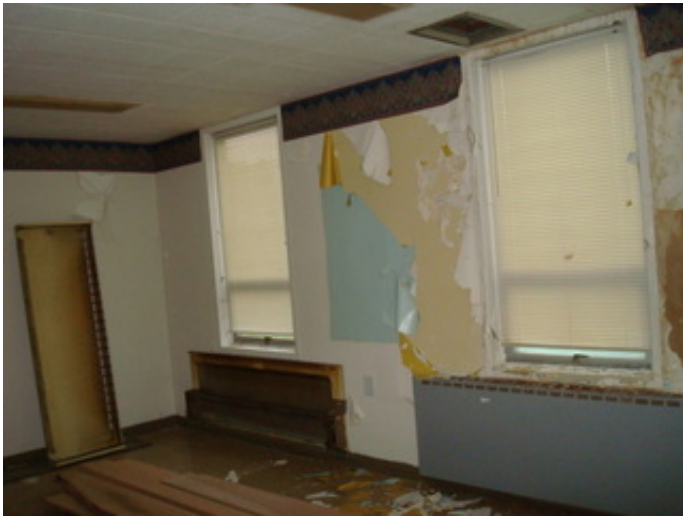
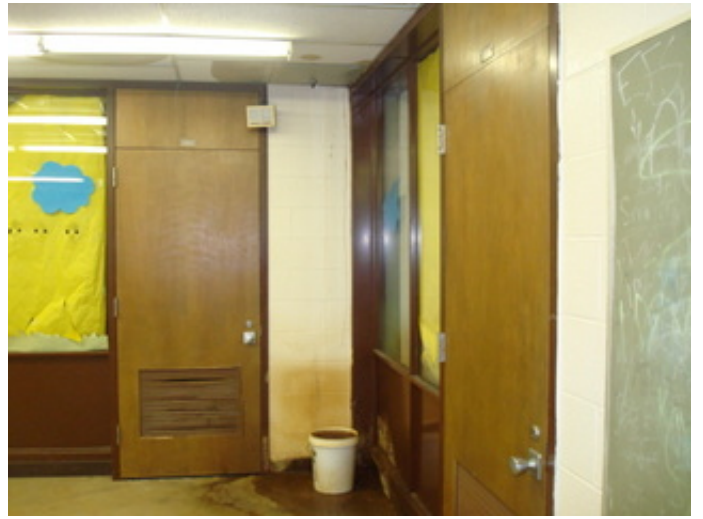
Description: The overall facility features conventionally partitioned Classrooms with vinyl tile and carpet flooring in poor condition, acoustical tile ceilings in extremely poor condition, as well as painted block and drywall wall finishes in poor condition. The overall facility has Corridors with terazzo and vinyl tile floors, acoustical tile ceilings, as well as painted block wall finishes, and they are in poor condition. The overall facility has Restrooms with ceramic mosaic tile flooring, plaster painted ceilings, as well as glazed and painted block wall finishes, and they are in poor condition. Toilet partitions are metal, and are in poor condition. Classroom casework in the overall facility is non-existent. The typical Classroom contains no lineal feet of casework, and Classroom casework provided ranges from 0 to 80 feet in the former Food Science Lab. Classrooms are provided chalkboards, markerboards, but not tackboards, which are in fair condition. The lockers, located in the Corridors, are adequately provided, and in poor condition and are not used by the current student population. Student materials are stored on hooks in Classroom spaces. The building does not have an Art program or Music program. The facility is equipped with wood louvered and non-louvered interior doors that are flush mounted without proper ADA hardware and clearances, and in poor condition. Glass lites in doors are not tempered. Some wire glass is present. The Gymnasium space has rubberized flooring in poor condition, tectum panel ceilings in fair to poor condition, as well as painted block wall finishes in good condition. Gymnasium telescoping stands are wood in poor condition. Gymnasium basketball backboards are fixed and electrically operated type, and are in good condition. A Media Center could not be located. Student Dining, located in the 1956 Original Construction, has vinyl tile flooring in poor condition, tectum panel ceilings in fair condition, as well as painted block wall finishes in fair condition. OSDM-required fixed equipment for Stage is not provided. The existing Kitchen is full service, is not in use, and the existing Kitchen equipment, installed 1971, is in poor condition. The Kitchen hood is in poor condition, and is equipped with the required UL 300 compliant wet chemical fire suppression system. The required 6" overhang on all three exposed sides of the cooking equipment is provided by the hood. Kitchen hood exhaust ductwork is of proper construction / material / insulation / and installed as required by the OSDM and OBMC. Walk-in coolers / freezers are located within the Kitchen spaces, and are in non-functioning condition.

Rating: 3 Needs Replacement

Original Office finishes

Classroom doorway

Recommendations: Provide complete replacement of finishes and casework due to installation of systems outlined in Items A, C, D, E, T, and U. Funding for replacement of interior doors is provided in Item O, including doors here noted as being in poor condition. Replace interior storefront damaged by roof leak. Replace bleachers. Provide a heat removal hood for the Art program kilns. Replace classroom cubbies/lockers. Provide kiln for art program. Replace entire Kitchen equipment due to conditions. Replace walk-in cooler/freezer. Replace partition wall with drywall. Replace toilet partitions and accessories. Rework walls to allow for ADA clearance in toilet rooms.

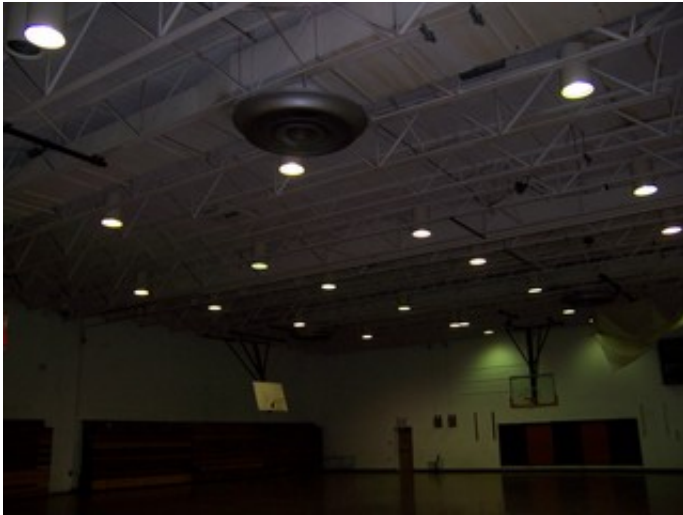
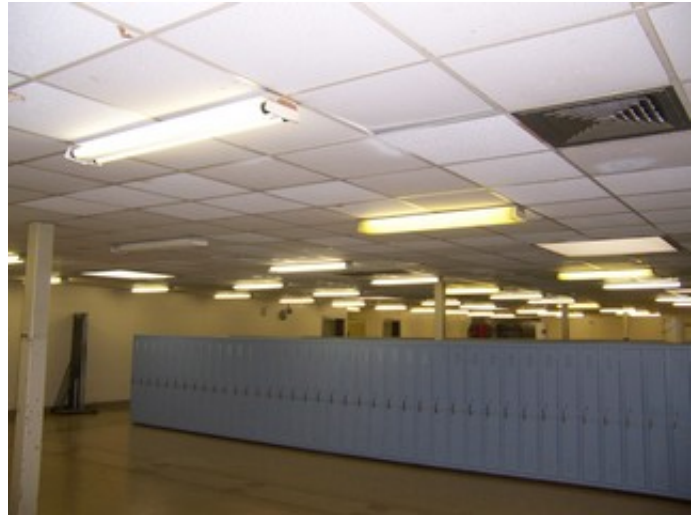
Description: The typical Classrooms in the overall facility are equipped with T-12, 1X4 suspended/ recessed fluorescent fixtures with single level switching. Classroom fixtures are in fair condition, providing an average illumination of 50 to 60 FC, thus complying with the 50 FC recommended by the OSDM. The typical Corridors in the overall facility are equipped with T-12, 1X4 surface mounted/recessed fluorescent fixtures with single level switching. Corridor fixtures are in fair condition, providing an average illumination of 20 to 25 FC, thus complying with the 20 FC recommended by the OSDM. The Primary Gymnasium / Student Dining space is equipped with mercury vapor pendant type lighting, in good condition, providing an average illumination of 60 to 65 FC, thus complying with the 50 ES FC recommended by the OSDM. The Media Center is equipped with T12, 2X4 recessed fluorescent type lighting in good condition, providing an average illumination of 50 to 60 FC, thus complying with the 50 FC recommended by the OSDM. The Kitchen spaces are equipped with 1X4 surface mounted, T12 fluorescent fixture type lighting with single level switching. Kitchen fixtures are in fair condition, providing an average illumination of 70 FC, which is less than the 75-80 FC recommended by the OSDM. The Service Areas in the overall facility are equipped with 1X4 surface mounted or industrial T12 fluorescent type lighting in fair to poor condition. There are some service corridors that have 1X1 recessed incandescent fixtures. The typical Administrative spaces in the overall facility are equipped with 1X4 surface mounted and 2X4 recessed T12, fluorescent type lighting in good condition, providing adequate illumination based on OSDM requirements. The overall lighting systems of the facility are not compliant with Ohio School Design Manual requirements due to age, condition and the utilization of T12 fluorescent (lamp and ballast) fixtures.

Rating: 3 Needs Replacement

Gymnasium Lighting

Interior Lighting

Recommendations: Provide complete replacement of lighting system due to condition, utilization of T12 fixtures and installation of fire protection system.

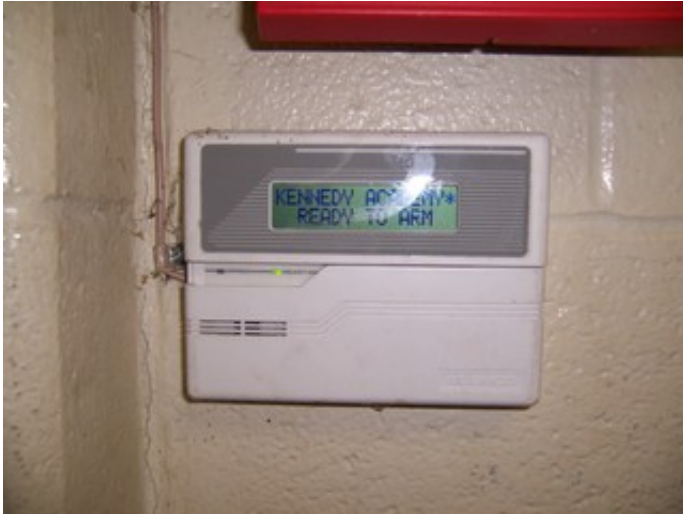
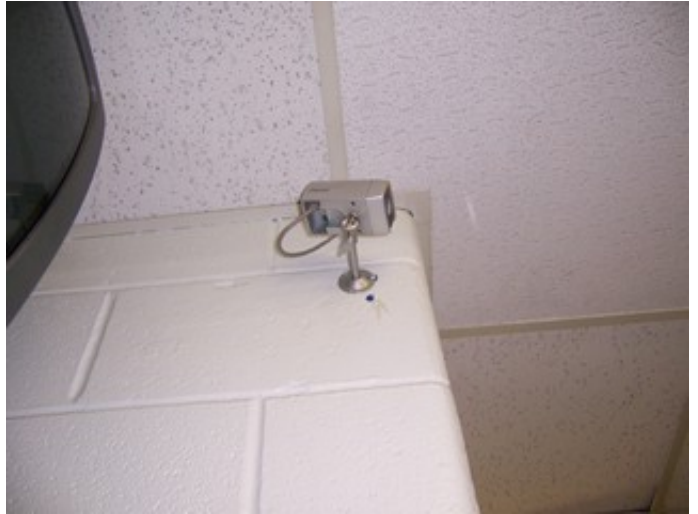
Description: The overall facility contains a multiple camera location type security system in fair condition. Motion detectors are not adequately provided in main entries, central gathering areas, offices, main Corridors, and spaces where 6 or more computers are located. All exterior doors are not equipped with door contacts. An automatic visitor control system is provided at main entrance. A compliant color CCTV camera is provided at main entry area only. Security cameras or controls are provided for parking lots, central gathering areas, and main Corridors. CCTV is monitored in Administrative Area with the use of TV, VCR, and multiplexer. A compliant computer controlled access control system integrating alarms and video signals, with appropriate UPS backup, is not provided. The system is not equipped with card / biometric readers. The security system is not adequately provided throughout, and the system is not fully compliant with Ohio School Design Manual guidelines. The playground fencing areas are not totally inclusive and therefore require attention. The exterior site lighting system is equipped with recessed incandescent entry lights in fair to poor condition. Pedestrian walkways are illuminated with street lighting in average condition. Parking and bus pick-up / drop off areas are illuminated pole mounted HID fixtures in fair condition. The exterior site lighting system provides inadequate coverage per the OSDM guidelines.

Rating: 3 Needs Replacement

Security Alarm Panel

Wall Mounted Security Camera

Recommendations: Provide complete replacement of security system to meet Ohio School Design Manual guidelines. Provide complete replacement of exterior site lighting system to meet Ohio School Design Manual guidelines.

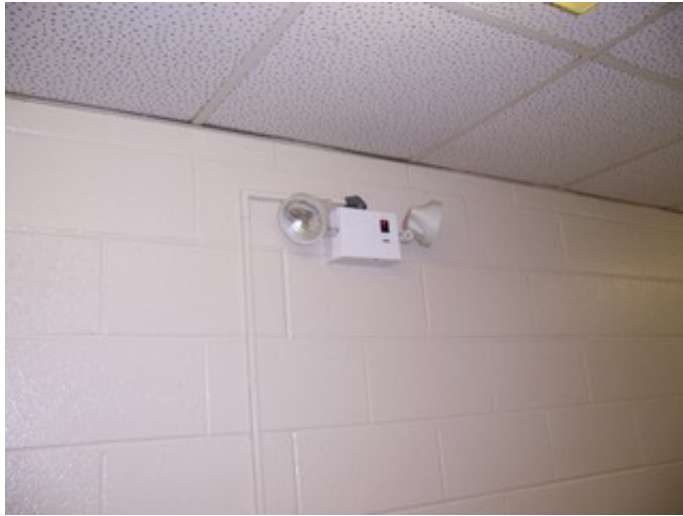
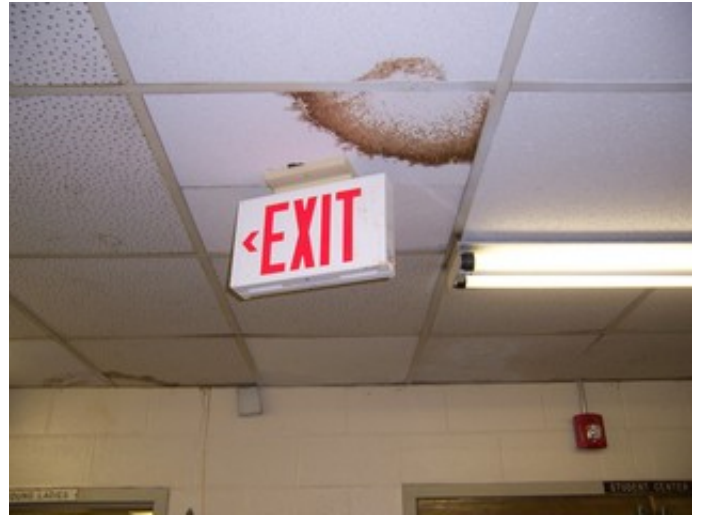
Rating: 3 Needs Replacement

Wall Mounted Emergency Lighting

Ceiling Mounted Exit Sign

Recommendations: Provide complete replacement of emergency / egress lighting system to meet Ohio School Design Manual guidelines.

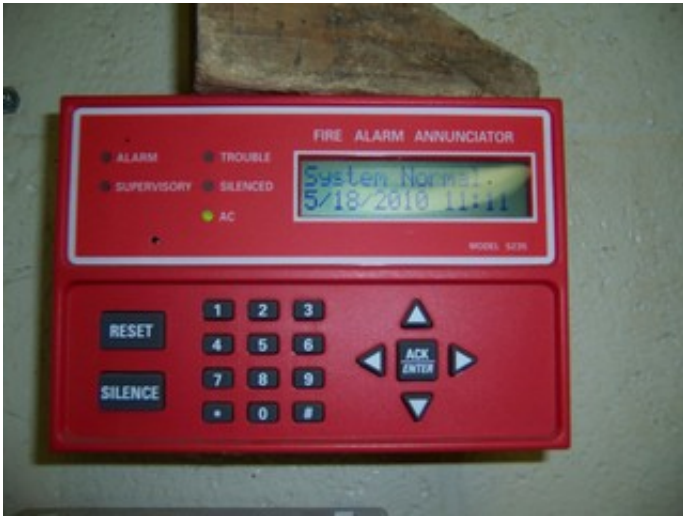
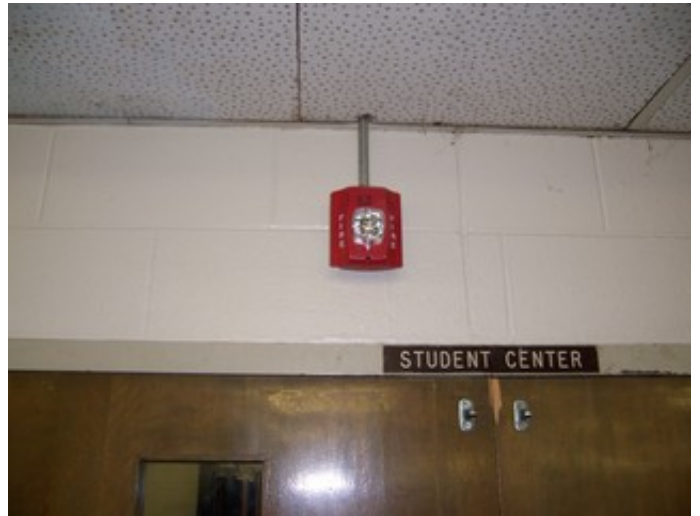
Rating: 3 Needs Replacement

Fire Alarm Control Device

Fire Alarm Strobe

Recommendations: Provide complete replacement of fire alarm system to meet OBC, NFPA, and Ohio School Design Manual guidelines.

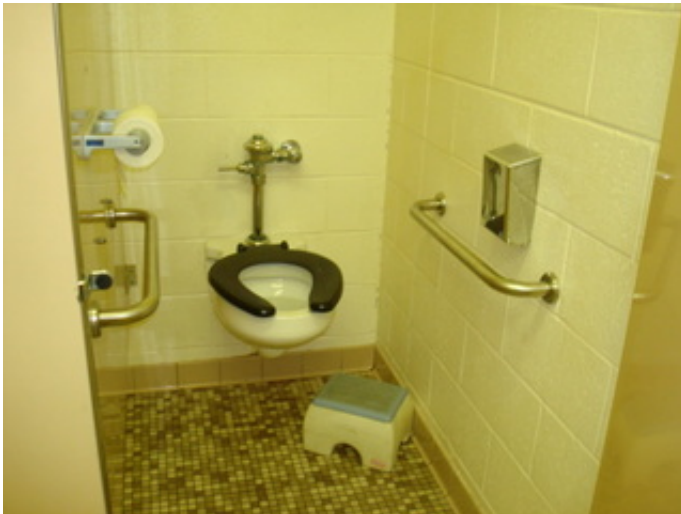
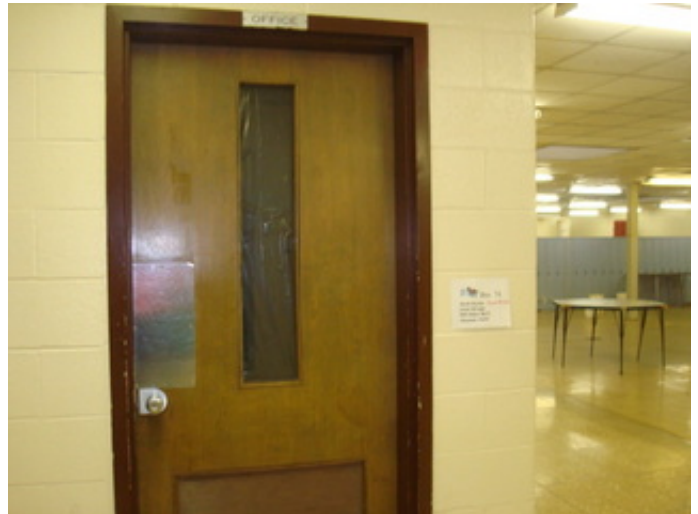
Toilet with grab bars

Door hardware

Recommendations: Provide ADA compliant signage, power assist door opener, toilet partitions and accessories, doors, frames and hardware in the overall facility. Parking issues are corrected in item P. Rework toilet rooms without proper clearance, provided in item J. Remount mirrors in toilet rooms.

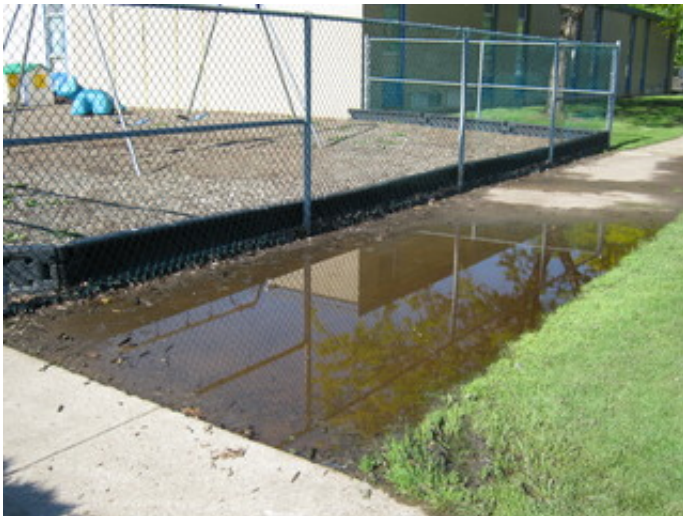
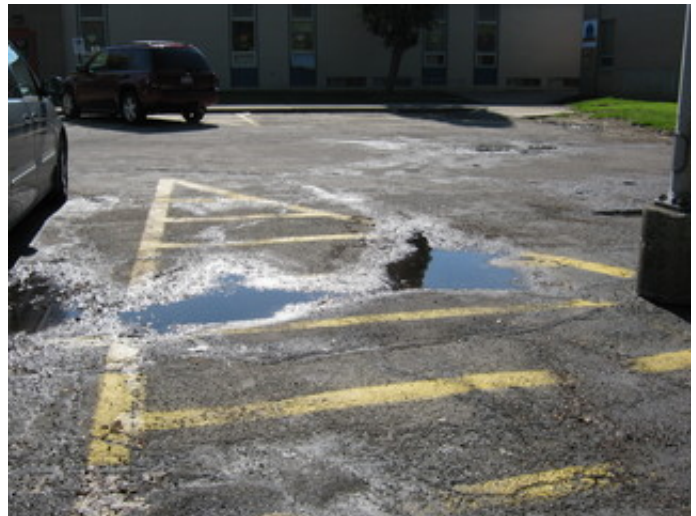
Sidewalk ponding

Parking lot ponding

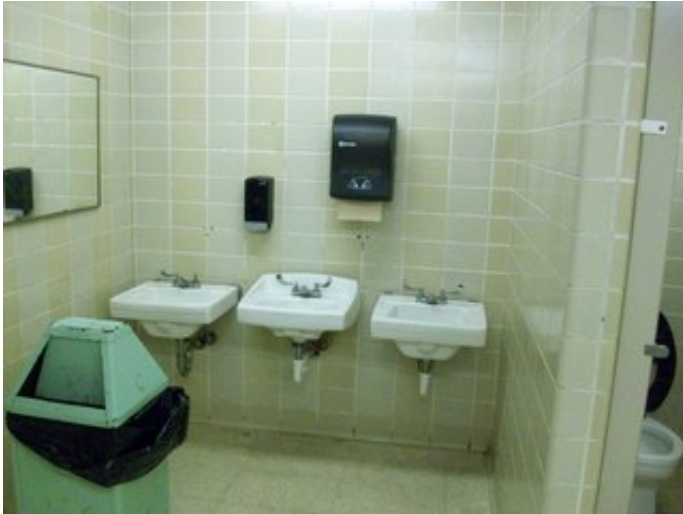
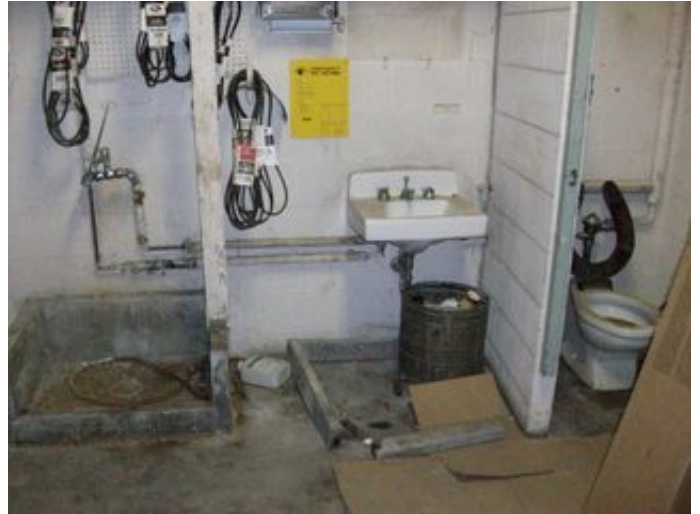
Sanitary drain below sink

Recommendations: Replace existing system due to age of pipe.

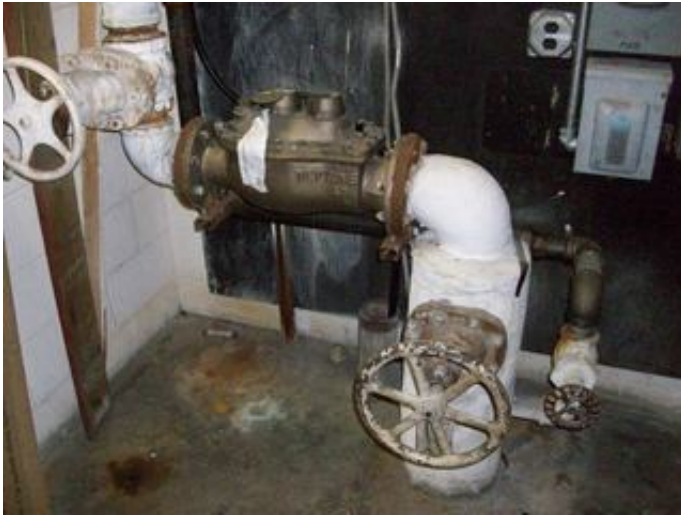
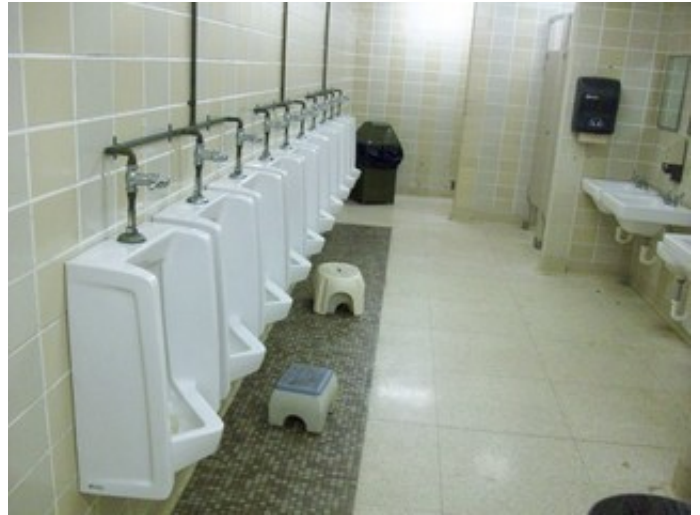
Domestic Water Piping

Domestic water piping at plumbing fixtures

Recommendations: The facility is not equipped with an automated fire suppression system, and the existing water supply will not provide adequate support for a future system.

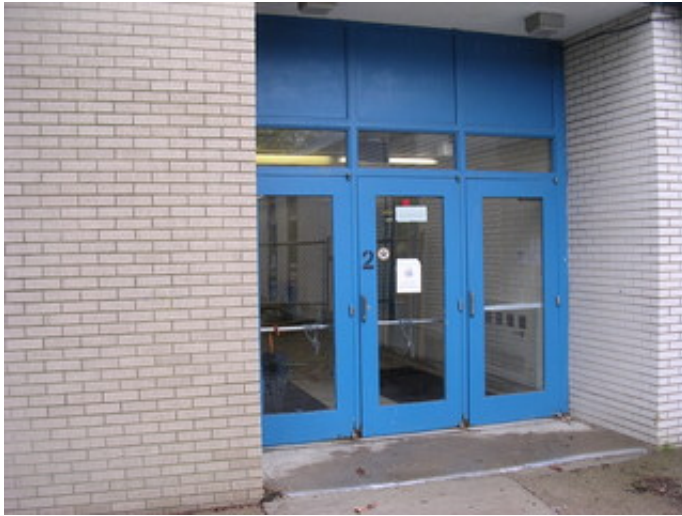
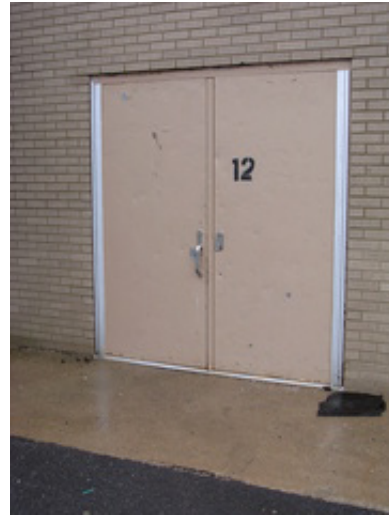
Typical hollow metal glazed doors.

Typical hollow metal doors.

Recommendations: Replace all exterior doors, due to poor condition and to comply with Ohio Building Code, ADA, and Ohio School Design Manual guidelines. Sidelite replacement included in item F.

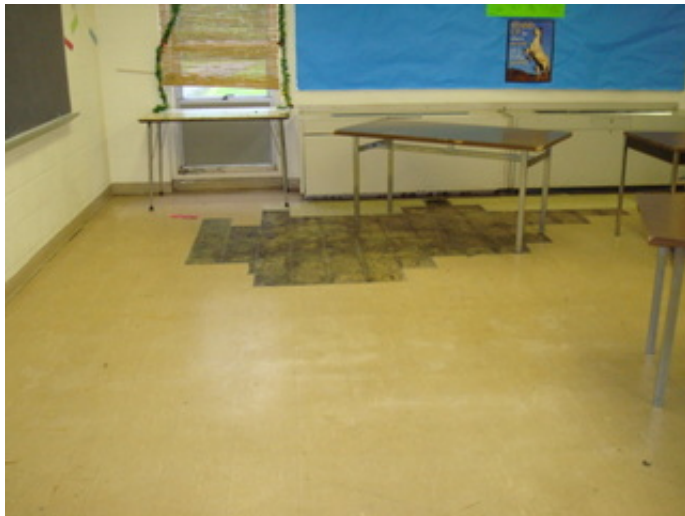
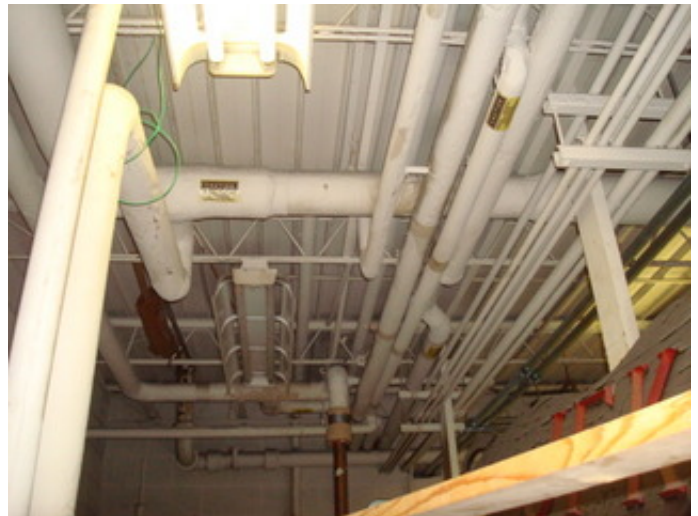
Vinyl tile

Pipe insulation

Recommendations: Remove all hazardous materials, inclusive of asbestos-containing materials in the overall facility, as noted in the attached Environmental Hazards Assessment.

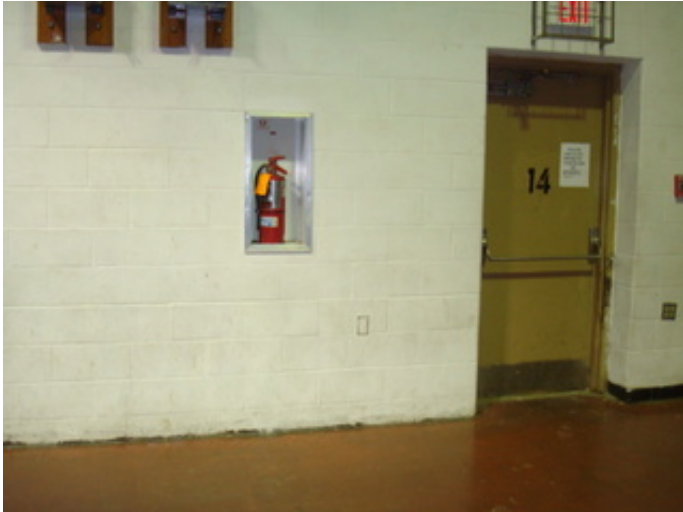
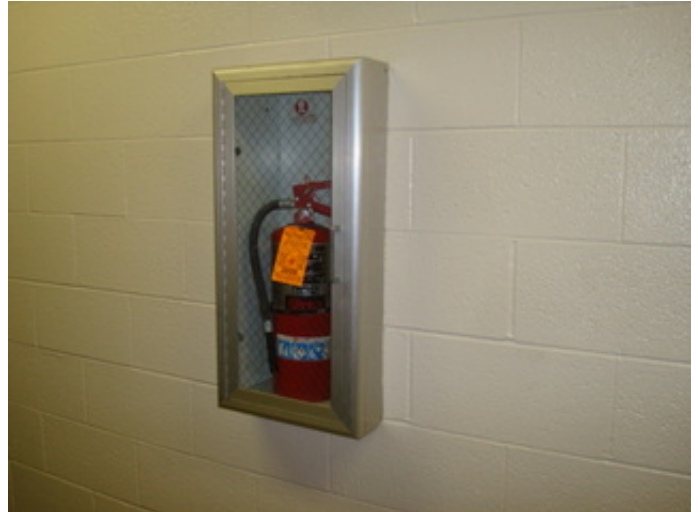
Fire extinguisher

Recommendations: Provide new automated fire suppression system to meet Ohio School Design Manual guidelines. Provide increased water service of a capacity sufficient to support the fire suppression system, funding included in fire suppression funding. Provide new emergency generator, with funding provided via complete replacement of electrical system in Item D. Provide second egress door for rooms with occupancy greater than 50.

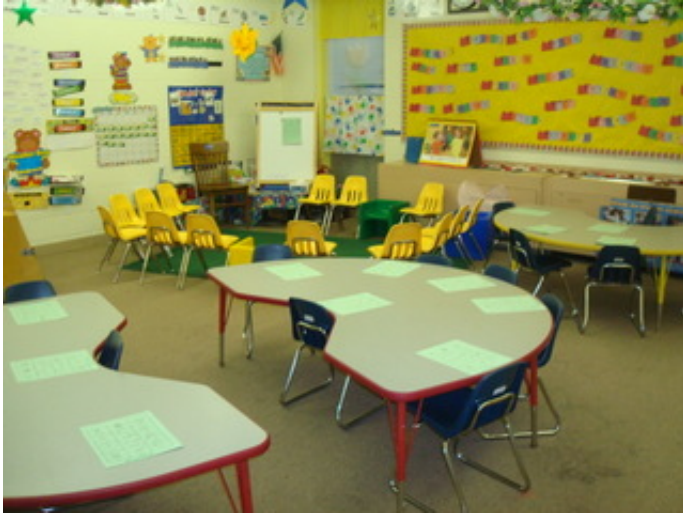
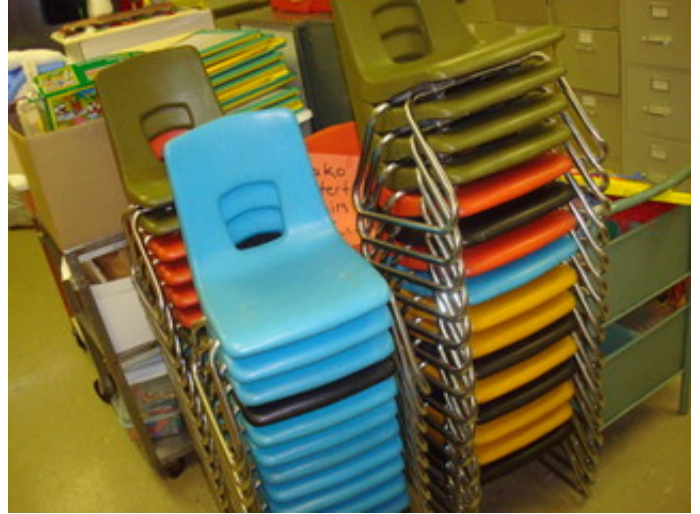
Pre-K room

Stored furniture

Recommendations: Provide for replacement of outdated or inadequate furniture.

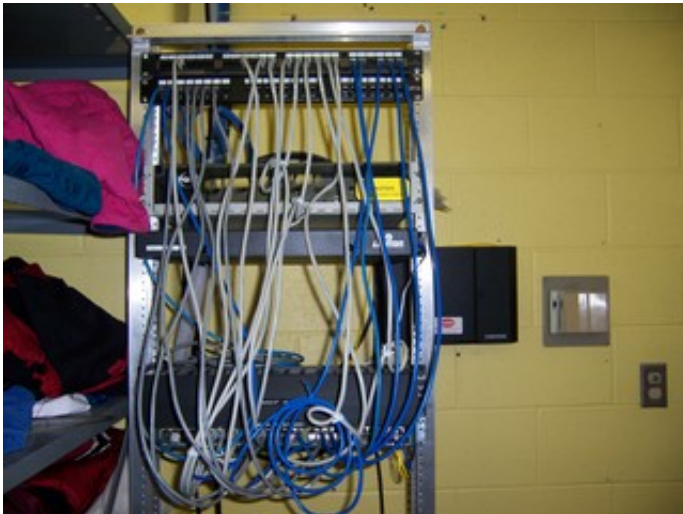
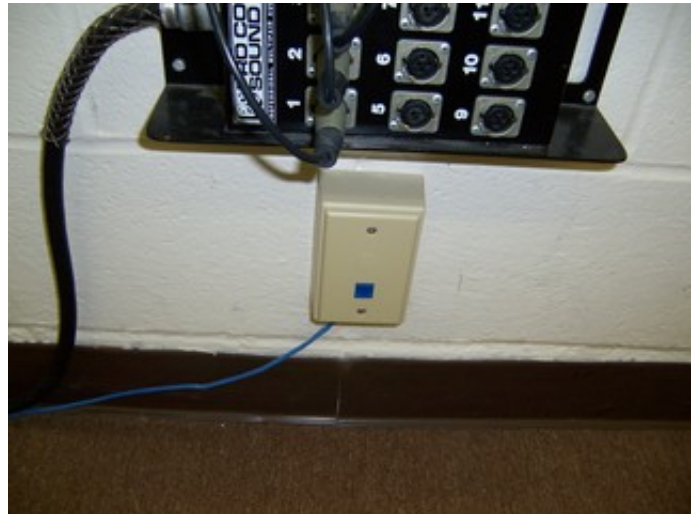
Main Data Frame

Technology Outlet
