**Building Information - Willoughby-Eastlake City SD (45104) - Eastlake Middle**

Program Type	Expedited Local Partnership Program (ELPP)
Setting	Suburban
Assessment Name	Eastlake Middle_2010_TCI
Assessment Date	2010-03-16
Cost Set:	2010
Building Name	Eastlake Middle
Building IRN	9621
Building Address	35972 Lake Shore Blvd.
Building City	Eastlake
Building Zipcode	44095
Building Phone	440/942-5696
Acreage	29.32
Current Grades	6-8
Teaching Stations	31
Number of Floors	2
Student Capacity	775
Current Enrollment	465
Enrollment Date	2010-04-01
Enrollment Date is the date in which the current enrollment was taken.	
Number of Classrooms	31
Historical Register	<b>NO</b>
Building's Principal	Mr. Mike Chokshi
Building Type	Middle

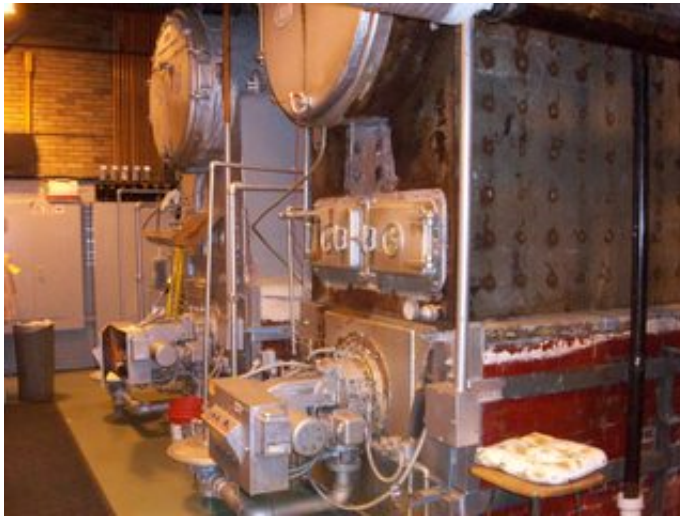
Original Gas Fired Hot Water Boilers

**Recommendations:** Provide new overall heating, ventilating, and air conditioning system to achieve compliance with Ohio Building Code and Ohio School Design Manual standards, including ventilation for unusable crawl spaces. Convert to ducted system to facilitate efficient exchange of conditioned air.

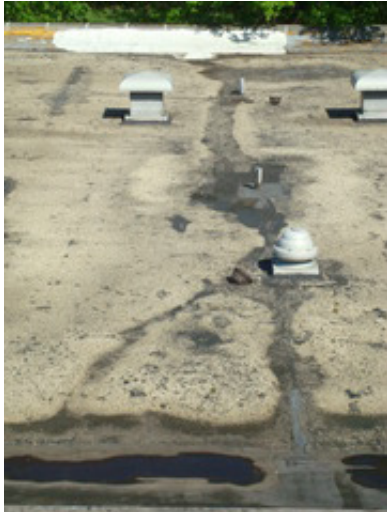
Ponding, patches and damaged roof drains on 1957 Addition

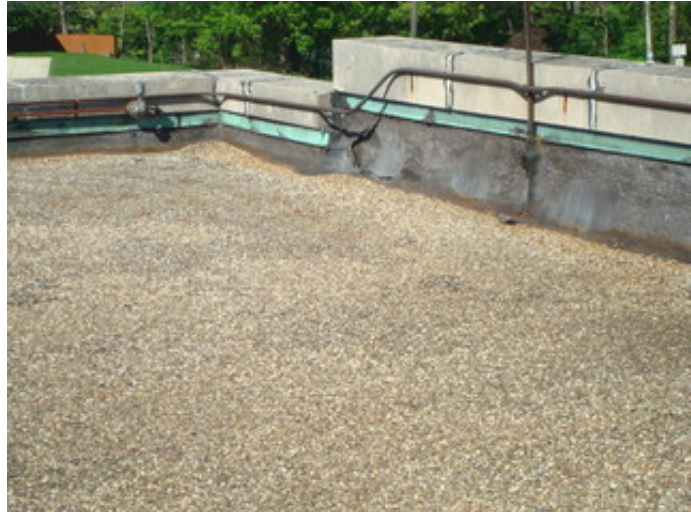
Damaged wall flashing on 1949 Original Construction

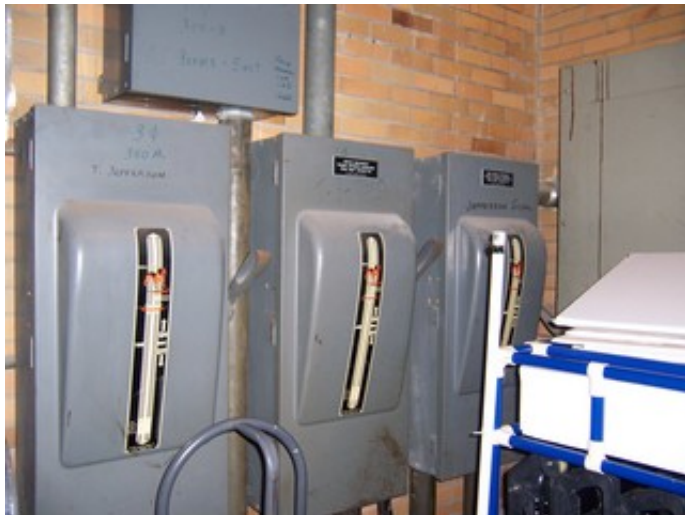
Campus Main Disc. Switches

**Recommendations:** The entire electrical systems requires replacement to meet Ohio School Design Manual guidelines and the Ohio Building Code for overall capacity due to lack of OSDM - required features and to accommodate the addition of an air conditioning system.

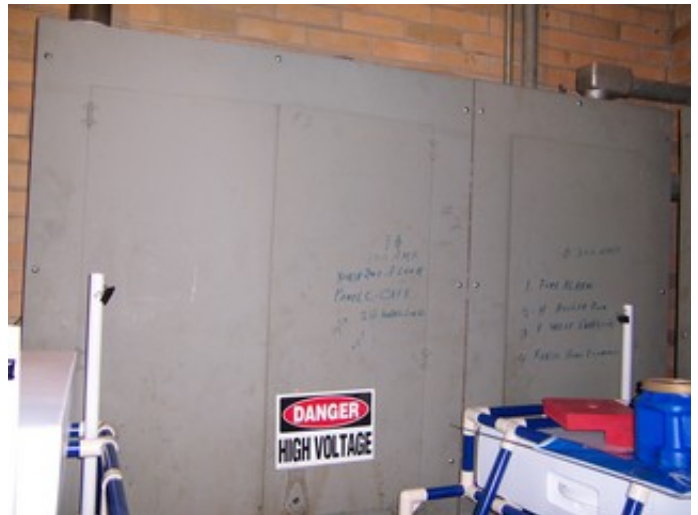
Main Distribution Switchboard

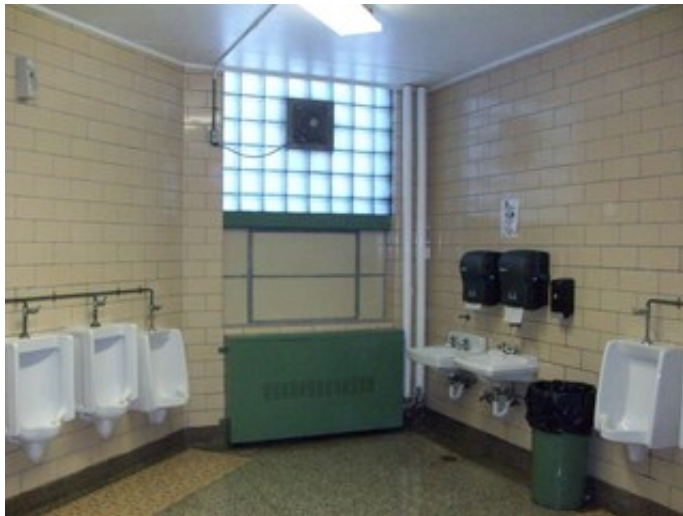
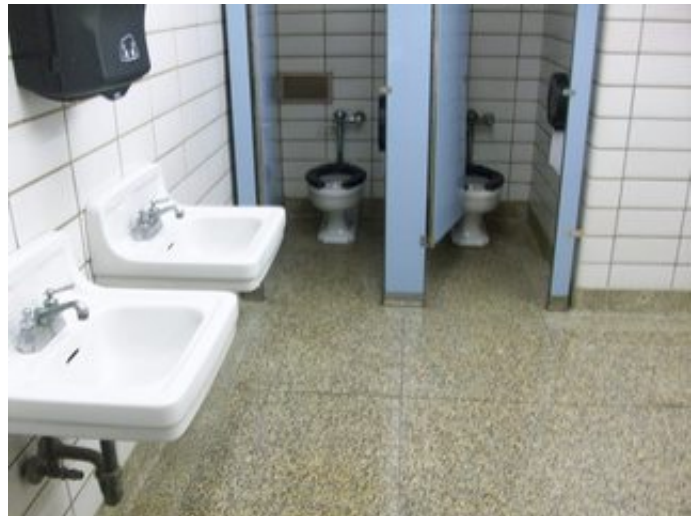
Toilet room fixtures

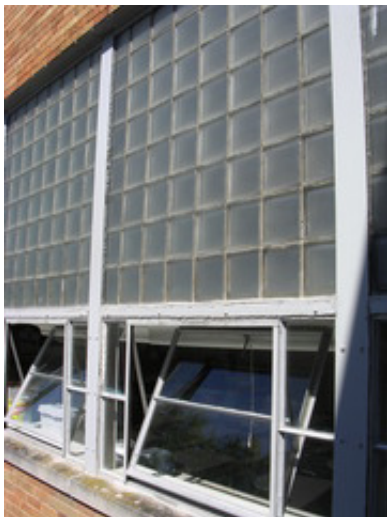
Typical window w/ glass block.

**Recommendations:** Replace the existing non-insulated window system and glass block in the Overall Facility with a new insulated window system to match existing insulated system and comply with Ohio School Design Manual requirements. Replace glass block windows in the gymnasium area of the 1949 Original Construction with translucent window panel system to comply with Ohio School Design Manual requirements. Replace the storefront wall system in the overall facility.

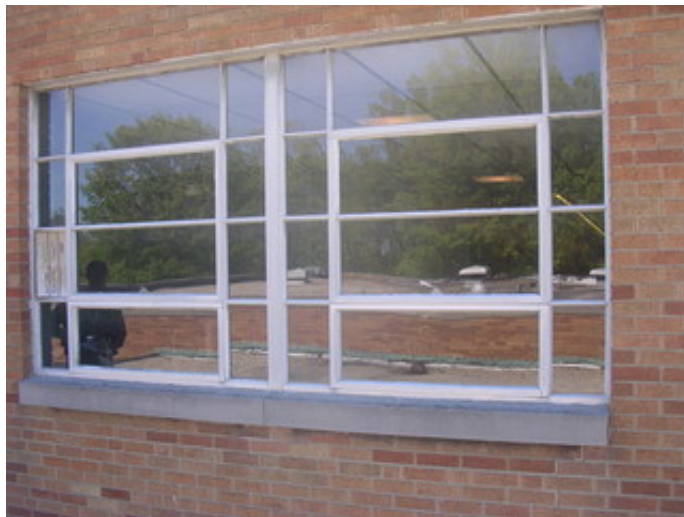
Typical aluminum window.

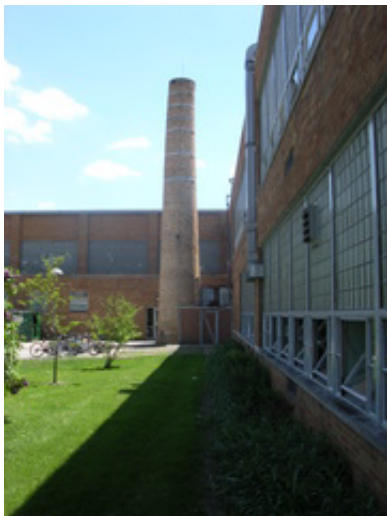
Group boys' toilets are not provided adequate privacy; fixtures are visible from the corridor due to missing doors. The masonry smokestack is in poor shape and visibly out of plumb. Site drainage is very inadequate. Substantial evidence of ponding was observed throughout the site, and erosion was observed along the north edge of the parking lot, where excess storm water drains onto the adjacent lawn.

Chimney is in poor condition.

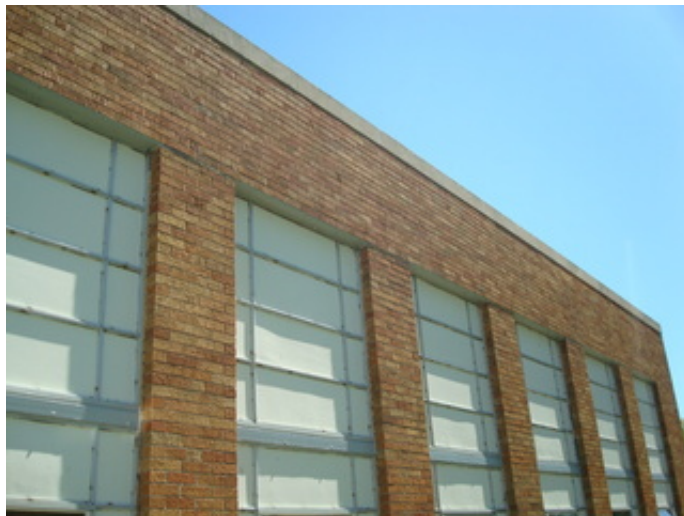
Rusted lintels and damaged brick in 1949 Original Construction

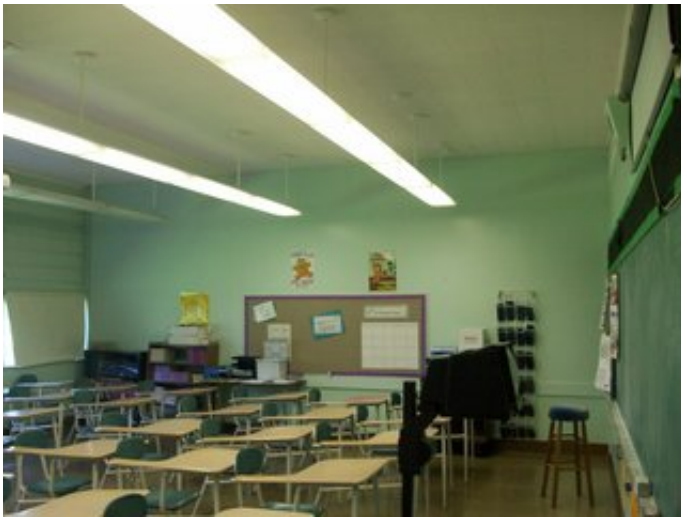
Typical Classroom Lighting

Provide complete replacement of lighting system due to age, of lighting fixtures and installation of a fire protection system.

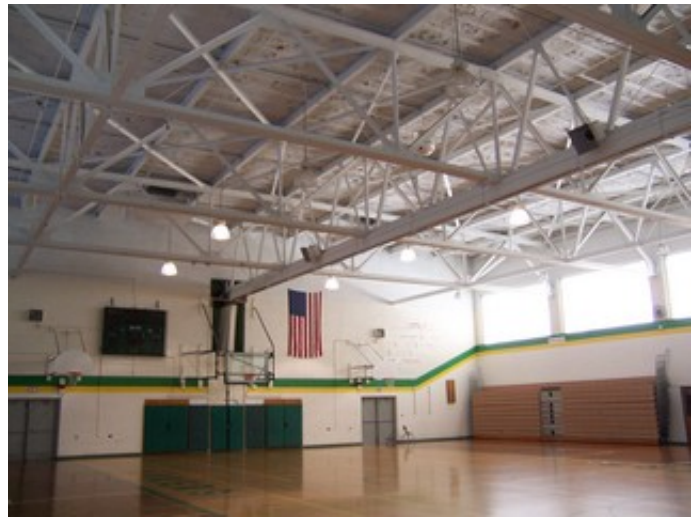
Gymnasium Lighting

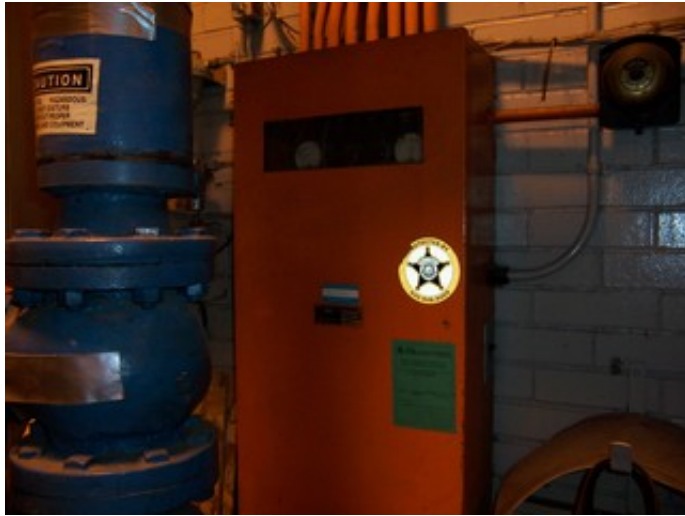
Fire Alarm Control Panel

**Recommendations:** Recommend providing a complete new Fire Alarm System to meet the Ohio School Design Manual and the Ohio Building Code.

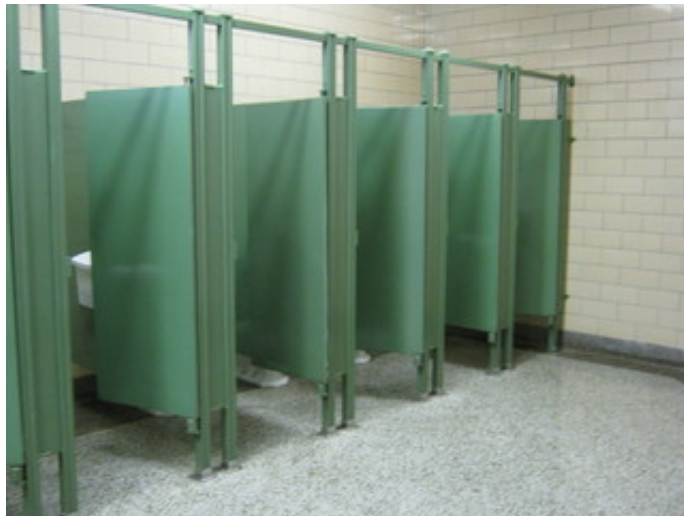
Non-compliant toilet partitions

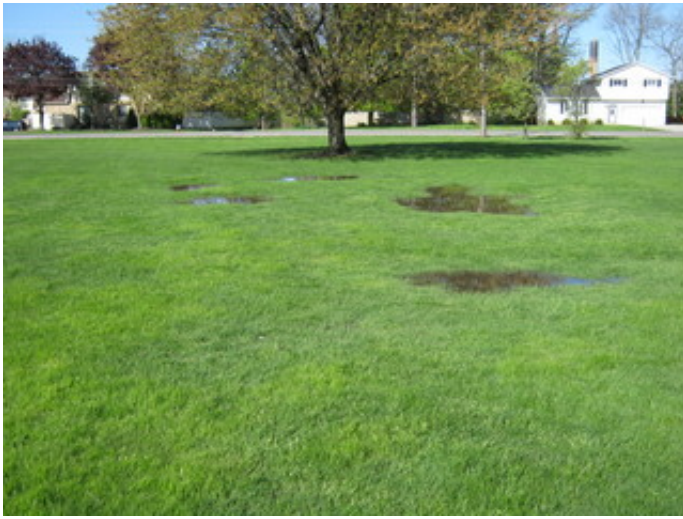
Ponding in front yard

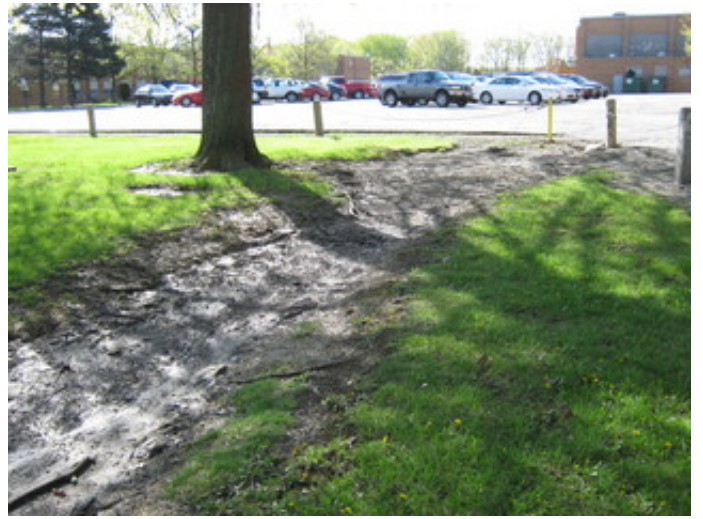
Evidence of erosion

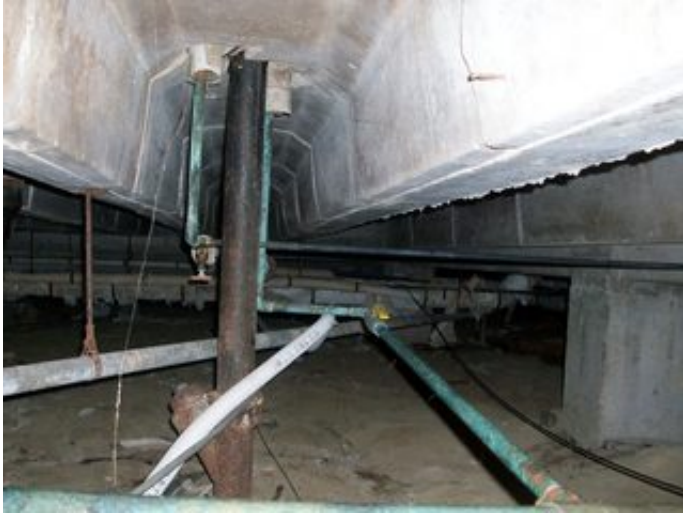
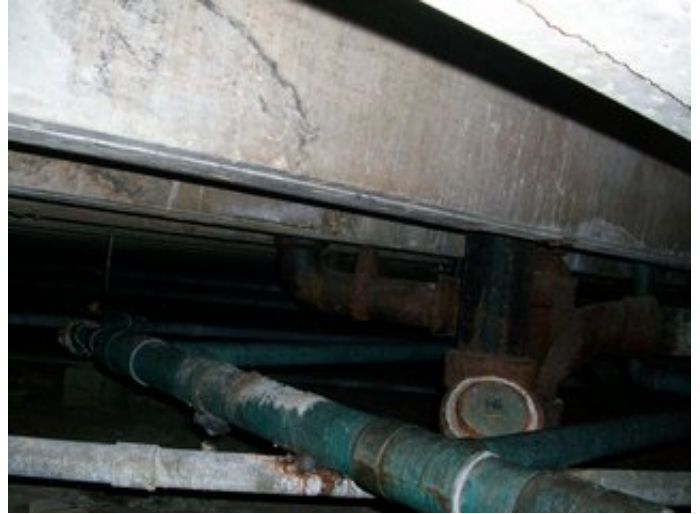
Sanitary drainage Piping

Recommendations: Replace existing system due to age of pipe.

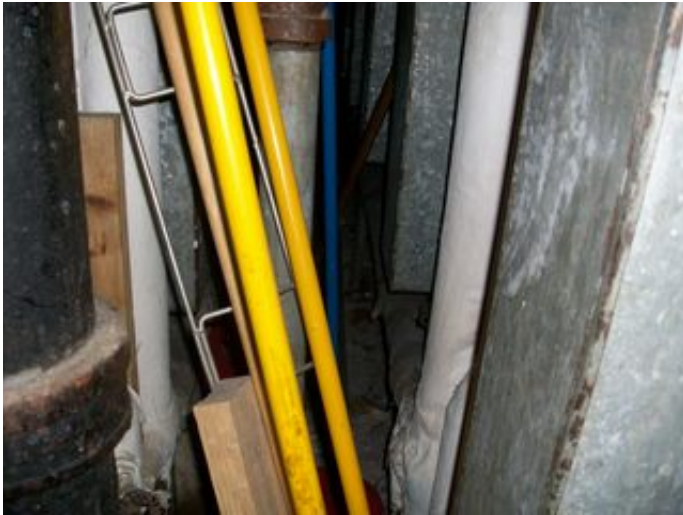
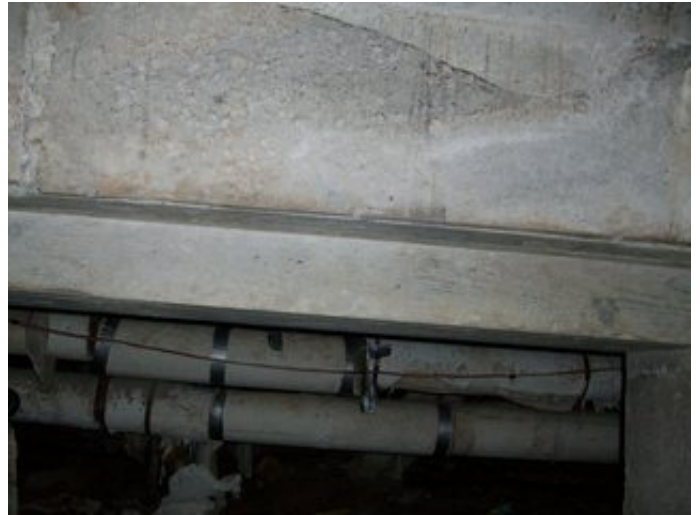
Domestic Water Piping

Domestic water piping

Recommendations: The facility is not equipped with an automated fire suppression system, and the existing water supply will not provide adequate support for a future system.

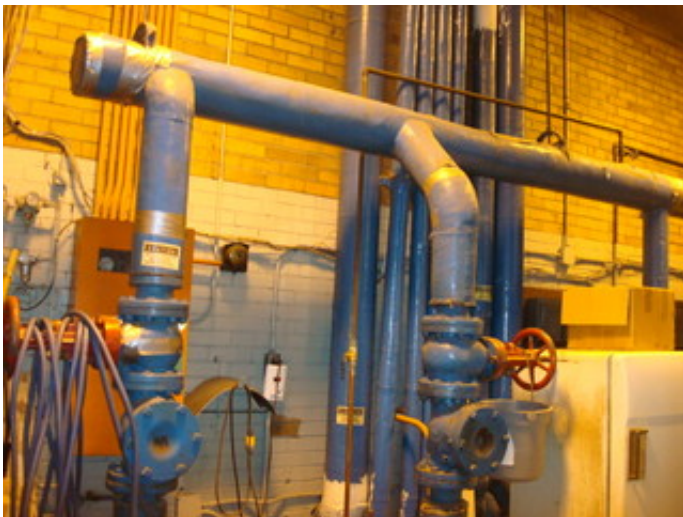
Pipe insulation and fittings

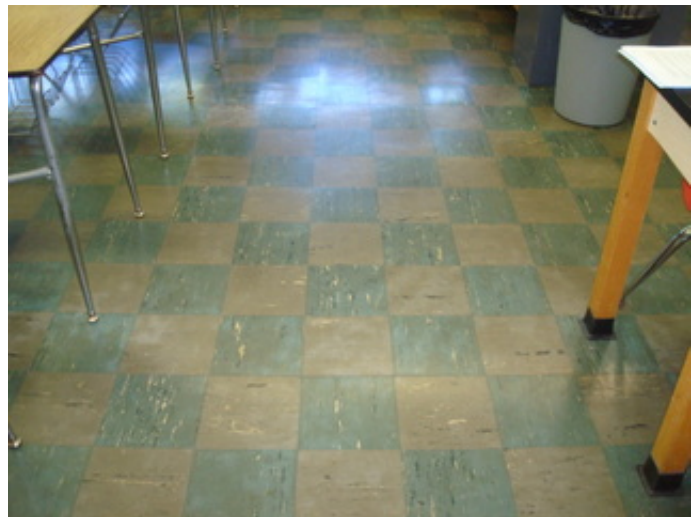
9x9 Floor tile
