Building Information - Willoughby-Eastlake City SD (45104) - Willowick Middle School

Program Type	Expedited Local Partnership Program (ELPP)
Setting	Suburban
Assessment Name	Willowick M_2010_TCI
Assessment Date	2010-03-16
Cost Set:	2010
Building Name	Willowick Middle School
Building IRN	41525
Building Address	31500 Royalview Dr
Building City	Willowick
Building Zipcode	44095
Building Phone	440/943-2950
Acreage	17.70
Current Grades	6-8
Teaching Stations	41
Number of Floors	1
Student Capacity	975
Current Enrollment	637
Enrollment Date	2010-04-01
Enrollment Date is the date in which the current enrollment was taken.	
Number of Classrooms	39
Historical Register	NO
Building's Principal	Ms. Lori Rodman
Building Type	Middle

Building Construction Information - Willoughby-Eastlake City SD (45104) - Willowick Middle School (41525)

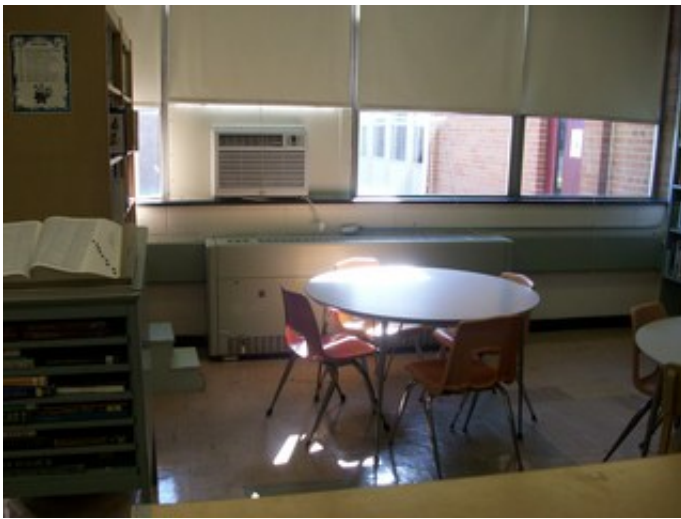
Description: The existing heating system for the overall facility is composed of three major hot water boilers centrally located in the main mechanical room which were installed in 1958. The units are in good condition. The heating system in the overall facility is part of the Original Construction and is a 2-pipe system supplying hot water heating. With very limited capacity for simultaneous heating and cooling operation, this system is not compliant with the OSDM requirements for basic system type. The forced draft hot water boilers, manufactured by York-Shifley were installed in 1958 and are in decent condition. Heating hot water is distributed to terminal units consisting of unit ventilators, cabinet heaters, unit heaters, and fin tubes. The terminal equipment was installed in 1958 and new with each addition and is in fair condition. The system does not comply with the 15 CFM per person fresh air requirements of the Ohio Building Code mechanical code and Ohio School Design Manual. The non DDC type system temperature controls were installed in 1958 and are in working condition. The system does feature individual heating temperature controls in all spaces required by the OSDM. The overall system does not feature any central energy recovery systems. The facility is equipped with louvered interior doors in classrooms, storage and utility rooms to facilitate Corridor utilization as return air plenums while the classrooms have a return air systems. The existing system is not ducted, and floor to structural deck heights will not accommodate the installation of properly sized ductwork for a future Ohio School Design Manual approved system. The overall heating system is evaluated as being not in safe and efficient working order, though long term life expectancy of the existing system is anticipated. The structure is not equipped with central air conditioning. The site does not contain underground fuel tanks that are currently in use.

Rating: 3 Needs Replacement

Typical Unit Ventilator

Recommendations: Provide new overall heating, ventilating, and air conditioning system to achieve compliance with Ohio Building Code and Ohio School Design Manual standards. Convert to ducted system to facilitate efficient exchange of conditioned air.

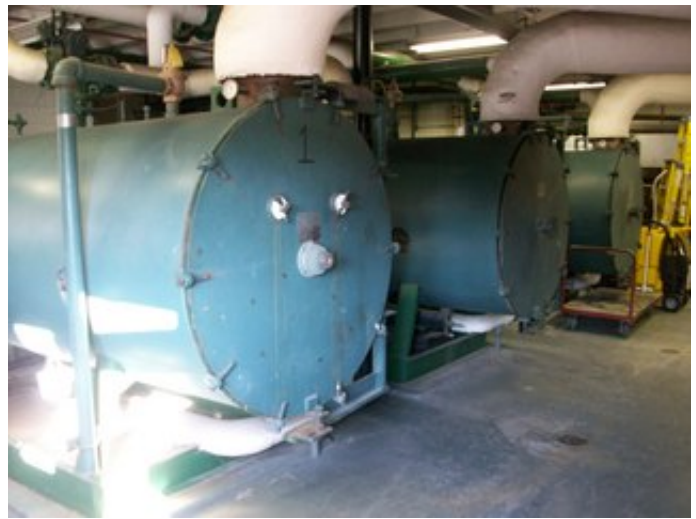
Gas Fired Hot Water Boilers

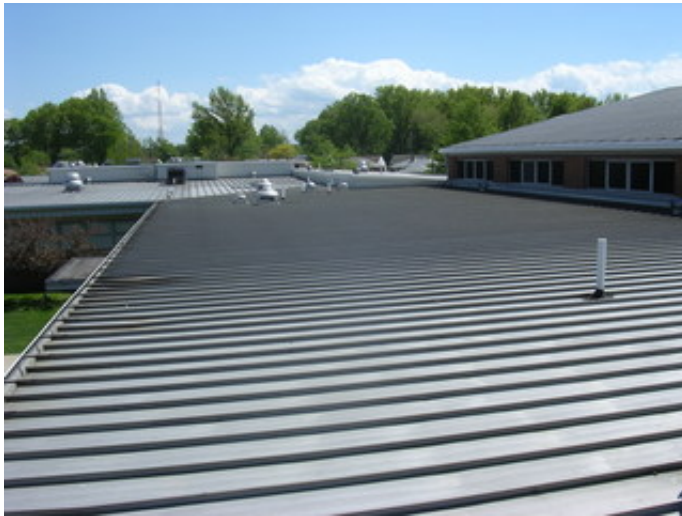
Description: The roof over the overall facility is a standing seam metal retrofit system that was assumed to be installed in 1987, and is in poor condition. Canopies in the overall facility are covered with a built-up roofing system that is in poor condition. There are District reports of current leaking throughout the 1958 Original Construction, in the corridor at the northern part of the 1962 Addition (where it connects to the 1958 Original Construction), and near the west door to the 1960 Addition. No signs of past leaking were observed during the physical assessment. Access to the roof was gained by access hatch that is in poor condition. Fall safety protection cages are not required. Standing water was not observed on the roof, but the leaks reported by the district suggest that the old roof under the standing seam metal retrofit system may have areas of standing water hidden from view. Metal cap flashings are in fair condition. Roof storm drainage is addressed through a system of gutters and downspouts which are properly located, and in poor condition. The roof is not equipped with overflow roof drains and they are not required. Roof penetrations were of similar condition to the roof surfaces. There are not any covered walkways attached to this structure.

Rating: 3 Needs Replacement

Typical standing seam roofing.

Recommendations: Replace metal roof and membrane to meet Ohio School Design Manual guidelines and due to condition. The flashing and coping on the overall facility require replacement with the roofing system. Replace gutters and downspouts due to condition. Replace roof drains with the roofing system. Replace roof hatch due to condition.

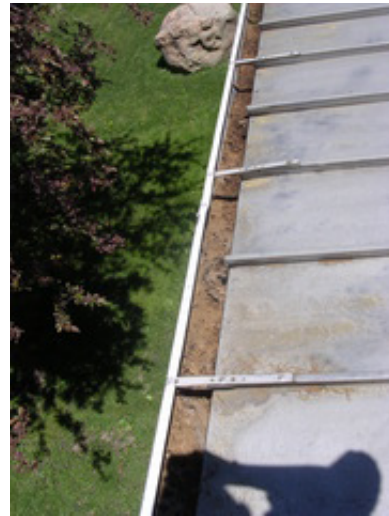
Gutter condition.

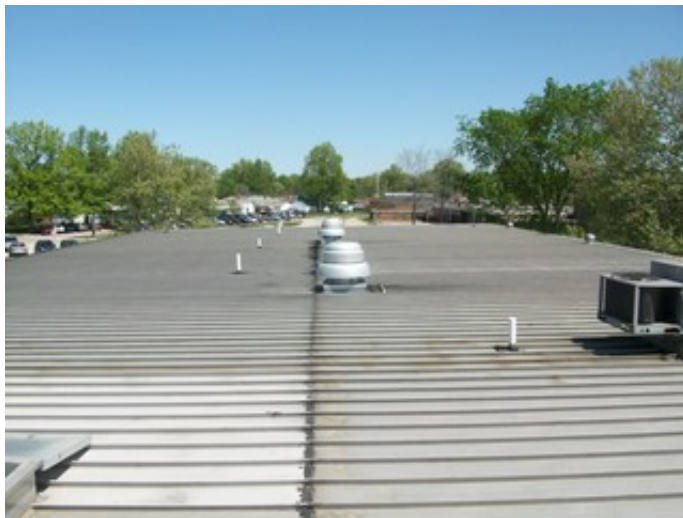
Description: The overall facility is not equipped with a central air conditioning system. Window units, split systems and roof top units are provided in miscellaneous locations such as offices, library, music, and media center. The ventilation system in the overall facility consists of unit ventilators and ducted air handlers installed initially in 1958 and are in fair condition, providing fresh air to classrooms and other miscellaneous spaces such as Gymnasiums, Student Dining, Media Center etc. Relief air venting is provided by relief fans and roof vents. The ventilation system does not meet the Ohio Building Code 15 CFM per occupant fresh air requirement. The overall system is not compliant with Ohio Building Code and Ohio School Design Manual requirements. Dust collection systems are not required in this facility and no system is provided. The Art program is not equipped with a kiln. Exhaust systems for Restrooms, Locker Rooms, Kitchen, Gymnasiums, Storage Rooms, Custodial Closets and specialized areas are adequately placed, and in working condition.

Rooftop Exhaust Fans

Recommendations: Provide an air conditioning system to meet with Ohio Building Code and Ohio School Design Manual requirements. Pricing included in Item A. Provide kiln exhaust system for kiln listed in item J.

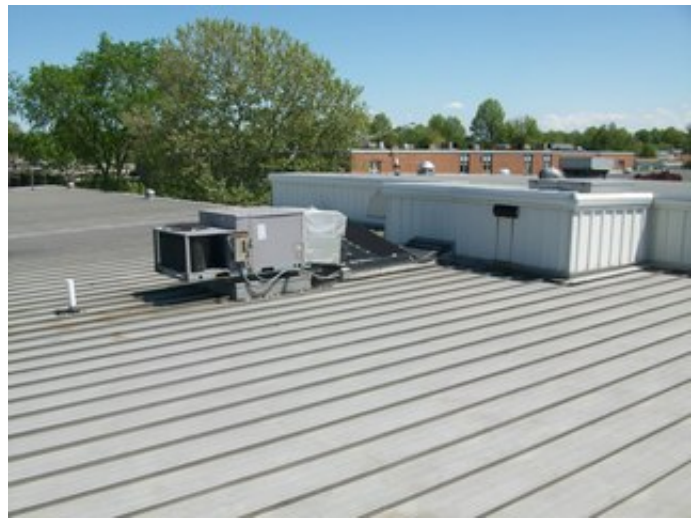
Rooftop Air Conditioning Unit

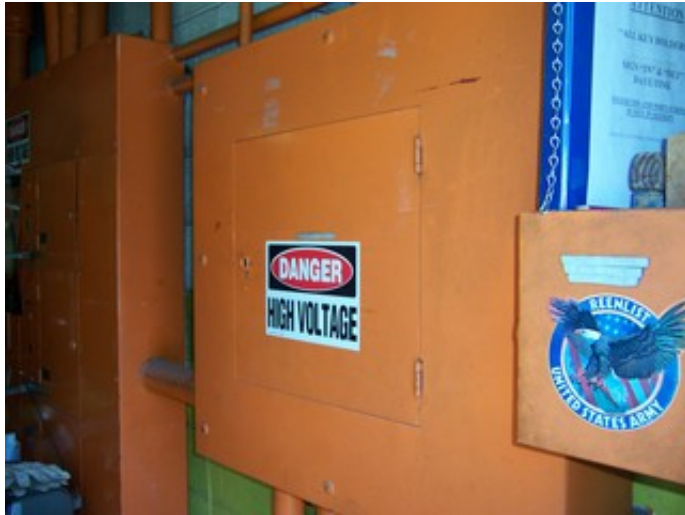
Description: There are two electrical systems provided to the overall facility; one is a 600 amp 120/240 volt, 1 phase, 3 wire original system from the year 1958, and is in fair condition. The second electrical system added under a later building addition is a 800 amp 120/240 volt, 3 phase, 3 wire system. Power is provided to the school by transformers within a vault room located near the rear of the school. The main distribution panels cannot be expanded to add additional capacity that would be required by the OSDM air conditioning requirements. The Classrooms are not equipped with adequate electrical outlets in some of the original areas per OSFC recommendations. The typical Classroom contains usually 2 to 3 general purpose outlets with certain classrooms having added outlets used for Classroom computers, and television. There are some spaces that have no electrical outlets such as storage areas and Janitor Closets. Some Corridors are not equipped with adequate electrical outlets for electrical servicing. Adequate GFI protected exterior outlets are not provided around the perimeter of the building. The facility is not equipped with an emergency generator. There is a 30 amp disconnect switch which feeds the Fire Alarm panel. Adequate building lightning protection safeguards are not provided. The original overall electrical system does not meet Ohio School Design Manual requirements, and both will be inadequate to meet the facility's future needs.

Rating: 3 Needs Replacement

Main Disconnect Switch

Recommendations: The entire electrical systems requires replacement to meet Ohio School Design Manual guidelines and the Ohio Building Code for overall capacity due to lack of OSDM - required features and to accommodate the addition of an air conditioning system.

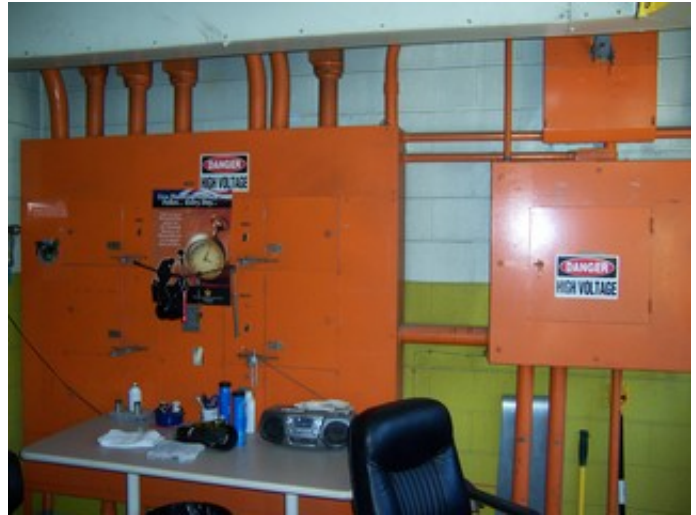
Main Distribution Switchboard

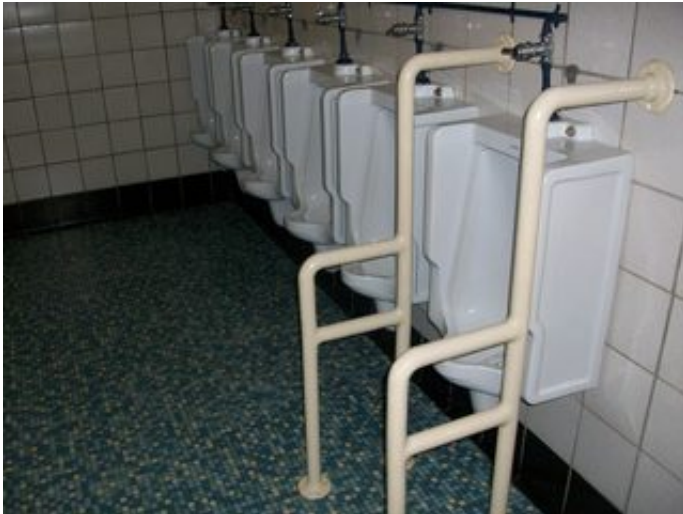
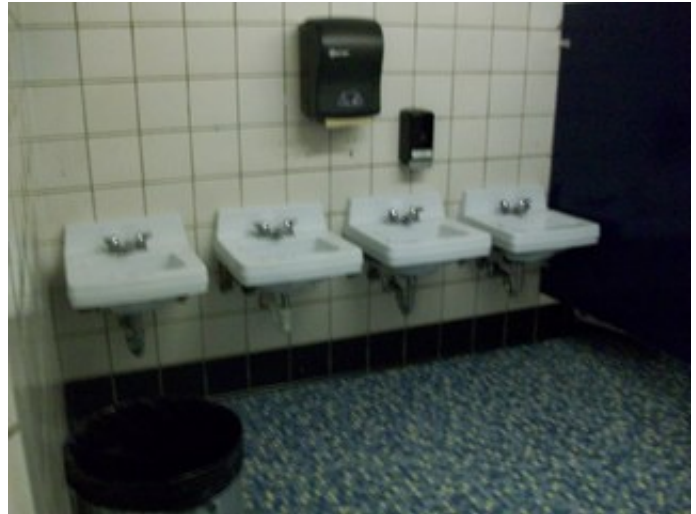
Rating: 3 Needs Replacement

Toilet room fixtures

Recommendations: Provide additional new fixtures to replace existing fixtures because they are not the new low flow type and do not meet ADA requirements. Replace grease interceptor as part of plumbing replacement.

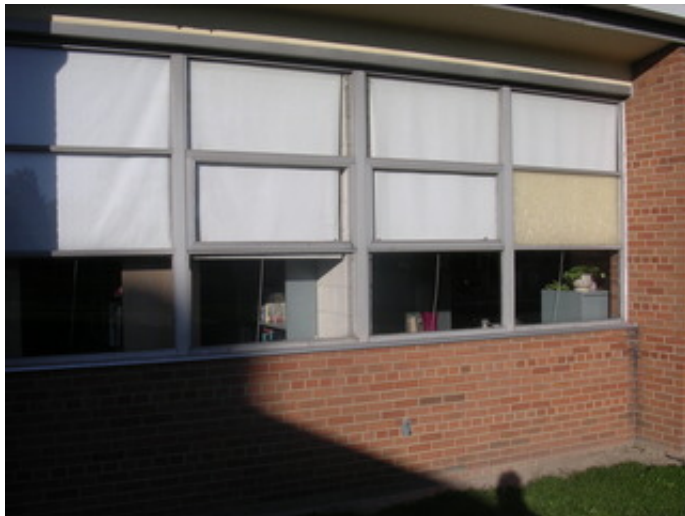
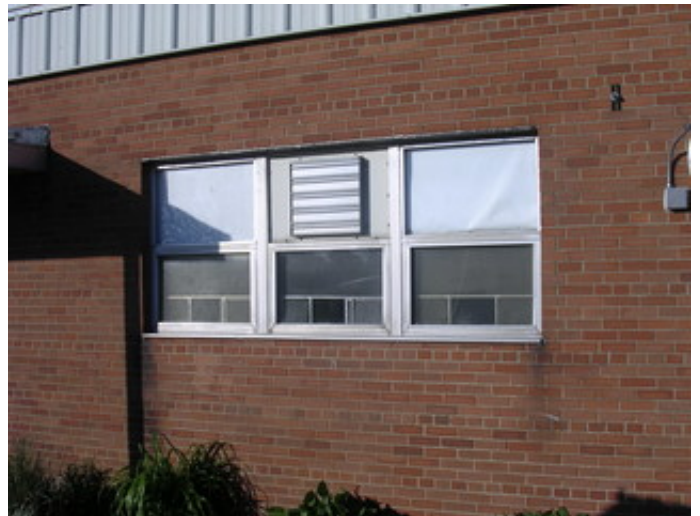
Description: The overall facility is equipped with non-thermally broken aluminum frame windows with single glazed non-insulated glazing type window system, which were installed at the dates of construction, and are in poor condition. Window system seals are in poor condition, with frequent air and water infiltration being experienced. Window system hardware is in poor condition. The window system features surface mounted blinds, which are in moderate condition. The window system is not equipped with insect screens on operable windows. Aluminum and hollow metal frame storefront window systems, with single tempered and non-tempered glazing are found in the overall facility and are in fair to poor condition. This facility does not feature any glass block windows. The 1958 and 1962 additions also contain aluminum frame window systems with cement board panels in poor condition. The school does not contain skylights. Window security grilles are not provided for ground floor windows. There is not a Greenhouse associated with this school.

Rating: 3 Needs Replacement

Typical aluminum window system.

Typical aluminum windows.

Recommendations: Provide a new insulated window system with integral blinds to meet with Ohio School Design Manual requirements. Replace storefront/curtainwall system due to condition.

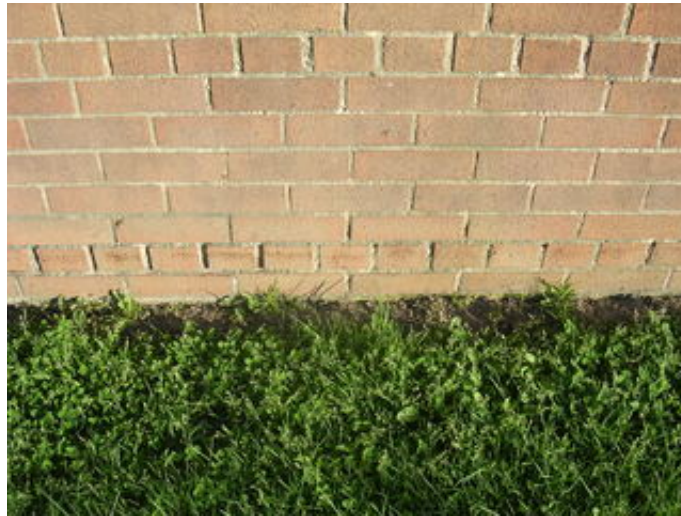
The exterior wall system of the 1960 Addition has evidence of detaching from the perpendicular masonry walls. From reviewing district provided construction documents, it is presumed that the 8" block masonry was not toothed in with the 4" block masonry, resulting in a separation due to settling of the structure.

Description: The overall facility foundations are masonry with trench concrete footings. Perimeter insulation is minimal and dampproofing is not noted. Foundations displayed locations of significant differential settlement, cracking, at the 1960 Addition and are in moderate condition. The District reports that there has been no past leaking. Minor grading / site drainage deficiencies were noted around the perimeter of the structure that could contribute to foundation / wall structural deterioration.

Rating: 2 Needs Repair

Typical foundation condition.

Recommendations: Provide foundation reinforcement at the west face of the 1960 addition.

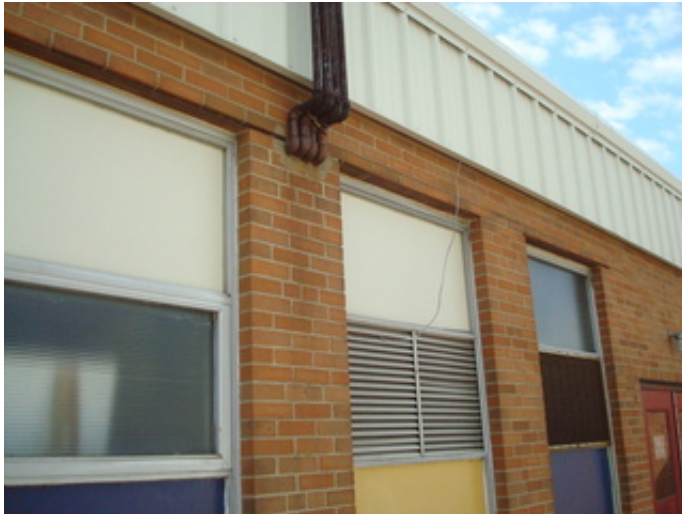
Description: The overall facility has a brick veneer on a masonry bearing wall system, which displayed locations of deterioration, and is in fair condition. The exterior masonry appears to have inappropriately spaced and adequately caulked control joints in fair condition. Control joints are not provided at lintel locations at doors and windows. The school has sufficient expansion joints between additions only, and they are in fair condition although caulk is in poor condition. The exterior masonry has not been cleaned and sealed in recent years, and shows evidence of mortar deterioration on all walls of the 1960 Addition, on the North wall of the 1958 Addition, and mild deterioration on the student dining part of the 1962 Addition, as well as at piers on all additions. Interior walls are concrete masonry units and are in fair condition. Interior masonry appears to have inadequately spaced and caulked control joints in fair condition. Soffits are in poor condition. The window sills are an element of the aluminum window system, and are in poor condition. The exterior lintels are steel, and are rusting above doors and in other locations where they are exposed. Chimneys are in fair condition although mortar has deteriorated and the precast coping is in poor condition.

Rating: 2 Needs Repair

Deteriorating lintels and brick

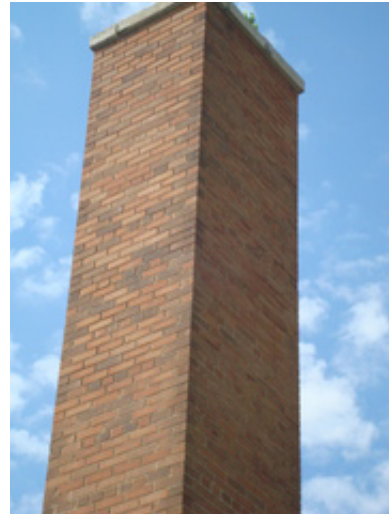
Chimney on 1962 Addition

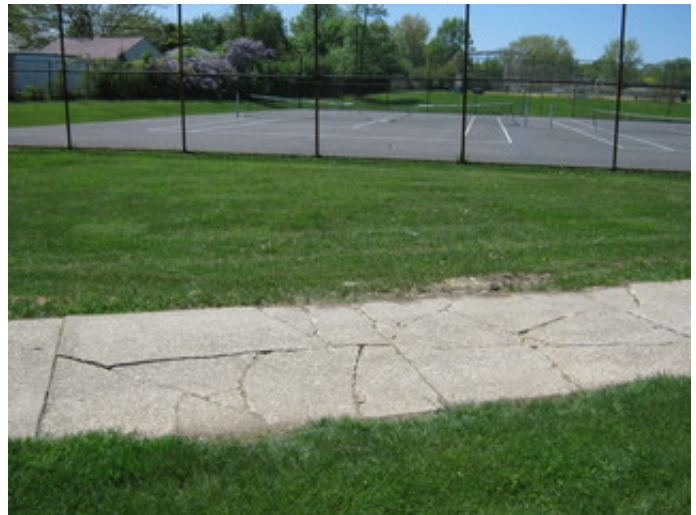
Rating: 2 Needs Repair

Sidewalk in poor condition

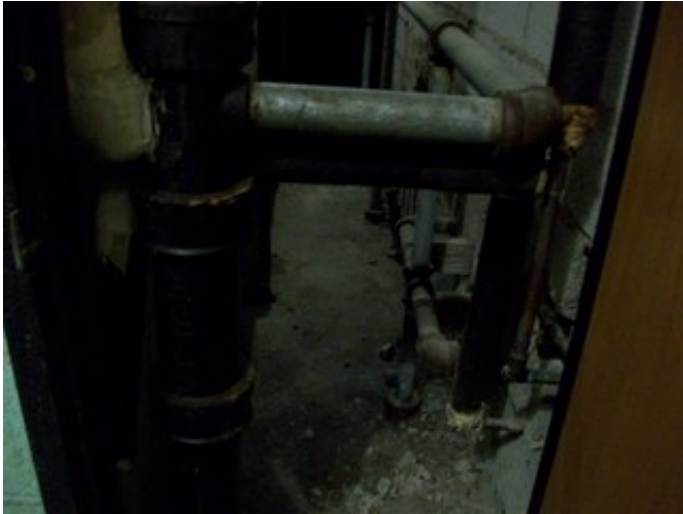
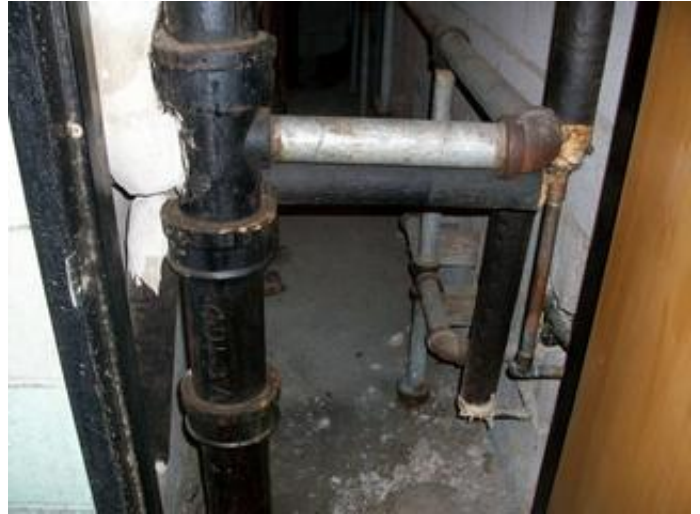
Sanitary drainage Piping

Recommendations: Replace existing system due to age of pipe.

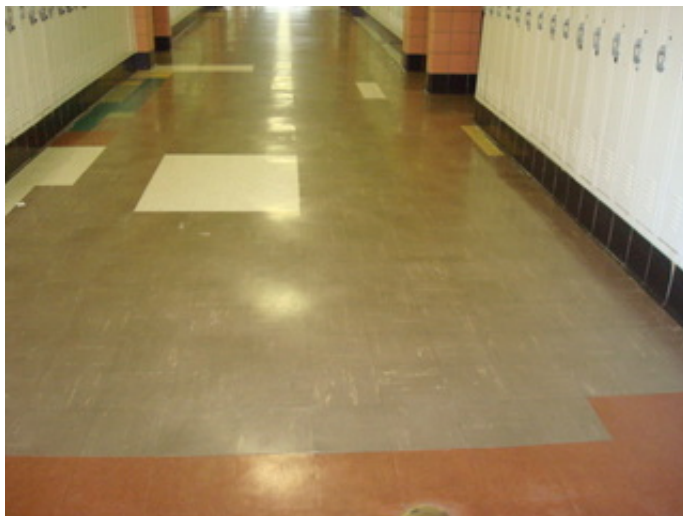
9x9 tile

Recommendations: Remove all hazardous materials, inclusive of asbestos-containing materials in the overall facility.

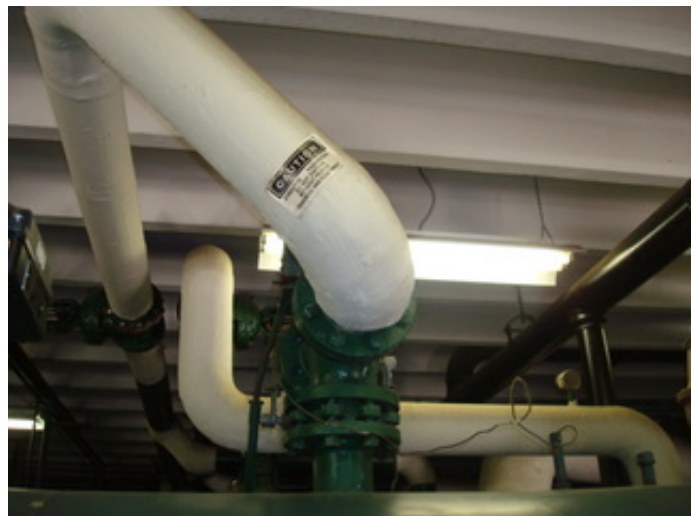
Pipe insulation
