**Building Information - Willoughby-Eastlake City SD (45104) - Longfellow Elementary School**

**Building Construction Information - Willoughby-Eastlake City SD (45104) - Longfellow Elementary School (21378)**

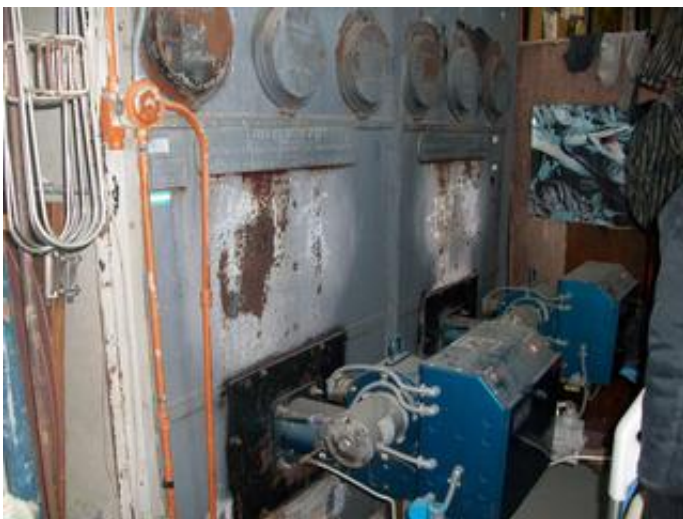
Gas Fired Hot Water Boiler

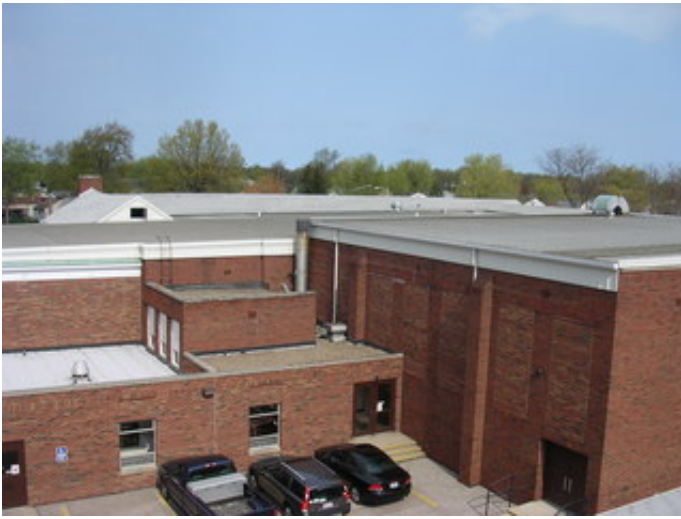
Typical roofing conditions.

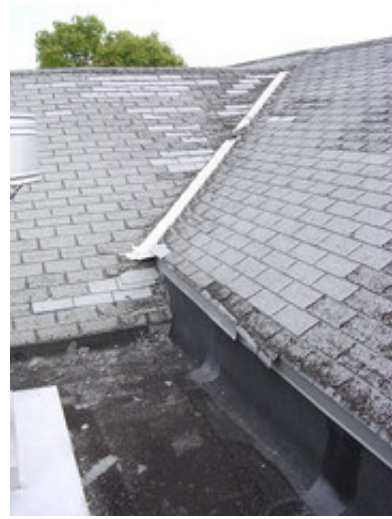
Asphalt shingles are in poor condition.

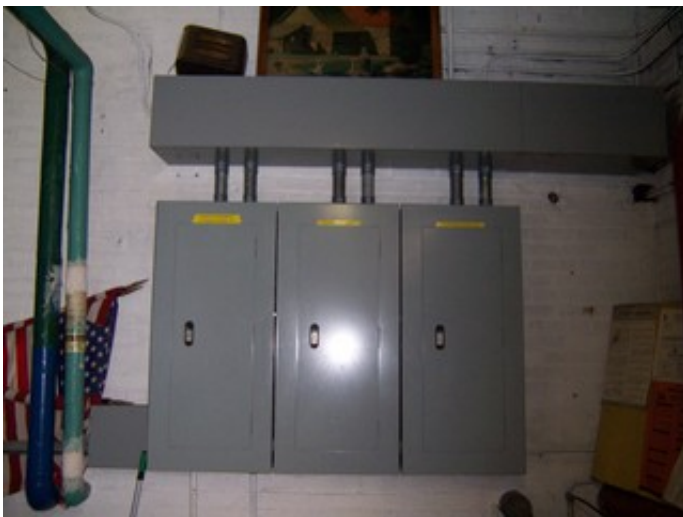
Electrical Distribution Panels 1, 2 and 3

**Recommendations:** The entire electrical system requires replacement to meet Ohio School Design Manual guidelines for overall capacity due to lack of OSDM - required features and to accommodate the addition of an air conditioning system.

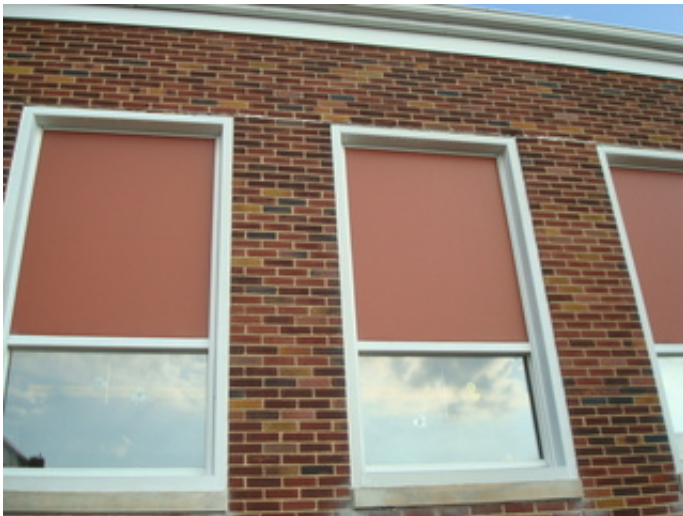
Aluminum replacement windows

**Recommendations:** Provide a new insulated window system with integral blinds to meet with Ohio School Design Manual requirements. Replace storefront system (transoms and sidelights) in the 1962 Addition to meet with Ohio School Design Manual requirements. Replace window transoms in exterior doors of the 1927 original construction, 1932 Addition, and the 1946 Addition due to condition and with approved safety glass to meet with Ohio School Design Manual requirements.

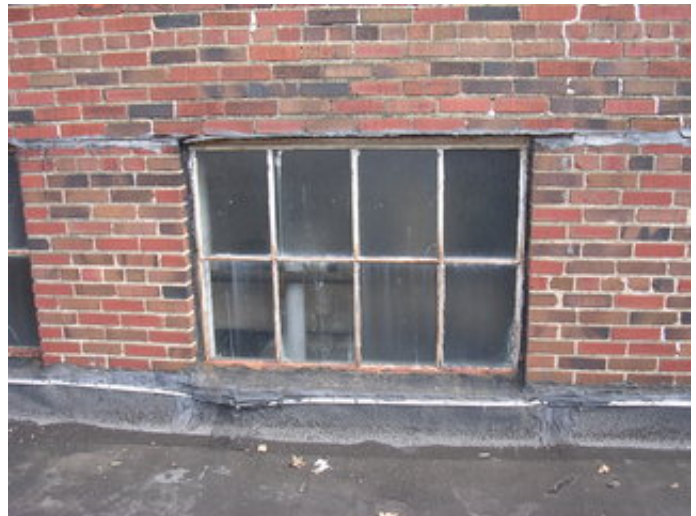
Steel frame window condition.

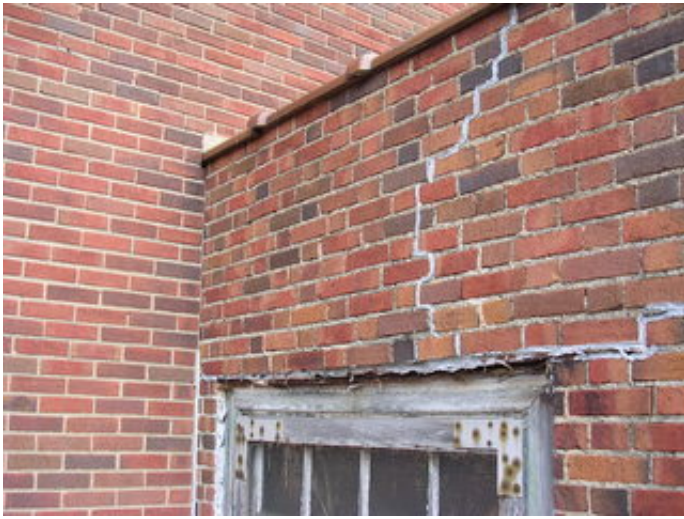
Failing window lintel and bulging masonry.

Replace Brick Veneer System:	\$35.00	sq.ft. (Qty)		495 Required			1,000 Required								\$52,325.00	(total removal and replacement including pinning and shoring)
Lintel Replacement:	\$250.00	ln.ft.		25 Required			26 Required			56 Required					\$26,750.00	(total removal and replacement including pinning and shoring)
Sill Replacement:	\$45.00	ln.ft.		37 Required			16 Required								\$2,385.00	(remove and replace)
Coping Replacement Stone and Masonry:	\$100.00	ln.ft.		149 Required			36 Required								\$18,500.00	(remove and replace)
Install Control Joints	\$60.00	ln.ft.											190 Required		\$11,400.00	
Other: Prep and Paint Steel Lintels	\$5.00	ln.ft.		95 Required			132 Required			61 Required			109 Required	189 Required	\$2,930.00	sand, prime and paint lintels
Other: Replace masonry bearing wall	\$65.00	sq.ft. (Qty)					2,450 Required								\$159,250.00	Replace brick veneer and bearing masonry exhibiting possible structural deficiency, brick cost listed separately

Other: Structural Evaluation	\$5,000.00	allowance					Required								\$5,000.00	Provide allowance for structural engineer to evaluate wall integrity
Sum:			\$407,983.50	\$71,717.50	\$0.00	\$0.00	\$261,490.00	\$0.00	\$0.00	\$29,348.00	\$0.00	\$0.00	\$21,786.50	\$23,641.50

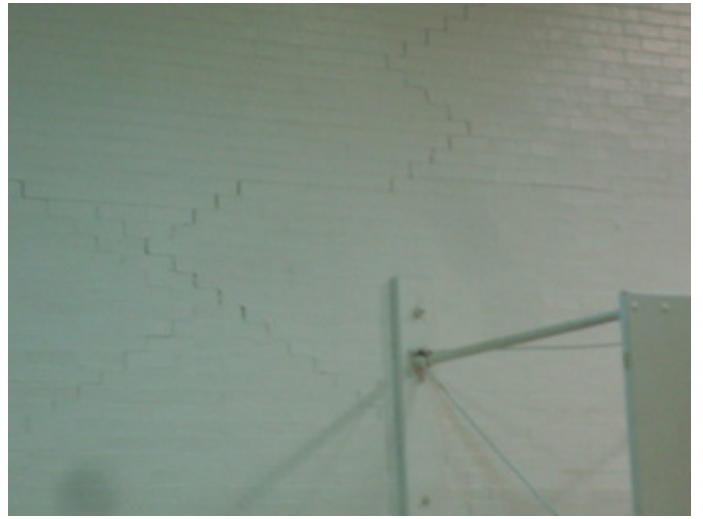
The 1932 Addition Gymnasium interior east wall has significant stair step cracks. The west wall has mortar separation and stair step cracks. The south wall lintels are in very poor condition. The 1932 Addition storage room adjacent to the Gymnasium has significant structural damage and the wall is visually out of plumb from the exterior. The 1932 Addition roof structure on the west side ridge is bowed. Collar ties are pulled apart and the wall is visually out of plumb. The roof structure of 1927 Original Construction and 1932 Addition have significant amounts of wood deterioration. The interior masonry walls show many cracks from settlement. The Gymnasium roof system consists of an interstitial space that averages in height to less than 30 inches, which does not qualify it as an attic space. No mechanical, electrical, or plumbing systems penetrate the area.

Gymnasium wall

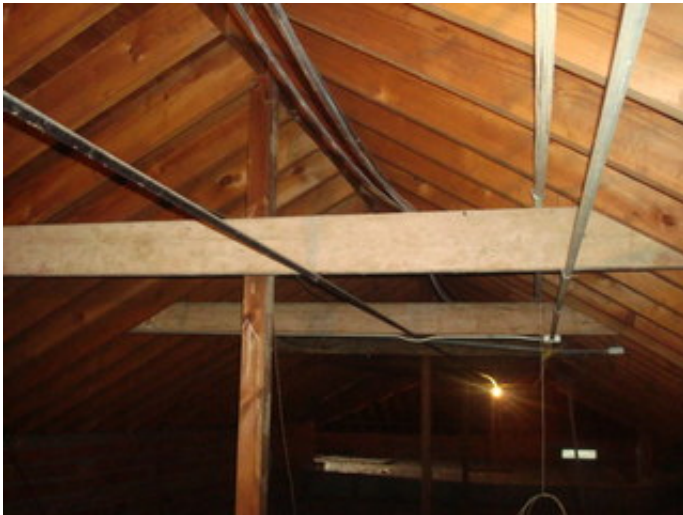
Wood roof

**Recommendations:** Refer to Item U for pricing of fire suppression system for wood structures. Replace roof structure in the 1927 Original Construction and 1932 Addition.

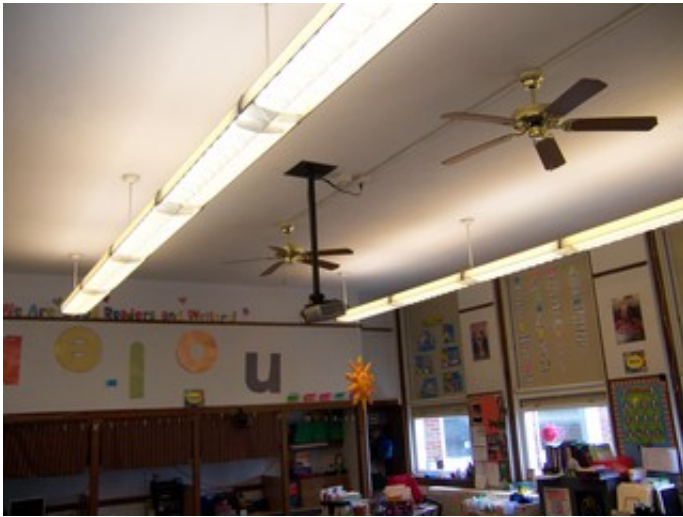
Typical Classroom Lighting

**Recommendations:** Provide complete replacement of lighting system due to age, condition of lighting fixtures and installation of a fire protection system.

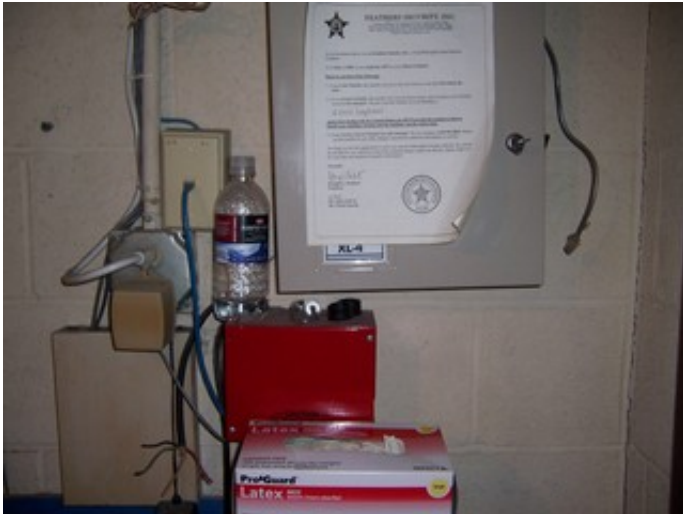
Security System Panel

**Recommendations:** Provide complete replacement of security system to meet Ohio School Design Manual guidelines. Provide complete replacement of exterior site lighting system to meet Ohio School Design Manual guidelines.

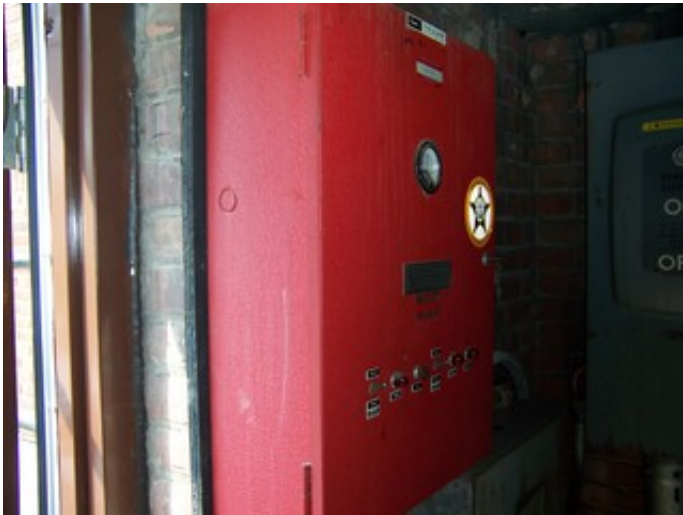
Fire Alarm Control Panel

**Recommendations:** Recommend providing a complete new Fire Alarm System to meet the Ohio School Design Manual and the Ohio Building Code.

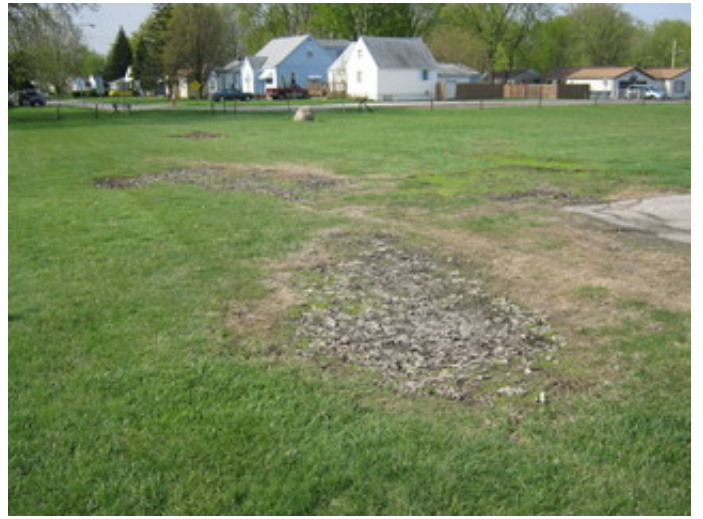
Evidence of ponding

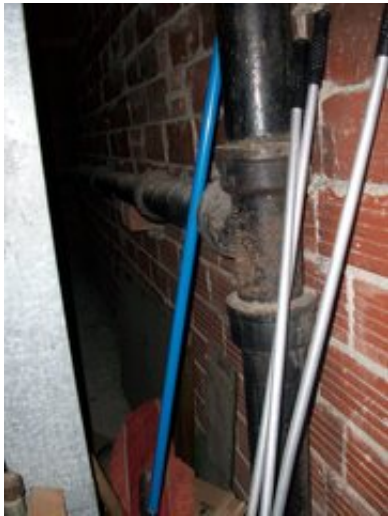
Sanitary Drainage Piping

Recommendations: The original building sanitary drainage system is 83 years old with updates with each new addition. Recommend replacing with new sanitary and vent piping.

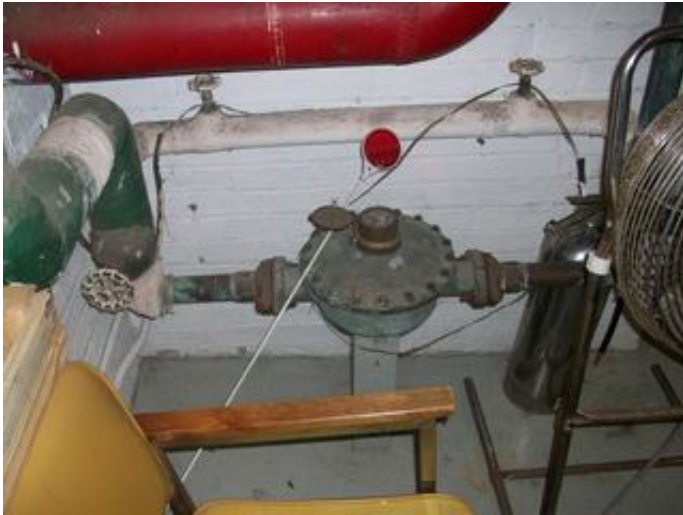
Domestic City Water Meter

Recommendations: Recommend replacing with new domestic water piping from the city site main. Provide booster pump.

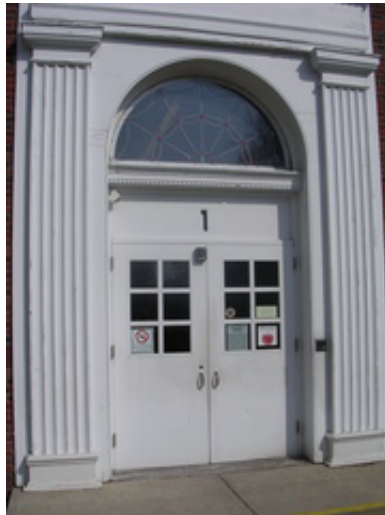
Typical hollow metal entry doors.

**Recommendations:** Replace exterior doors in the overall facility due to poor condition.

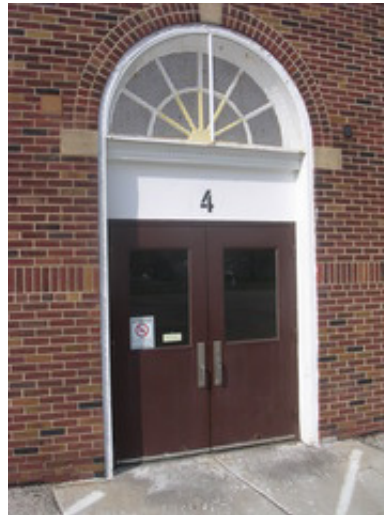
Typical hollow metal doors.

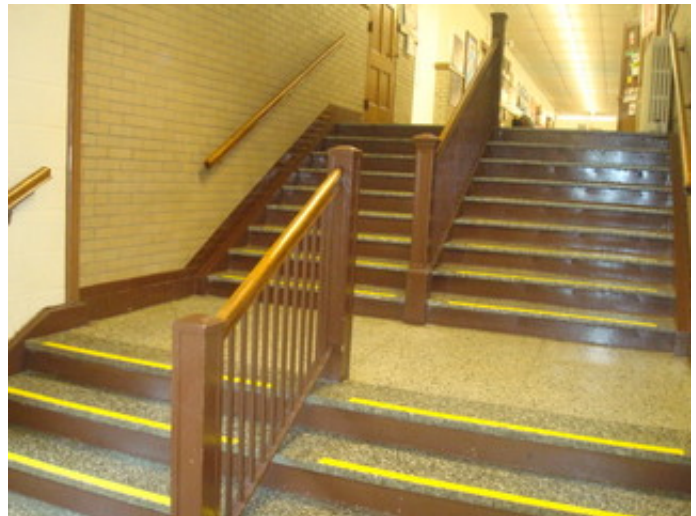
Level change with non compliant handrail

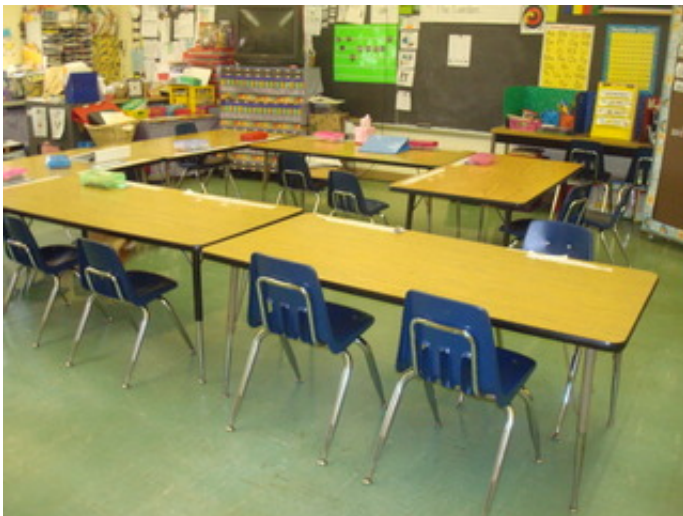
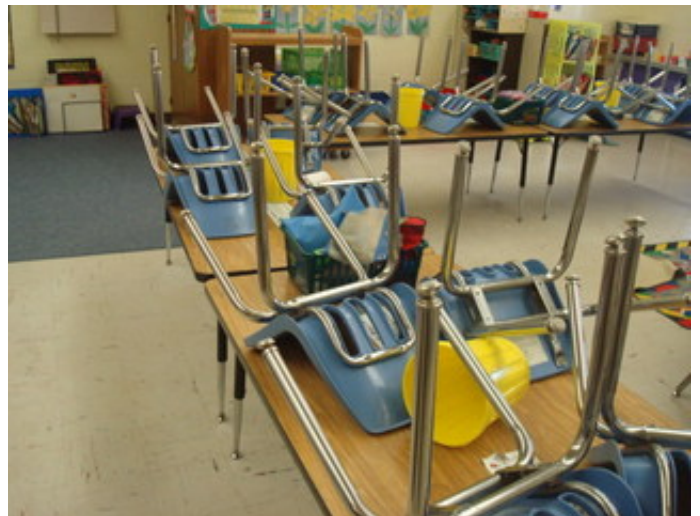
Classroom furniture

**Recommendations:** Provide for replacement of outdated or inadequate furniture.
