Building Information - Willoughby-Eastlake City SD (45104) - Washington Elem

Program Type	Expedited Local Partnership Program (ELPP)
Setting	Suburban
Assessment Name	Washington E_2010_TCI
Assessment Date	2010-03-16
Cost Set:	2010
Building Name	Washington Elem
Building IRN	39321
Building Address	503 Vegas Dr
Building City	Eastlake
Building Zipcode	44095
Building Phone	440/975-3710
Acreage	9.27
Current Grades	K-5
Teaching Stations	34
Number of Floors	2
Student Capacity	775
Current Enrollment	470
Enrollment Date	2010-04-01
Enrollment Date is the date in which the current enrollment was taken.	
Number of Classrooms	31
Historical Register	NO
Building's Principal	Ms. Betty Stevens
Building Type	Elementary

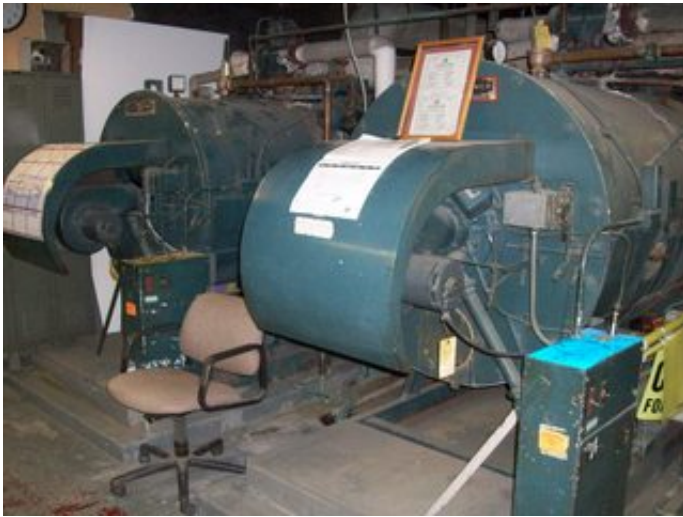
Description: The existing heating system for the overall facility is composed of two major hot water boilers centrally located in the main mechanical room which were installed in 1961. The units are in good condition. The heating system in the overall facility is part of the Original Construction and is a 2-pipe system supplying hot water. With very limited capacity for simultaneous heating and cooling operation, this system is not compliant with the OSDM requirements for basic system type. The forced draft hot water boilers, manufactured by York were installed in 1961 and are in decent condition. Heating hot water is distributed to terminal units consisting of unit ventilators, cabinet heaters, unit heaters, and fin tubes. The terminal equipment was installed in 1961 and new with the addition and is in fair condition. The system does not comply with the 15 CFM per person fresh air requirements of the Ohio Building Code mechanical code and Ohio School Design Manual. The non DDC type system temperature controls were installed in 1961 and are in working condition. The system does feature individual heating temperature controls in all spaces required by the OSDM. The overall system does not feature any central energy recovery systems. The facility is equipped with louvered interior doors in classrooms, storage and utility rooms to facilitate Corridor utilization as return air plenums while the classrooms have a return air systems. The existing system is not ducted, and floor to structural deck heights will not accommodate the installation of properly sized ductwork for a future Ohio School Design Manual approved system. The overall heating system is evaluated as being not in safe and efficient working order, though long term life expectancy of the existing system is anticipated. The structure is not equipped with central air conditioning. The site does not contain underground fuel tanks that are currently in use.

Rating: 3 Needs Replacement

Gas Fired Hot Water Boilers

Recommendations: Provide new overall heating, ventilating, and air conditioning system to achieve compliance with Ohio Building Code and Ohio School Design Manual standards. Convert to ducted system to facilitate efficient exchange of conditioned air.

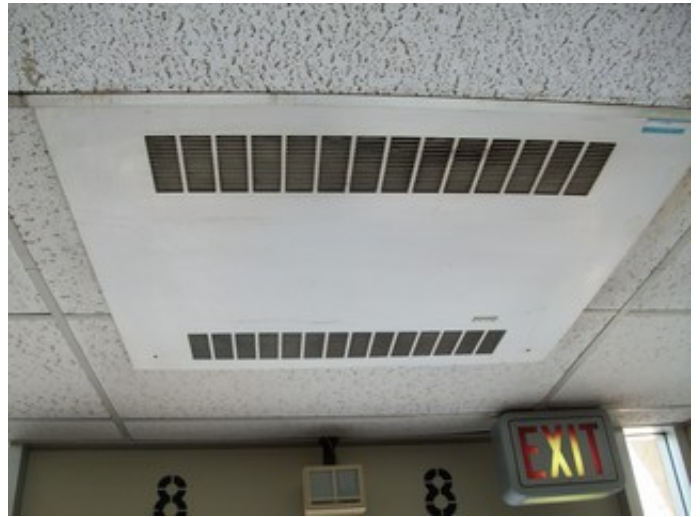
Ceiling Unit Heater

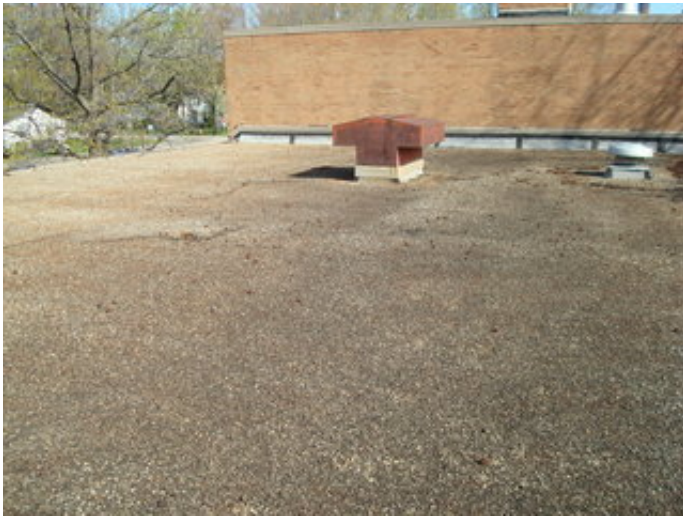
Description: The roof of the overall facility is a gravel-ballasted built-up system that was installed in 1998, and is in poor condition. There are District reports of current leaking. The roof reportedly leaks at the southwest area of the north roof surface, on the 1963 addition just to the north of the gymnasium and just to the southwest of the gymnasium, and on the south roof surface just to the southwest of the courtyard. Signs of past leaking were observed in these locations during the physical assessment. The roof does not have positive slope to drain. Access to the roof was gained by portable ladder and between different roof surfaces by a metal ladder. Fall safety protection cages are not required, and are not provided. Evidence of recent ponding on the southern roof surface of the 1961 Original Construction was observed. Metal cap flashings and stone copings are in poor condition. Roof storm drainage is addressed through a system of roof drains, which are properly located, and in fair condition. The roof is not equipped with overflow roof drains though they are needed on this building. Flashing at the chimney and at the vent fans near the chimney were in need of attention. The expansion joint cover flashing at the edges of the 1963 addition were in need of repair or replacement. There are not any covered walkways attached to this structure.

Rating: 3 Needs Replacement

Evidence of ponding on roof

Recommendations: The roofing requires replacement with single-ply membrane roofing to meet Ohio School Design Manual guidelines for lack of insulation and lack of positive slope. The flashing and coping require replacement due to condition. Overflow drainage is needed, along with new roof drains with the new roofing system. Tapered insulation is needed both to give the roof positive slope and to provide compliant thermal insulation.

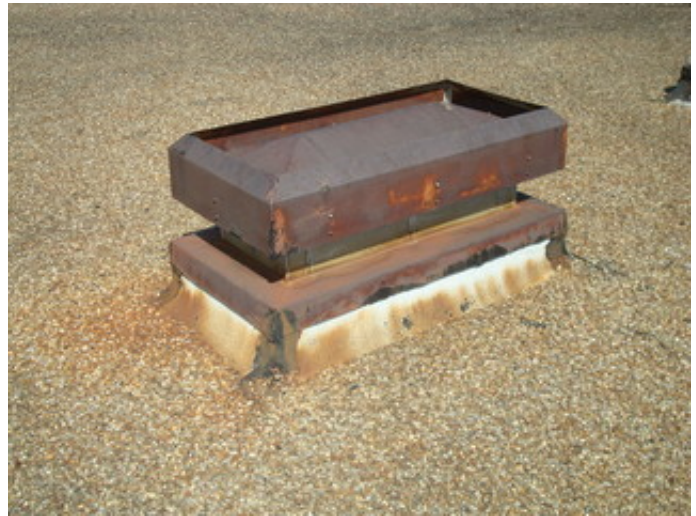
Hood with flashing that possibly leaks

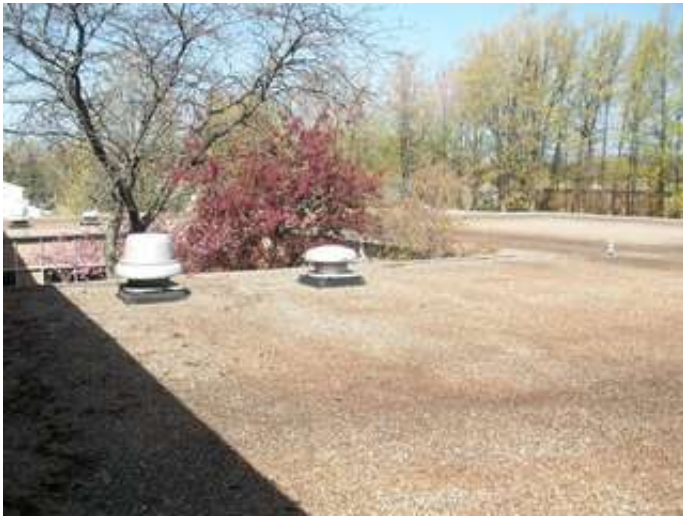
Description: The overall facility is not equipped with a central air conditioning system. Window units are provided in miscellaneous locations such as offices, library, and media center. The ventilation system in the overall facility consists of unit ventilators and ducted air handlers installed initially in 1961 and are in fair condition, providing fresh air to classrooms and other miscellaneous spaces such as Gymnasiums, Student Dining, Media Center etc. Relief air venting is provided by relief fans and roof vents. The ventilation system does not meet the Ohio Building Code 15 CFM per occupant fresh air requirement. The overall system is not compliant with Ohio Building Code and Ohio School Design Manual requirements. Dust collection systems are not required in this facility and no system is provided. The Art program is non-existent. Exhaust systems for Restrooms, Locker Rooms, Kitchen, Gymnasiums, Storage Rooms, Custodial Closets and Career Tech specialized areas are adequately placed, and in working condition.

Exhaust Fans / Roof Ventilator

Recommendations: Provide an air conditioning system to meet with Ohio Building Code and Ohio School Design Manual requirements. Pricing included in Item A. Provide kiln exhaust system for art kiln listed in item J.

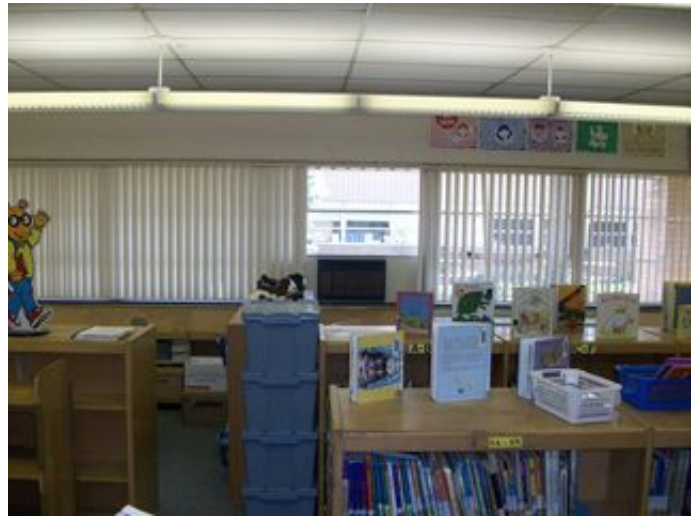
Thru-the-Wall Air Conditioner

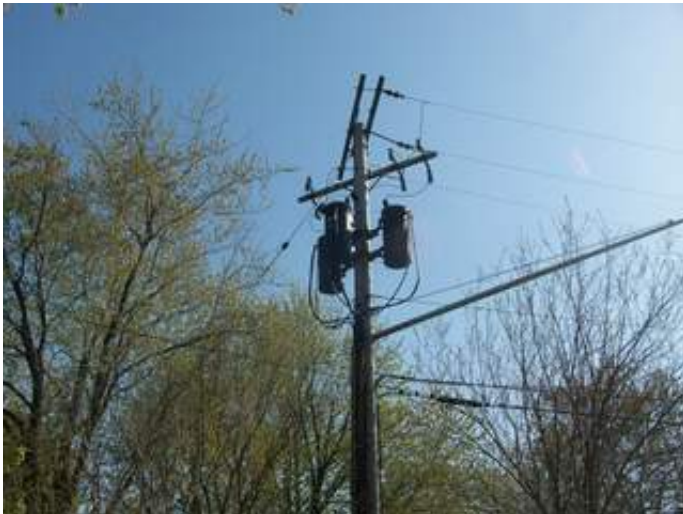
Description: The electrical system provided to the overall facility is a 400 amp 120/208 volt, 3 phase, 4 wire original system from the year 1961, and is in fair condition. Power is provided to the school by pole mounted utility owned transformers. The main distribution panel cannot be expanded to add additional capacity that would be required by the OSDM air conditioning requirements. The Classrooms are not equipped with adequate electrical outlets in some of the original areas per OSFC recommendations. The typical Classroom contains usually 2 to 3 general purpose outlets with certain classrooms having added outlets used for Classroom computers, and television. There are some spaces that have no electrical outlets such as storage areas and Janitor Closets. Most Corridors are equipped with adequate electrical outlets for electrical servicing. Adequate GFI protected exterior outlets are not provided around the perimeter of the building. The facility is not equipped with an emergency generator. There is a 100 amp emergency panel 'E', which feeds items such as exit lights, emergency lights and the Fire Alarm panel. Panel 'E' is fed directly from a 60 amp 240 V. disconnect switch. Adequate building lightning protection safeguards are not provided. The overall electrical system does not meet Ohio School Design Manual requirements, and will be inadequate to meet the facility's future needs.

Rating: 3 Needs Replacement

Pole Mounted Power Transformer

Recommendations: The entire electrical system requires replacement due to lack of OSDM - required features and to accommodate the addition of an air conditioning system.

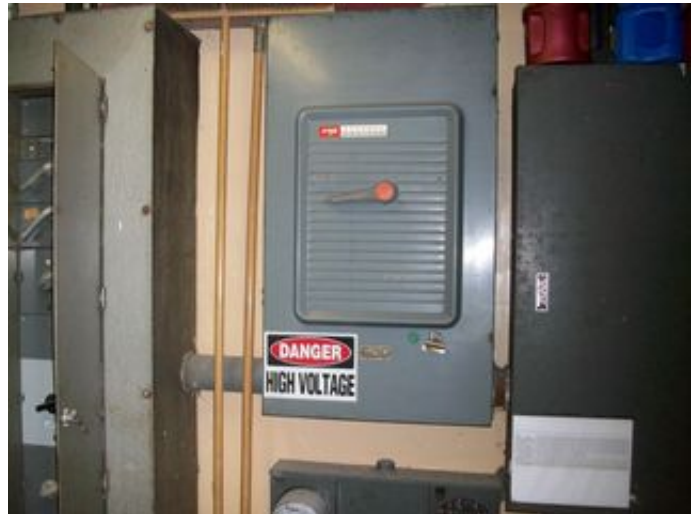
Main Electrical Switch Panel

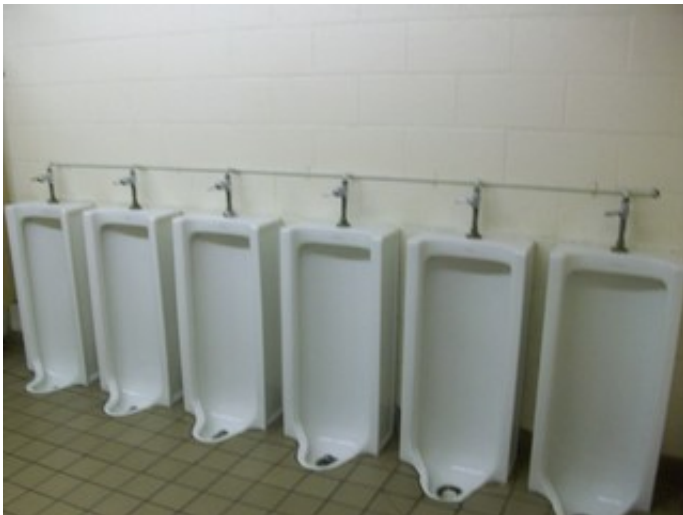
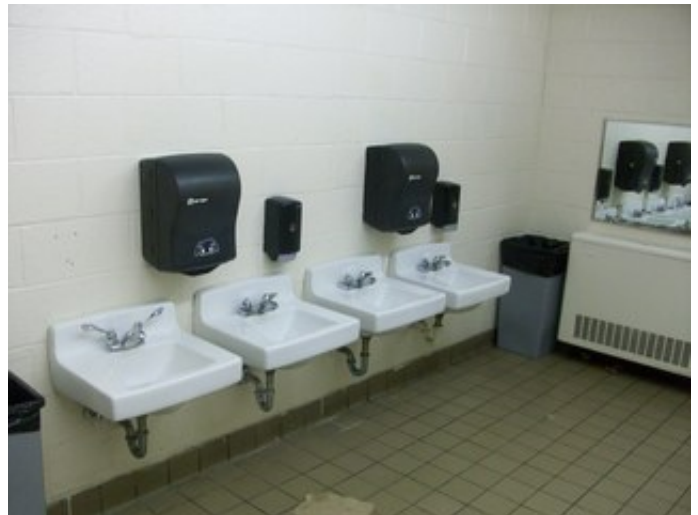
Description: This school has 27 wall hung water closets, 10 urinals, 28 lavatories, 5 wall hung electric water coolers, 27 sinks, and 3 mop sinks. Most of the plumbing fixtures are in fair condition, but ADA requirements are not met for plumbing fixtures. A 3 inch reduced principle backflow preventer is required. The building has a 3 inch domestic water supply line. This water heater appears to be in very good condition. Domestic water piping is copper and appears to be in good condition. Sanitary drainage and vent piping is cast iron that appears to be in good condition.

Rating: 3 Needs Replacement

Recommendations: Provide all new plumbing fixtures, faucets and flush valves to replace the existing because of ADA requirements, water efficiency, and condition of old plumbing fixtures. Replace existing water heater with new high efficient gas fired boilers. The recommendation for domestic water piping is in section R. The recommendation for sanitary drainage piping is in section Q.

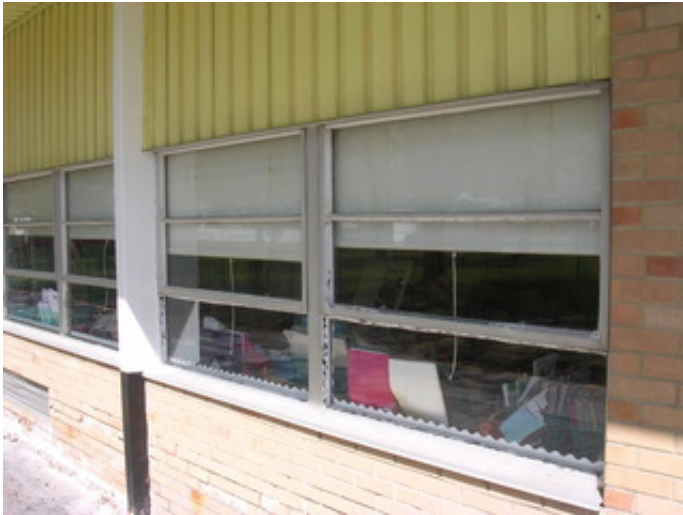
Description: The overall facility is equipped with non-thermally broken aluminum windows with single glazed type window system, which were installed in 1961 and 1963, and are generally in poor condition. Window system seals are in moderate condition, with moderate air and water infiltration being experienced. Window system hardware is in moderate condition. The window system features surface mounted shades which are in moderate condition. The window system is not equipped with insect screens on operable window. Aluminum frame storefront systems are found in the overall facility, in fair to poor condition. This facility does not feature any glass block windows. The exterior doors in the overall facility are equipped with non-thermally broken aluminum sidelights and transoms with single glazing in poor condition. Glazing panels are a combination of tempered, non-tempered, and wired glass, with some fiberglass spandrel panels. Window security grilles are not provided for ground floor windows. The school does not contain skylights. There is not a Greenhouse associated with this school.

Rating: 3 Needs Replacement

Typical aluminum window system.

Recommendations: Provide a new insulated window system with integral blinds to meet with Ohio School Design Manual requirements. Replace storefront wall system in the overall facility to meet with Ohio School Design Manual requirements. Replace window transoms / sidelights in exterior doors of the overall facility with approved safety glass to meet with Ohio School Design Manual requirements.

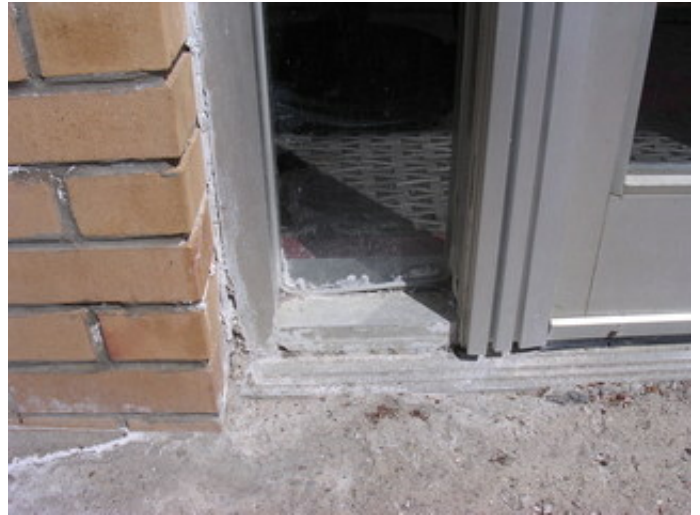
Aluminum storefront window system damage.

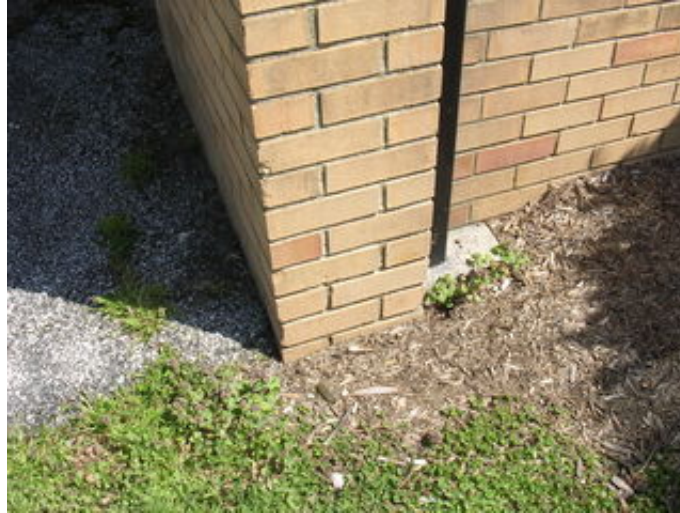
Description: The overall facility is equipped with concrete masonry unit foundation walls on concrete footings which displayed no locations of significant differential settlement, cracking, or leaking, and are in good condition. The District reports that there has been no past leaking. No grading or site drainage deficiencies were noted around the perimeter of the structure that are contributing or could contribute to foundation / wall structural deterioration.

Typical foundation condition.

Recommendations: Existing conditions require no renovation or replacement at the present time.

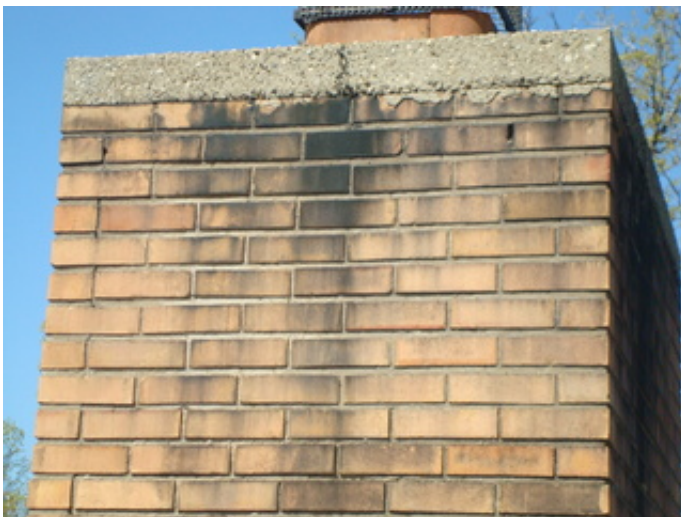
Description: The overall facility has a steel frame with brick veneer and curtain wall system which displayed no locations of deterioration, and is in fair condition. The exterior masonry appears to have appropriately spaced and inadequately caulked control joints in poor condition. Control joints are not provided at lintel locations at doors and windows. The 1961 Original Construction has sufficient expansion joints, and they are in poor condition and need repair. The exterior masonry has not been cleaned and sealed in recent years, and shows evidence of mortar deterioration at the base of the South side, at the base of the wall on the North wall of the entry canopy, at the base of the wall on the walls just East and West of the North entries. Extensive efflorescence and spalling has occurred at the base of the south wall between the entries. Exterior metal panels are located in both the 1961 Original Building and the 1963 Addition, and are in fair condition. Metal panel flashings and joints are in poor condition. Interior walls are concrete masonry units with some wood framed partitions with gypsum board and are in fair condition. Interior masonry appears to have adequately spaced and caulked control joints in fair condition. Soffits are in fair condition, but flashing between soffits and metal wall panels are in poor condition. The window sills are an element of the aluminum window system, and are in poor condition. The exterior lintels are steel, and are rusting and in fair condition. Chimneys are in poor condition with spalling brick veneer and a deteriorated coping.

Rating: 2 Needs Repair

Damaged brick and coping at chimney

Recommendations: Provide tuckpointing in all areas of mortar deterioration as required in the 1961 Original Construction. Provide masonry cleaning and sealing through the overall facility. Recaulk existing control joints. Sawcut and caulk new appropriately spaced expansion joints in existing masonry in the 1961 Original Construction. Replace spalling brick at the base of the building along the South wall of the 1961 Original Construction where salt damage has occurred. Replace metal panels in the overall facility. Replace chimneys with brick veneer and coping in poor condition.

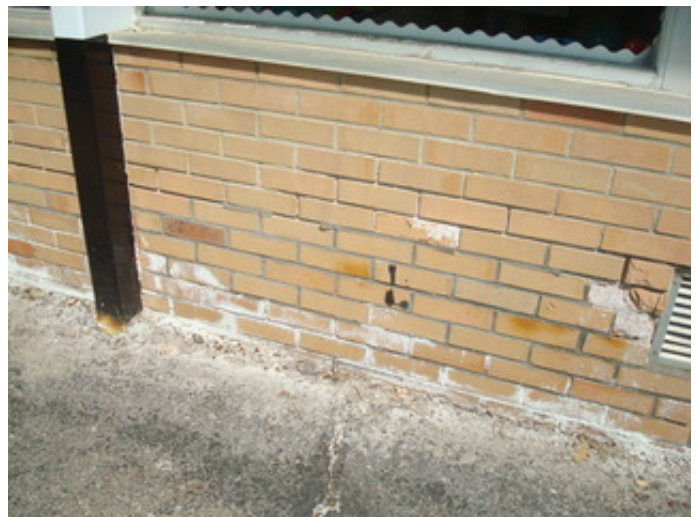
Damaged brick at South wall

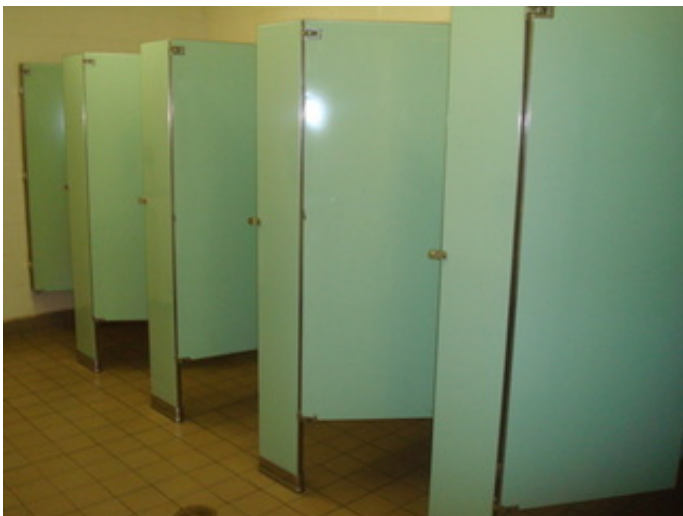
Description: The overall facility features conventionally partitioned Classrooms with vinyl tile flooring in fair to poor condition, acoustical lay in tile ceilings in fair to poor condition, as well as painted block wall finishes in fair condition. The overall facility has Corridors with vinyl tile and ceramic tile flooring in fair condition, acoustical lay in tile ceilings in fair condition, as well as painted block wall finishes in fair condition. The overall facility has Restrooms with ceramic tile type flooring, acoustical lay in tile ceilings, as well as painted block and ceramic tile wall finishes, and they are in poor condition. Toilet partitions are metal, and are in poor condition. Classroom casework in the overall facility is wood construction with plastic laminate tops, is inadequately provided in some locations, and in poor condition. The typical Classroom contains 25 lineal feet of casework, and Classroom casework provided ranges from 4 to 26 feet. Classrooms are provided adequate chalkboards, markerboards, and tackboards, which are in fair condition. The Classroom storage cubbies, located in the Corridors of the 1961 Original Construction are adequately provided, and in fair condition. Student classroom storage in the 1963 Addition is in the classrooms and in poor condition. The Art program is not equipped with a kiln. The program does not have a dedicated classroom space. The facility is equipped with wood louvered interior doors that are flush mounted and recessed without proper ADA hardware and clearances, and in poor condition. The Gymnasium space has vinyl tile flooring, acoustical tile ceilings, as well as painted block wall finishes, and they are in poor condition. The Gymnasium does not have telescoping stands or fixed seating. Gymnasium basketball backboards are fixed, and are in poor condition. The Media Center, located in the 1961 Original Construction, has carpet flooring, acoustical lay in tile ceilings, as well as painted block wall finishes, and they are in fair condition. Student Dining, located in the 1961 Original Construction, has vinyl tile flooring, acoustical tile ceilings, as well as painted block wall finishes, and they are in fair condition. OSDM-required fixed equipment for Stage is not provided. The existing Kitchen is a satellite from North High School facility, is undersized based on current enrollment, and the existing Kitchen equipment, installed at an unknown date, is in fair condition. The Kitchen does not contain a hood. Walk-in coolers / freezers are not located on the property.

Rating: 3 Needs Replacement

Toilet partitions

Recommendations: Provide complete replacement of finishes and casework due to installation of systems outlined in Items A, C, D, E, K, T and U and condition. Provide a kiln for Art program. Provide funding for door replacement not addressed in item O. Provide new toilet partitions and accessories. Replace Gymnasium backboards. Rework Non-ADA Toilet Room Walls.

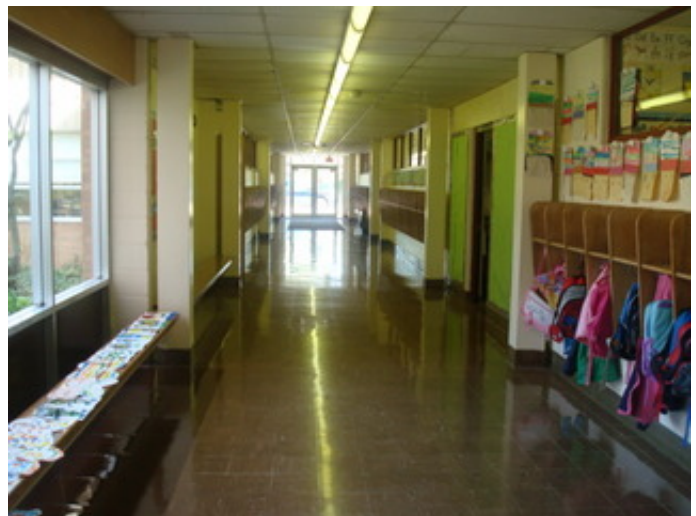
Corridor

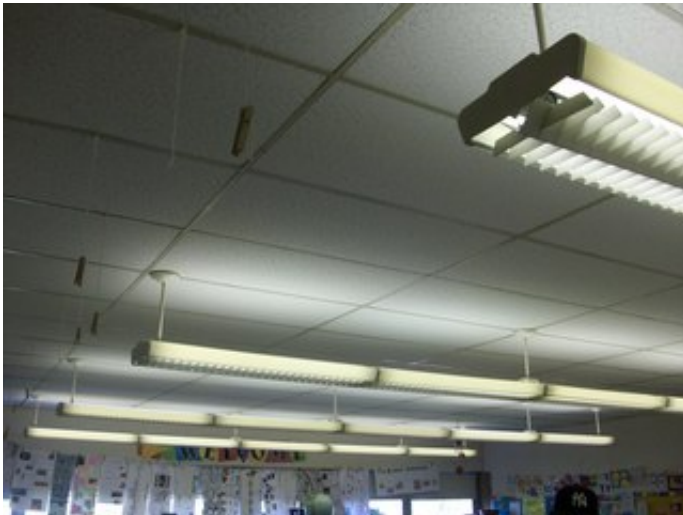
Description: The typical Classrooms of the facility are equipped with T-8 1'X4' tandem pendant mounted style fluorescent fixtures with single level switching. Some of these Classrooms provide 60 to 70 footcandles while others only provide 35 to 45 footcandles of light which is below the recommended 50 FC. The typical Corridors in the overall facility are equipped with T-8, 1'X4' tandem surface mounted fluorescent fixtures with single level switching. Corridor fixtures are in fair condition, providing an average illumination of 15 to 20 FC; Sometimes complying with the 20 FC recommended by the OSDM and sometimes not. The Multi Purpose / Cafeteria area / Gymnasium is equipped with recessed mounted incandescent type lighting in fair condition, providing an average illumination of 40 FC; not complying with the 50 FC recommended by the OSDM. The Library is equipped with T-8, 1'X4' tandem pendant mounted fluorescent type lighting in fair condition, providing an average illumination of 40 to 50 FC; not complying with the 50 FC recommended by the OSDM. The Kitchen space is equipped with T-8 1'X4' tandem surface mounted fluorescent type lighting fixtures with single level switching. Kitchen fixtures are in fair condition, providing an average illumination of 55 to 60 FC, which is less than the 75-80 FC recommended by the OSDM. The Service Areas in the overall facility are equipped with pendant or chain mounted fluorescent type lighting and surface mounted incandescent fixtures in poor condition. The typical Administrative spaces in the overall facility are equipped with 1'X4' pendant fluorescent fixtures and 1'X4' surface mounted T-8 fluorescent type lighting in fair condition, providing inadequate illumination based on OSDM requirements. The overall lighting systems of the facility are not compliant with Ohio School Design Manual requirements due to age, condition of the lighting fixtures and installation of a fire protection system.

Rating: 3 Needs Replacement

Typical Classroom Lighting

Recommendations: Provide complete replacement of lighting system due to age, condition of lighting fixtures and installation of a fire protection system.

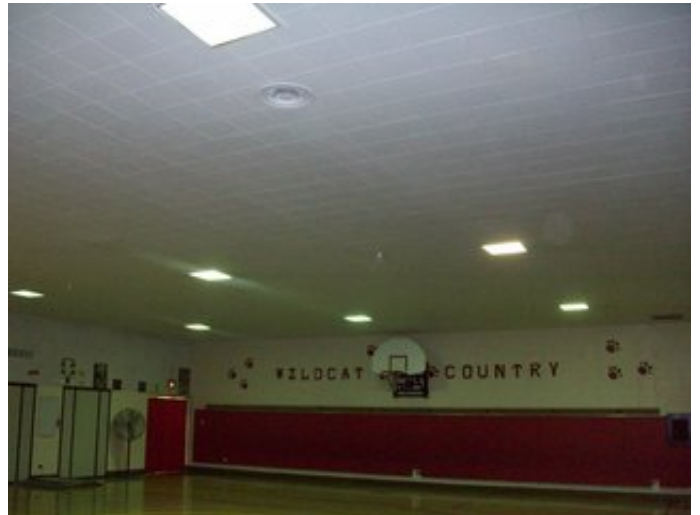
Gymnasium Lighting

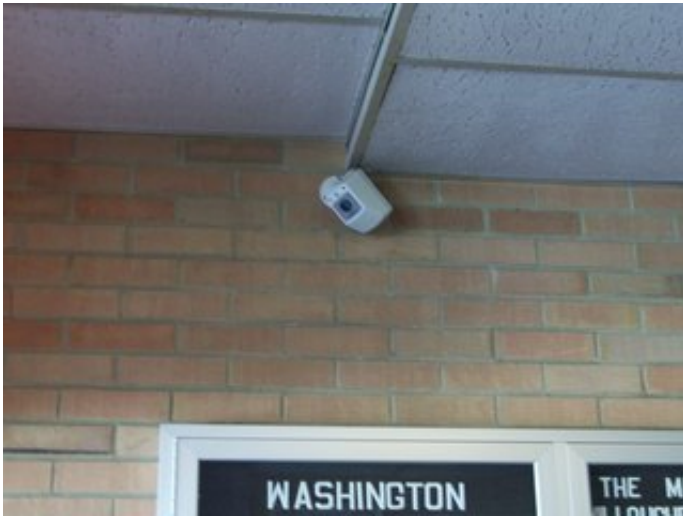
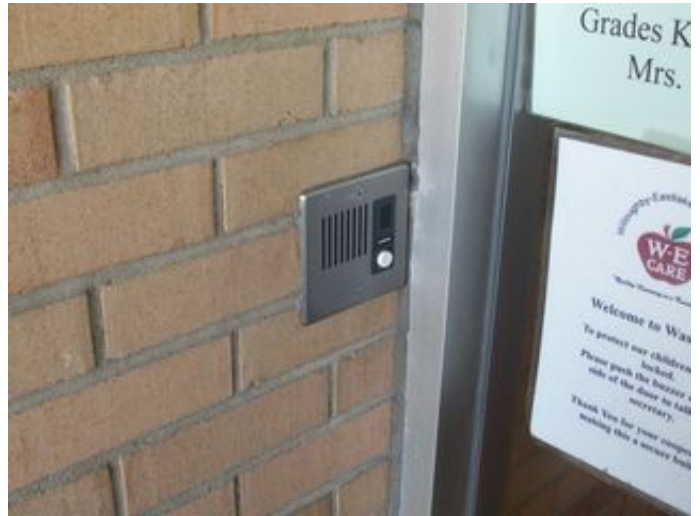
Description: The overall facility contains a security system including head-end equipment and security buzzer at main entry. The security system is not adequately provided throughout, and is not fully compliant with Ohio School Design Manual guidelines regarding security lighting throughout the site. The exterior building lighting system is equipped with incandescent wall mounted lights and incandescent spot lights; all in poor condition. Parking and bus pick-up / drop off areas are illuminated with pole mounted par 38 floodlight fixtures in fair condition. The exterior site lighting system provides inadequate coverage per the OSDM guidelines.

Rating: 3 Needs Replacement

Main Entrance CCTV Camera

Main Entrance Visitor Intercom

Recommendations: Provide complete replacement of security system to meet Ohio School Design Manual guidelines. Provide complete replacement of exterior site lighting system to meet Ohio School Design Manual guidelines.

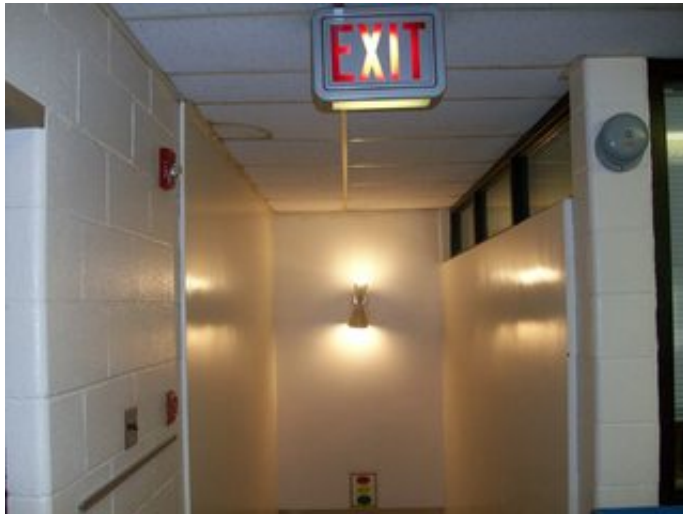
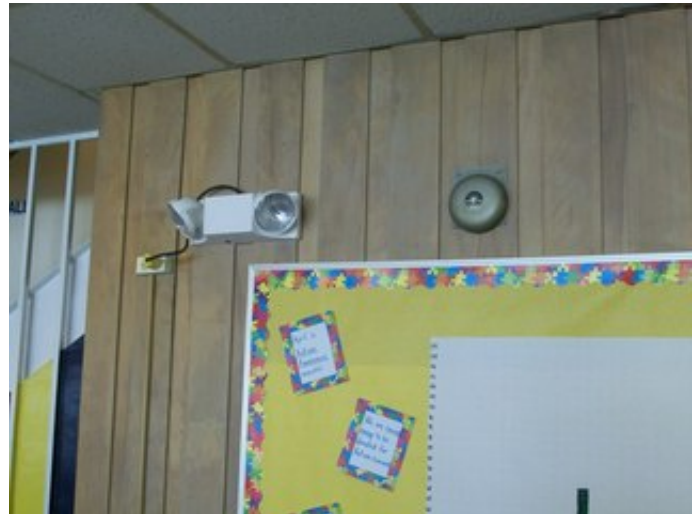
Description: The overall facility is equipped with an emergency egress lighting system consisting of exit lighting fed from the emergency panel and emergency lighting. There are some stand alone emergency floodlight units in several areas of the entire facility. The exterior egress doors have par 38 incandescent type wall-pack or incandescent wall mounted fixtures, but are not provided with emergency lighting heads. Most of the system is in poor condition and in need of repair and / or additional emergency lighting equipment. The emergency egress lighting units that are provided with appropriate battery backup but, no written battery replacement schedule was available. The system is not adequately provided throughout, and does not meet Ohio School Design Manual and Ohio Building Code requirements in all cases.

Rating: 3 Needs Replacement

Typical Exit Sign

Typical Emergency Lighting Unit

Recommendations: Provide complete replacement of the emergency / egress lighting system throughout to meet the Ohio School Design Manual guidelines.

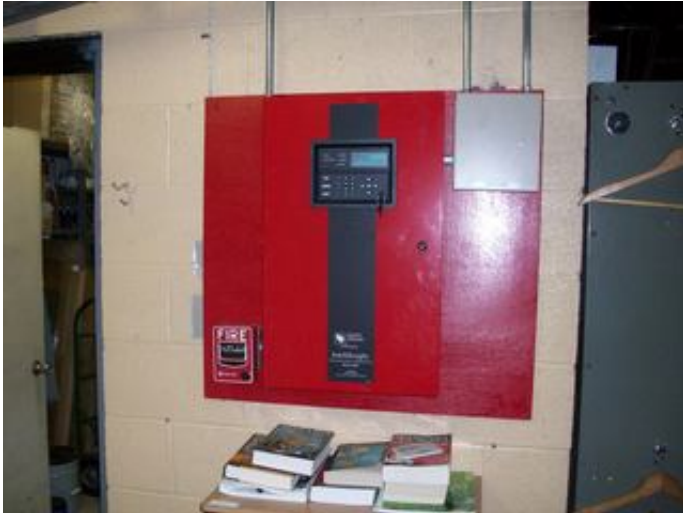
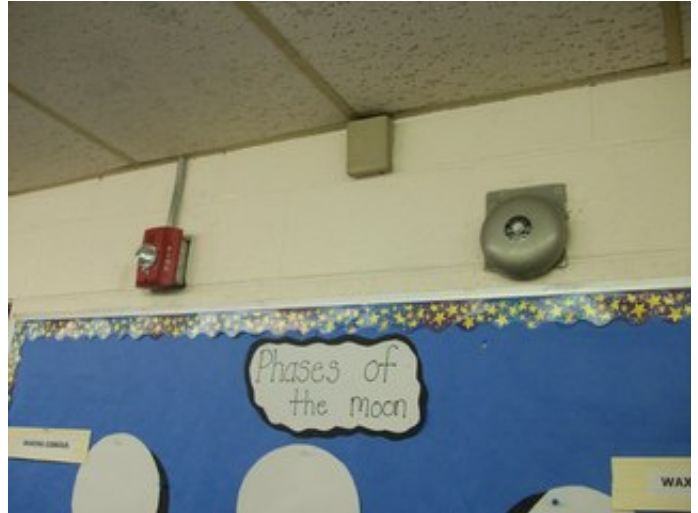
Rating: 3 Needs Replacement

Main Fire Alarm Panel

Typical Fire Alarm Devices

Recommendations: Recommend providing a complete new Fire Alarm System to meet the Ohio School Design Manual and the Ohio Building Code.

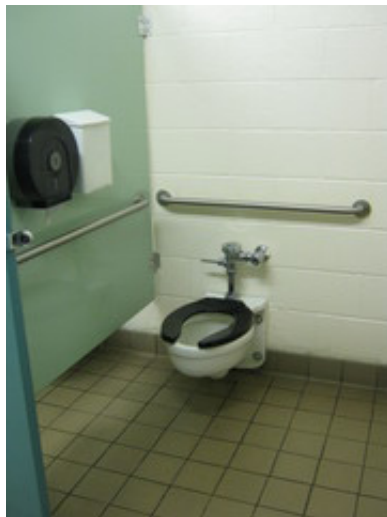
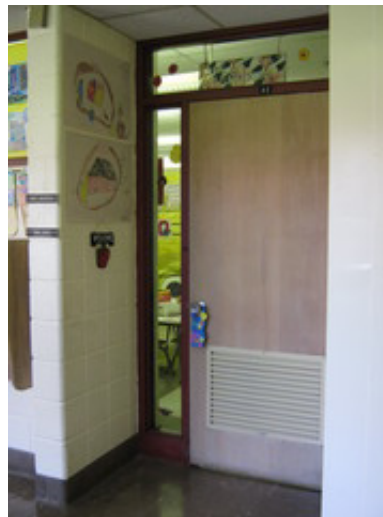
Rating: 2 Needs Repair

Accessible toilet stall

Typical recessed classroom door

Recommendations: Provide ADA compliant signage. Provide a power assist door opener at the main entry in the 1961 Original Construction. Provide compliant toilet partitions and accessories at group toilet rooms where required. Provide compliant accessories at all private toilet rooms. Remount mirrors to compliant height where required. At all private toilets, rework walls to provide adequate clearances. Costs for reworked walls are covered in Item J. Replacement of plumbing fixtures is covered in Item E. Parking issues are corrected in Item P. Rework door openings to provide adequate clearances where required. Replace doors noted in poor condition in item J.

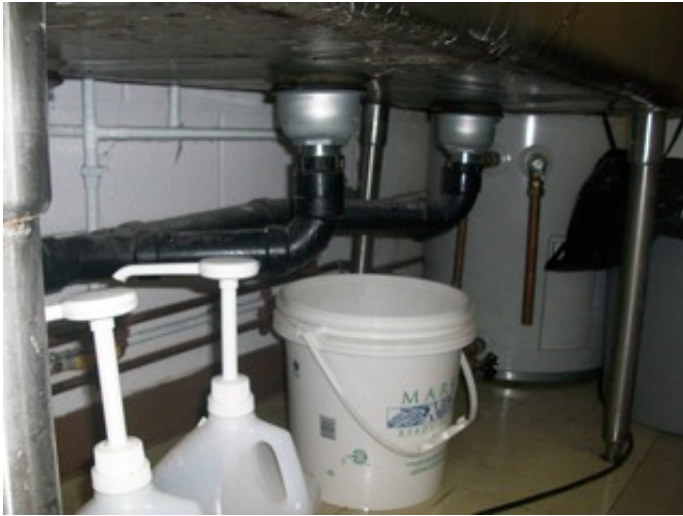
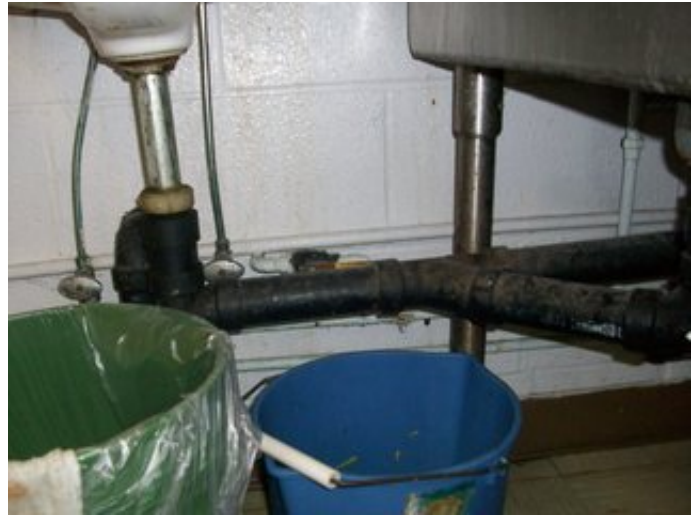
Sanitary drain below sink

Recommendations: The sanitary drainage system is 49 years old. Recommend replacing with new sanitary and vent piping.

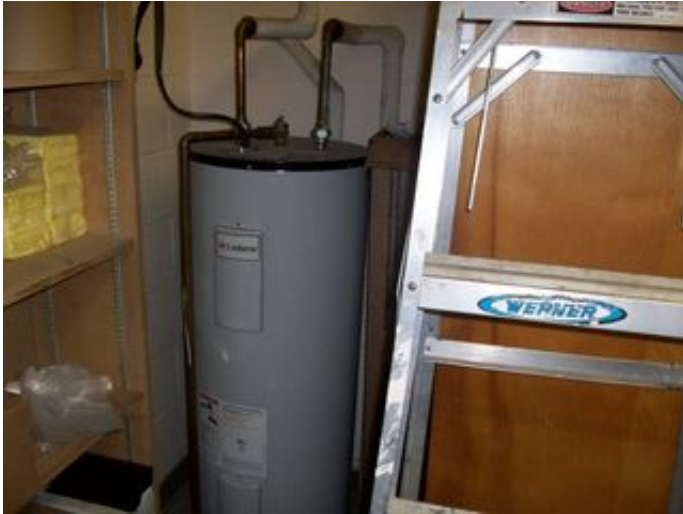
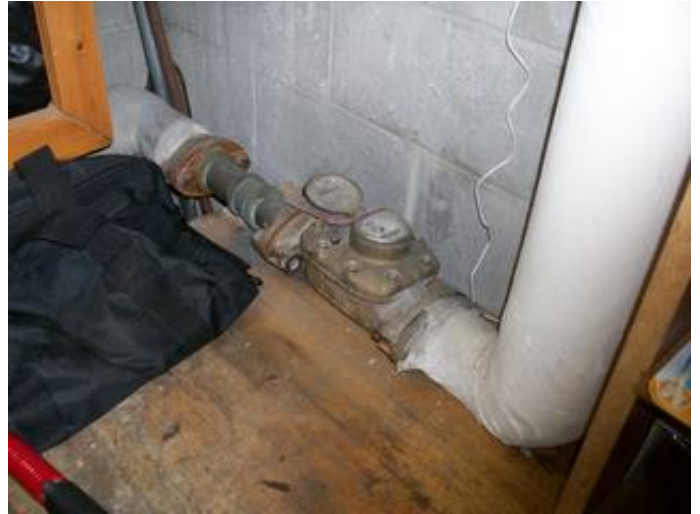
Domestic Water Piping

Recommendations: The existing domestic water piping is 49 years old. Recommend replacing with new domestic water piping from the city site main. Backflow preventer provided in item E.

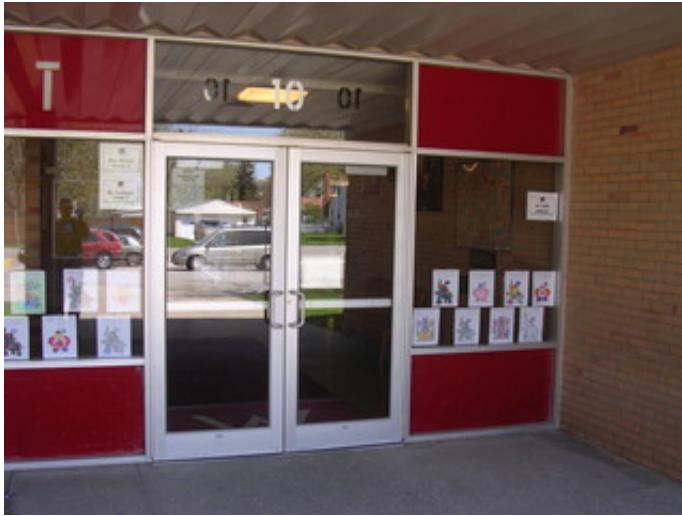
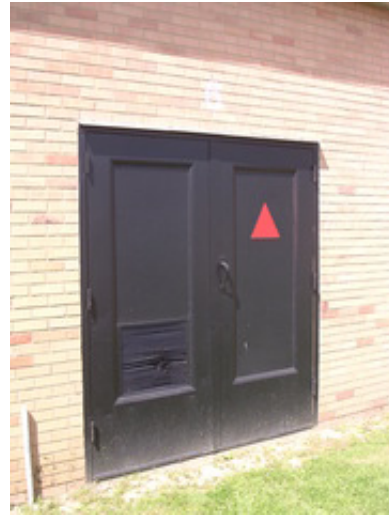
Typical aluminum entry doors.

Typical hollow metal doors.

Recommendations: Replace exterior doors to comply with Ohio Building Code, ADA, and Ohio School Design Manual guidelines and due to condition.

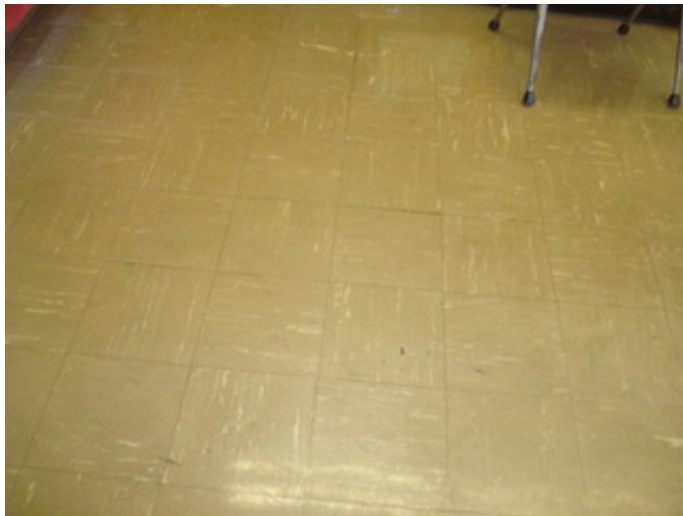
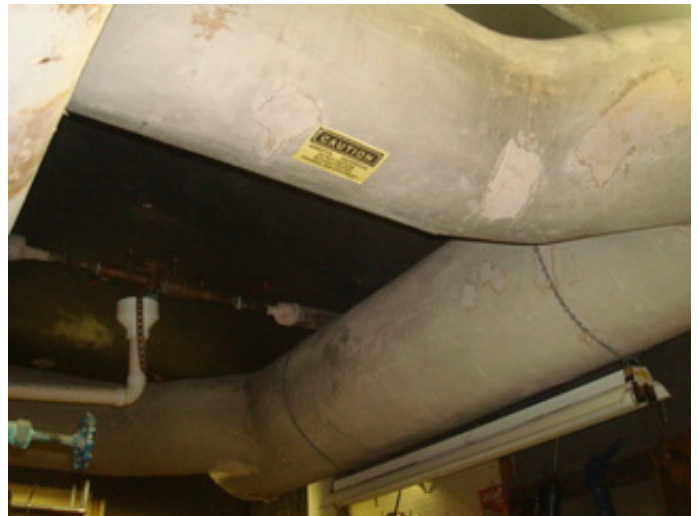
Vinyl tile

Pipe insulation

Recommendations: Remove all hazardous materials, inclusive of asbestos-containing materials in the overall facility, as noted in the attached Environmental Hazards Assessment.
