Building Information - Willoughby-Eastlake City SD (45104) - Edison Elem

Program Type	Expedited Local Partnership Program (ELPP)
Setting	Suburban
Assessment Name	Edison E_2010_TCI
Assessment Date	2010-03-16
Cost Set:	2010
Building Name	Edison Elem
Building IRN	9985
Building Address	5288 Karen Isle Dr
Building City	Willoughby
Building Zipcode	44094
Building Phone	440/954-3555
Acreage	17.88
Current Grades	K-5
Teaching Stations	29
Number of Floors	1
Student Capacity	600
Current Enrollment	636
Enrollment Date	2010-04-01
Enrollment Date is the date in which the current enrollment was taken.	
Number of Classrooms	24
Historical Register	NO
Building's Principal	Mr. Brian Patrick
Building Type	Elementary

Edison Elementary, which is not on the National Register of Historic Buildings, and originally constructed in 1962, is a 1 story, 44,771 square foot brick school building located in a suburban residential setting. The existing facility features a conventionally partitioned design, and does utilize modular buildings. The modular unit is 4,020 square feet with electrical service. Water, gas, and sanitary services are not provided. The unit is in fair condition. The structure of the overall

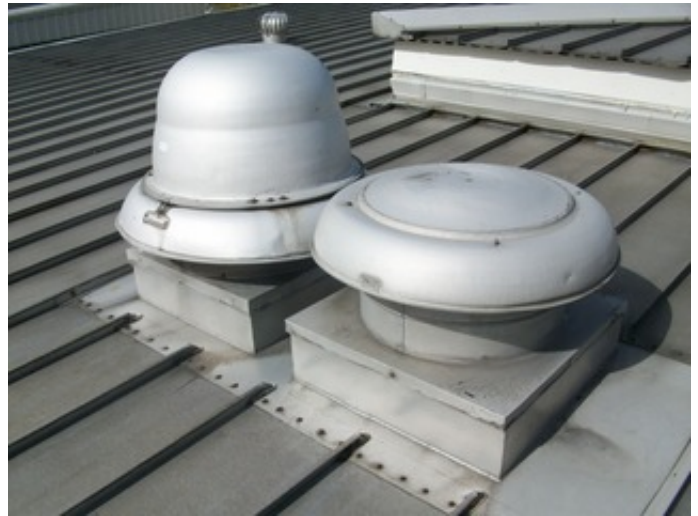
Roof Mounted Exhaust Fans

Recommendations: Provide an air conditioning system to meet with Ohio Building Code and Ohio School Design Manual requirements. Pricing included in Item A. Provide kiln exhaust system for kiln listed in item J.

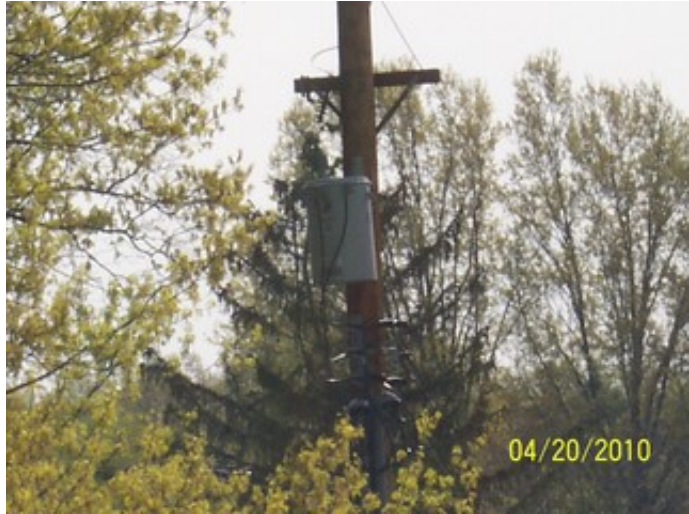
Pole Mounted Transformer

Recommendations: The entire electrical system requires replacement to meet Ohio School Design Manual guidelines for overall capacity due to lack of OSDM - required features and to accommodate the addition of an air conditioning system.

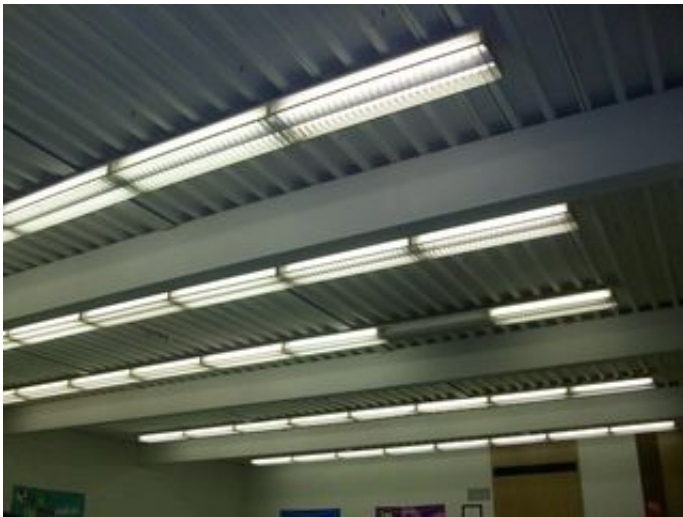
Typical Classroom Lighting

Recommendations: Provide complete replacement of lighting system due to age, condition of lighting fixtures and installation of a fire protection system.

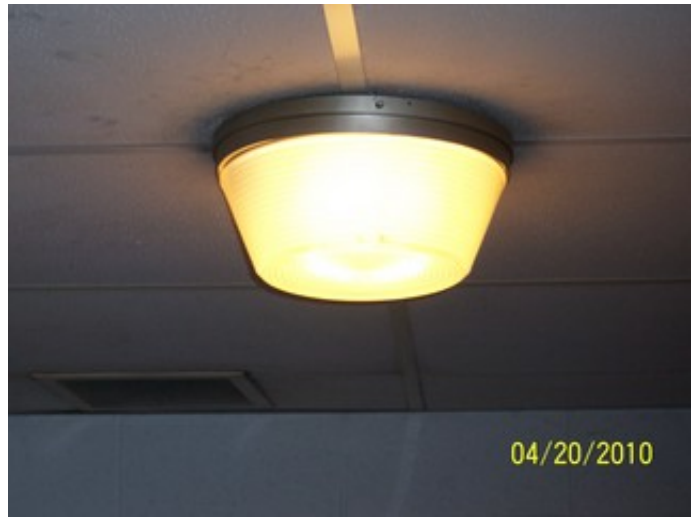
Variation Of Lighting Fixture

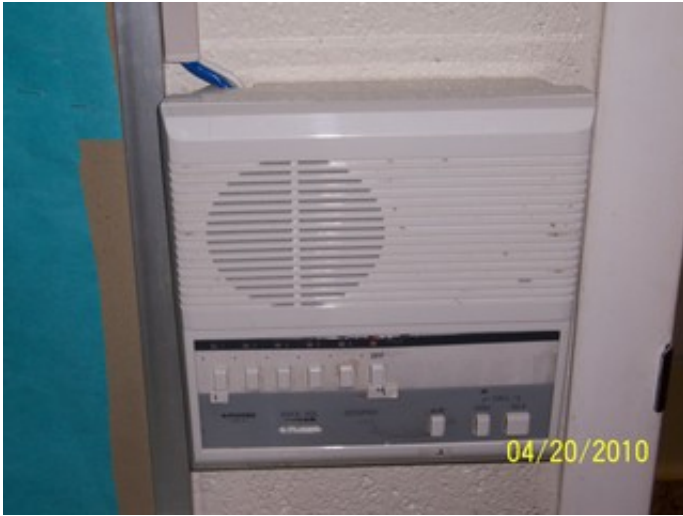
Security Buzzer

Recommendations: Provide complete replacement of security system to meet Ohio School Design Manual guidelines. Provide complete replacement of exterior site lighting system to meet Ohio School Design Manual guidelines.

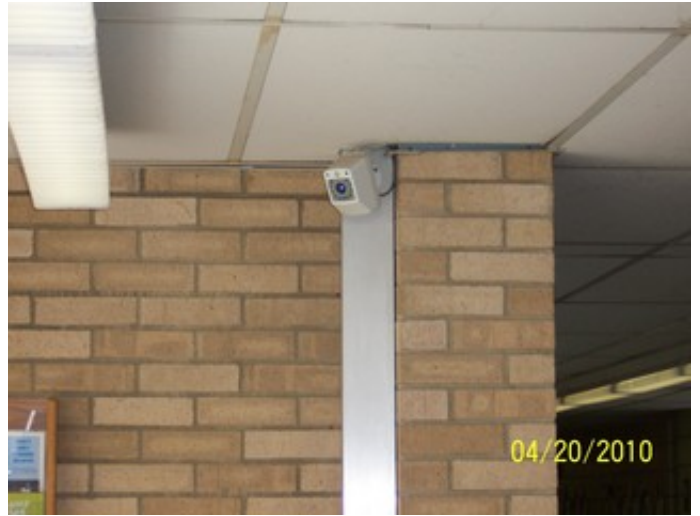
Main Entrance Security CCTV Camera

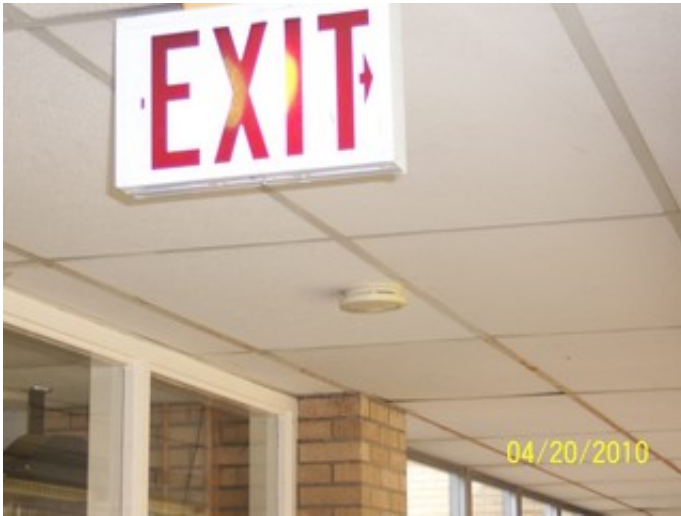
Typical Exit Sign

Recommendations: Provide complete replacement of emergency / egress lighting system to meet Ohio School Design Manual guidelines.

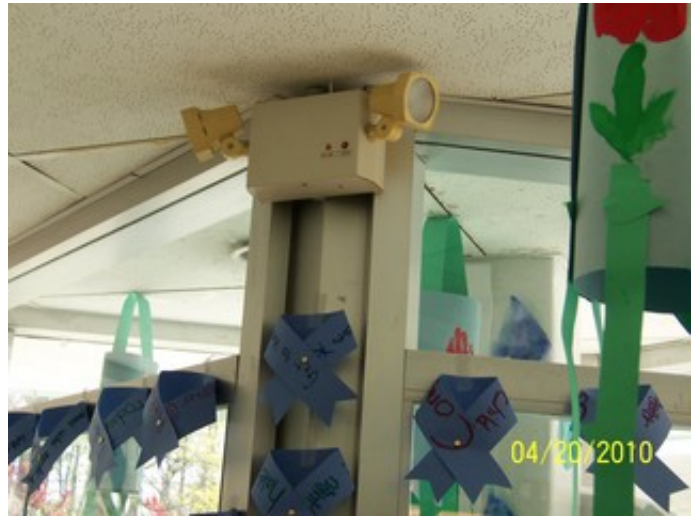
Emergency Lights

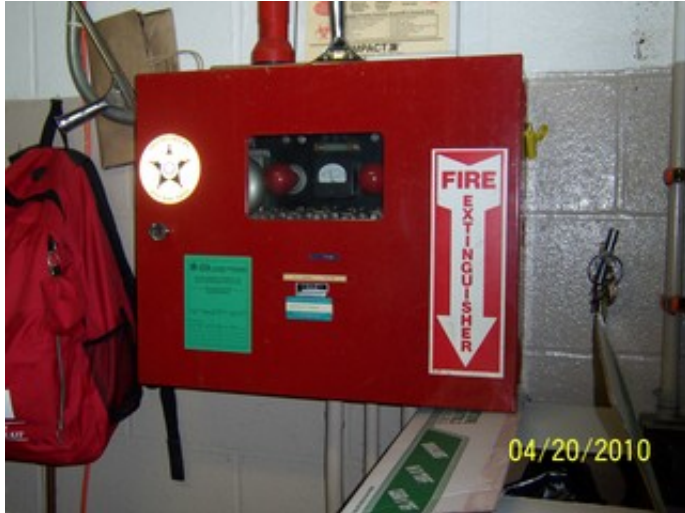
Main Fire Alarm Panel

Recommendations: Recommend providing a complete new Fire Alarm System to meet the Ohio School Design Manual and the Ohio Building Code.

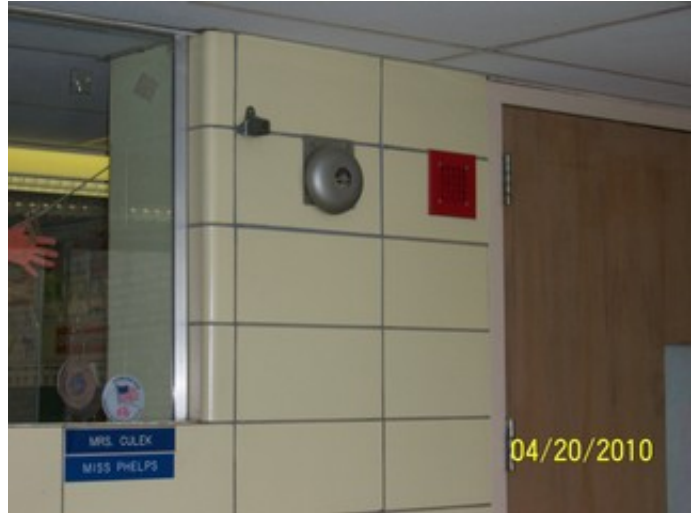
Typical Fire Alarm Devices

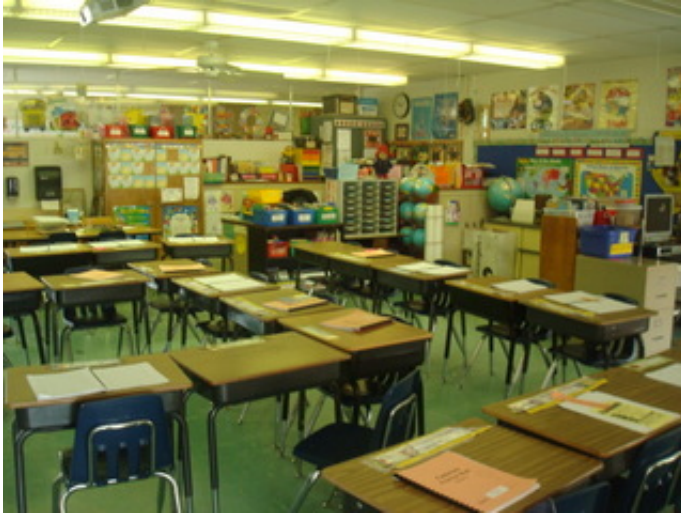
Classroom furniture

Recommendations: Provide for replacement of outdated or inadequate furniture.

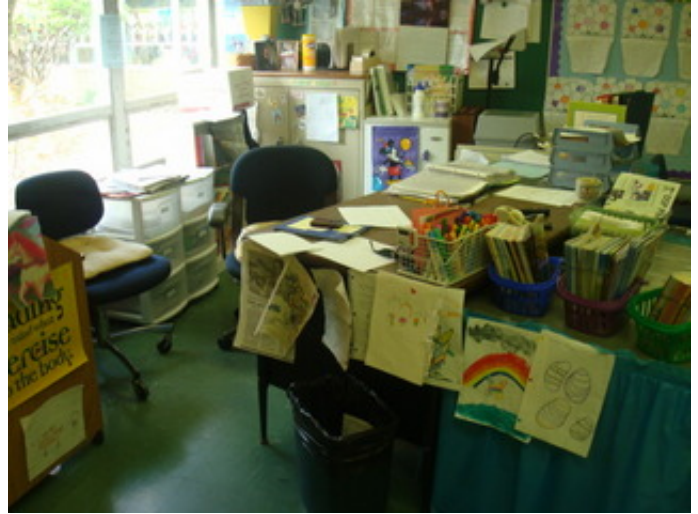
Teacher workstation

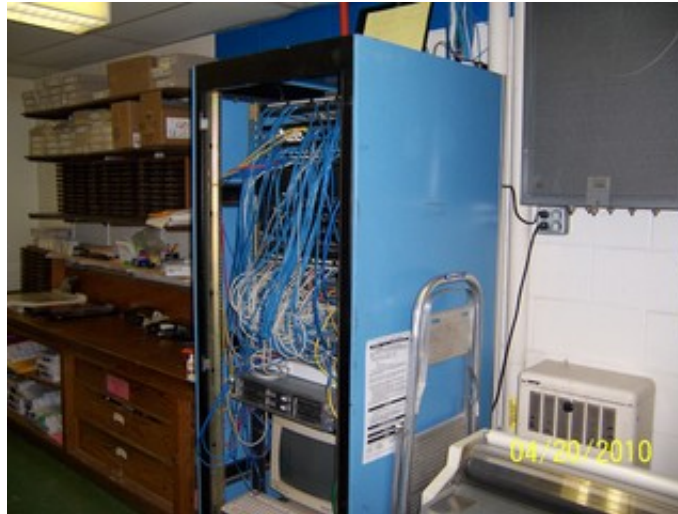
Technology Main Frame

Recommendations: Provide complete replacement of technology systems to meet Ohio School Design Manual requirements for this facility.
