Building Information - Willoughby-Eastlake City SD (45104) - Jefferson Elementary

Program Type	Expedited Local Partnership Program (ELPP)
Setting	Suburban
Assessment Name	Jefferson E_2010_TCI
Assessment Date	2010-03-16
Cost Set:	2010
Building Name	Jefferson Elementary
Building IRN	18077
Building Address	35980 Lake Shore Blvd
Building City	Eastlake
Building Zipcode	44095
Building Phone	440/942-7244
Acreage	6.45
Current Grades	K-5
Teaching Stations	32
Number of Floors	2
Student Capacity	800
Current Enrollment	478
Enrollment Date	2010-04-01
Enrollment Date is the date in which the current enrollment was taken.	
Number of Classrooms	32
Historical Register	NO
Building's Principal	Ms. Barrie Alves
Building Type	Elementary

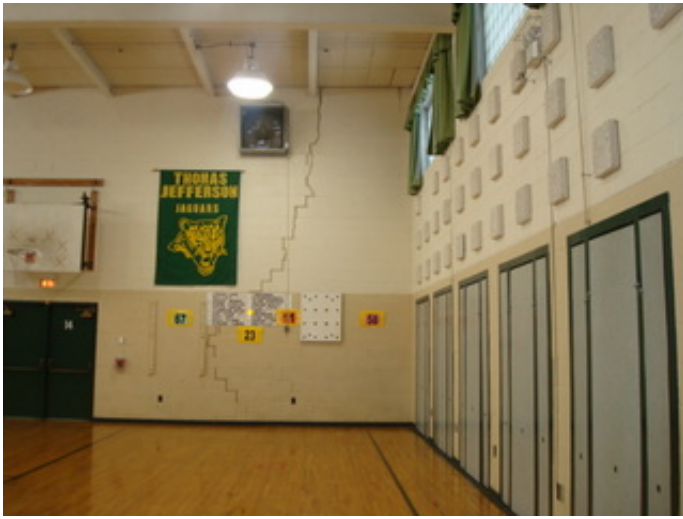
Student Dining/Multipurpose

The 1951 Original Construction Student Dining space has visible signs of damage from an earthquake in 1986. A portion has been repaired and further evidence of cracking is ongoing. Foundation damage is suspected from the same earthquake. Structural evaluation is called for in items G and H. The 1951 Original Construction second floor Corridor walls have diagonal fissures both within the Corridor and occurring in several Classrooms. Similar fissures occur near the Kitchen and Workroom. Areas indicate being saw cut, patched and painted. The 1970 Addition has walls with substantial cracking near the south exit in the classroom and toilet room. Settlement from earthquake is suspected.

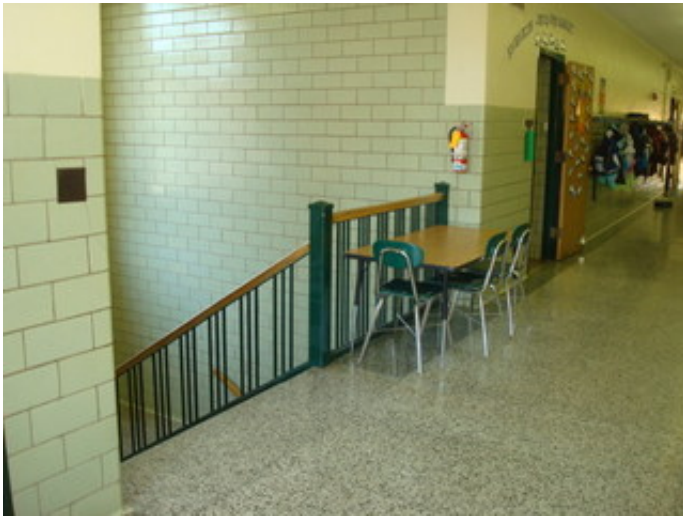
Stair guard and hand rail with fire extinguisher

Recommendations: Provide new automated fire suppression system to meet Ohio School Design Manual guidelines. Provide increased water service of a capacity sufficient to support the fire suppression system, funding included in fire suppression funding. Provide new emergency generator, with funding provided via complete replacement of electrical system in Item D. Provide new handrails to meet the requirements of the Ohio Building Code. Fire-rated enclosure around existing stair tower is not required with due to automatic suppression system. Provide second door to Media Center.

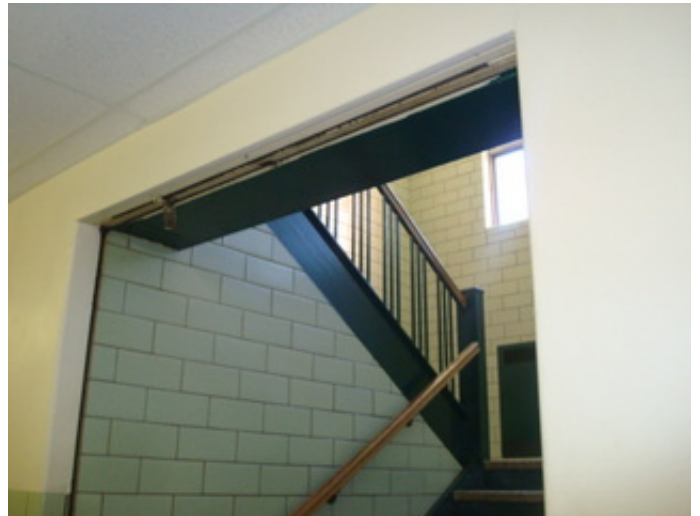
Stair guard and handrail
