Building Information - Willoughby-Eastlake City SD (45104) - Royalview Elementary School

Program Type	Expedited Local Partnership Program (ELPP)
Setting	Suburban
Assessment Name	Royalview E_2010_TCI
Assessment Date	2010-03-16
Cost Set:	2010
Building Name	Royalview Elementary School
Building IRN	32904
Building Address	31500 Royalview Dr
Building City	Willowick
Building Zipcode	44094
Building Phone	440/944-3130
Acreage	9.00
Current Grades	K-5
Teaching Stations	47
Number of Floors	2
Student Capacity	1175
Current Enrollment	829
Enrollment Date	2010-04-01
Enrollment Date is the date in which the current enrollment was taken.	
Number of Classrooms	47
Historical Register	NO
Building's Principal	Ms. Tamee Tucker
Building Type	Elementary

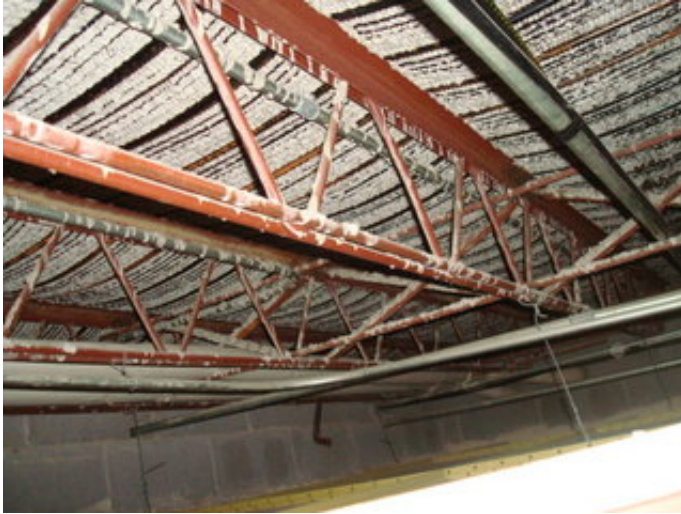
Roof

The overall facility roof is the original system and is failing in several areas. The canopy on the north side of the 1966 Addition is visually unlevel. Beams are substantially rusted and the foundation has settled unlevel.
