Building Information - Willoughby-Eastlake City SD (45104) - Willowick Middle School

Program Type	Expedited Local Partnership Program (ELPP)
Setting	Suburban
Assessment Name	Willowick M_2010_TCI
Assessment Date	2010-03-16
Cost Set:	2010
Building Name	Willowick Middle School
Building IRN	41525
Building Address	31500 Royalview Dr
Building City	Willowick
Building Zipcode	44095
Building Phone	440/943-2950
Acreage	17.70
Current Grades	6-8
Teaching Stations	41
Number of Floors	1
Student Capacity	975
Current Enrollment	637
Enrollment Date	2010-04-01
Enrollment Date is the date in which the current enrollment was taken.	
Number of Classrooms	39
Historical Register	NO
Building's Principal	Ms. Lori Rodman
Building Type	Middle

Building Construction Information - Willoughby-Eastlake City SD (45104) - Willowick Middle School (41525)

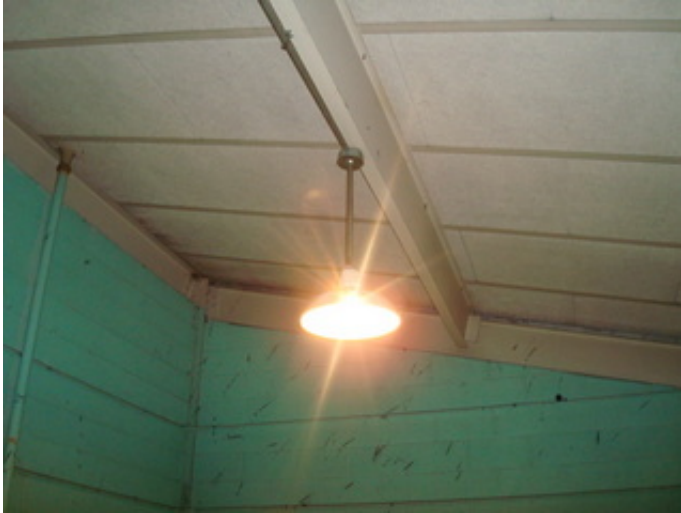
Gymnasium roof

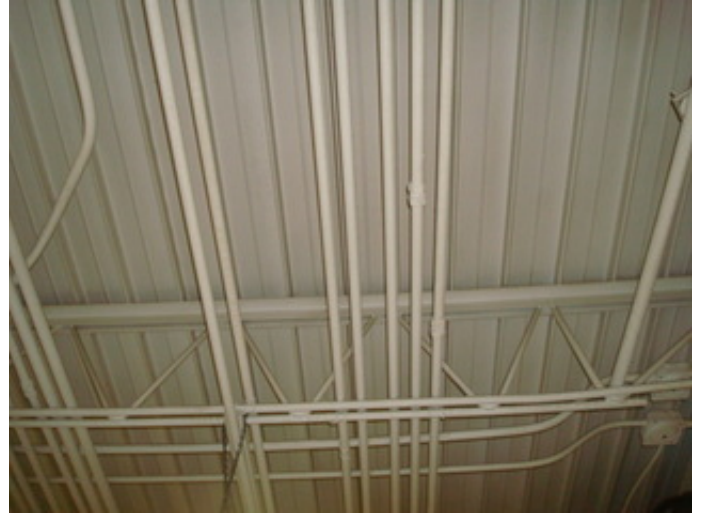
Roof system

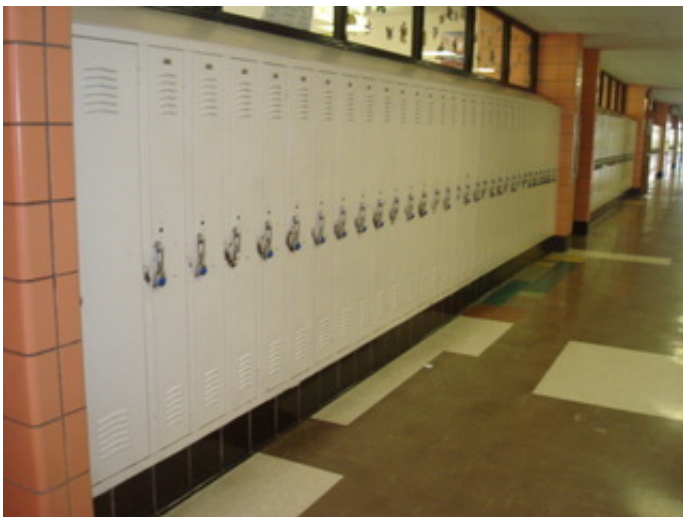
Corridor lockers

Recommendations: Provide complete replacement of finishes and casework due to installation of systems outlined in Items A, C, D, E, K, L, T, and U. Funding for replacement of interior doors is provided in Item O, including doors here noted as being in poor condition. Provide an Art program kiln. Provide new toilet partitions and accessories. Replace kitchen equipment.

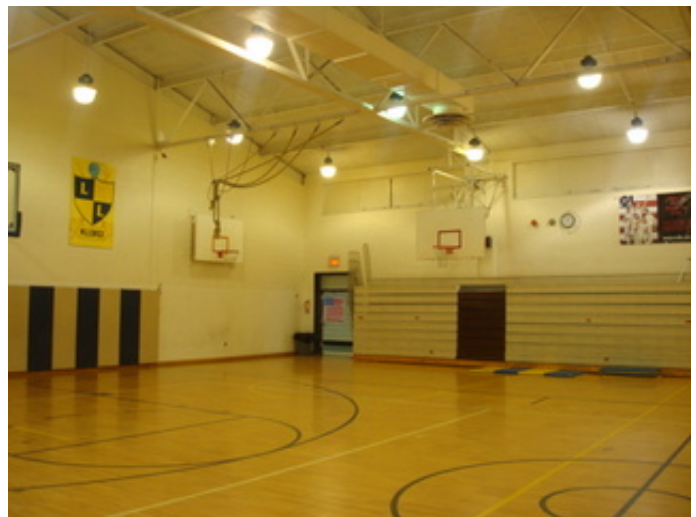
Gymnasium

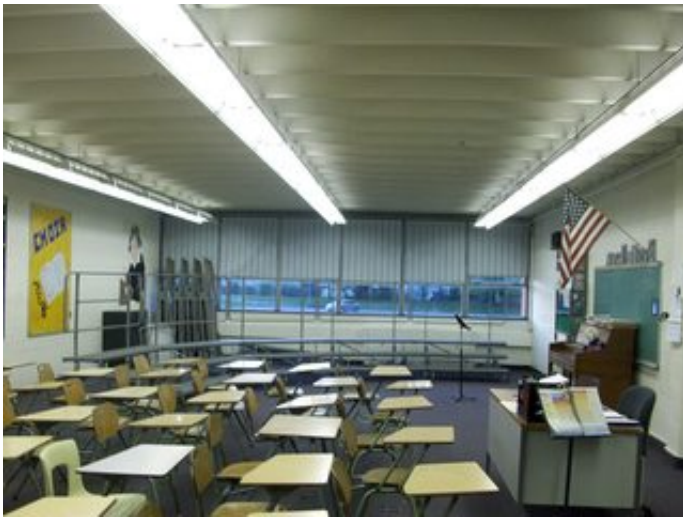
Typical Classroom Lighting

Recommendations: Provide complete replacement of lighting system due to age, of lighting fixtures and installation of a fire protection system.

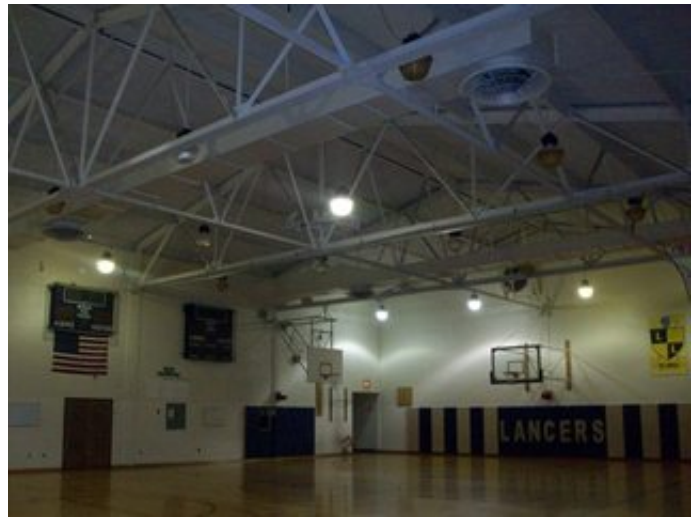
Gymnasium Lighting

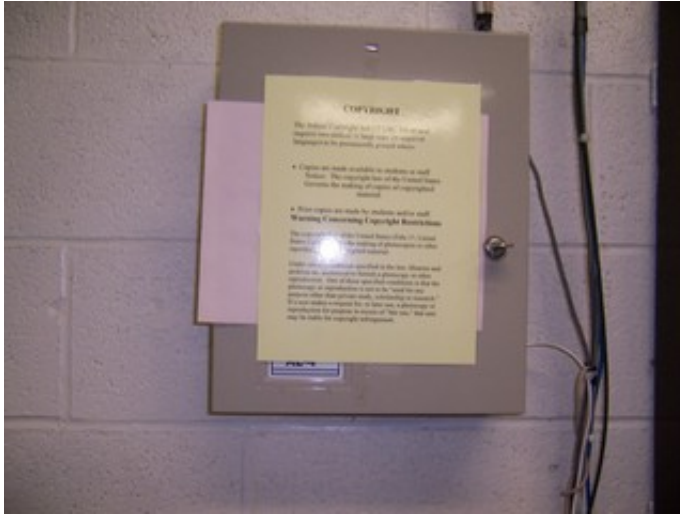
Security Headend Equipment

Recommendations: Provide complete replacement of security system to meet Ohio School Design Manual guidelines. Provide complete replacement of exterior site lighting system to meet Ohio School Design Manual guidelines.

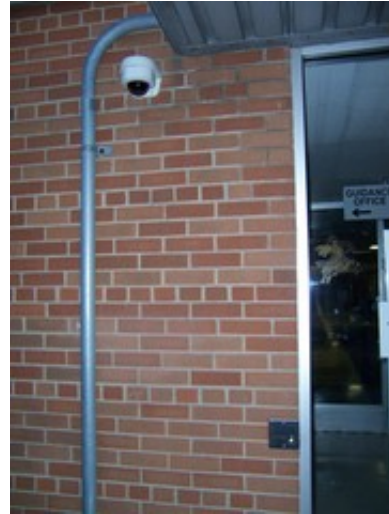
Security Camera and Keypad

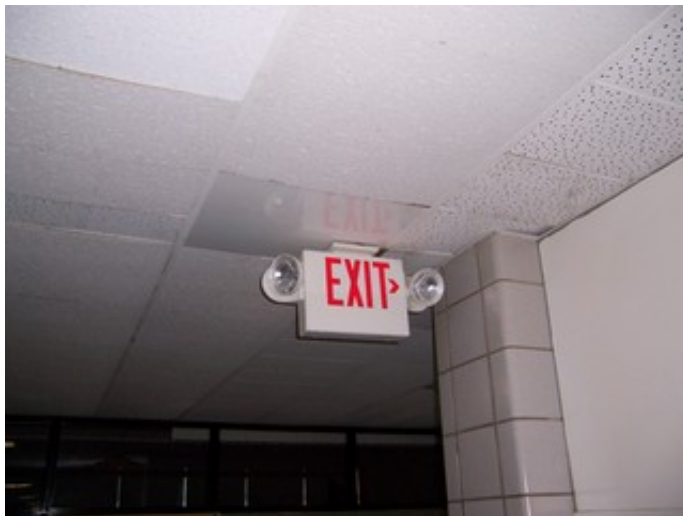
Typical Exit Sign with EM. Heads

Recommendations: Provide complete replacement of the emergency / egress lighting system throughout to meet the Ohio School Design Manual guidelines.

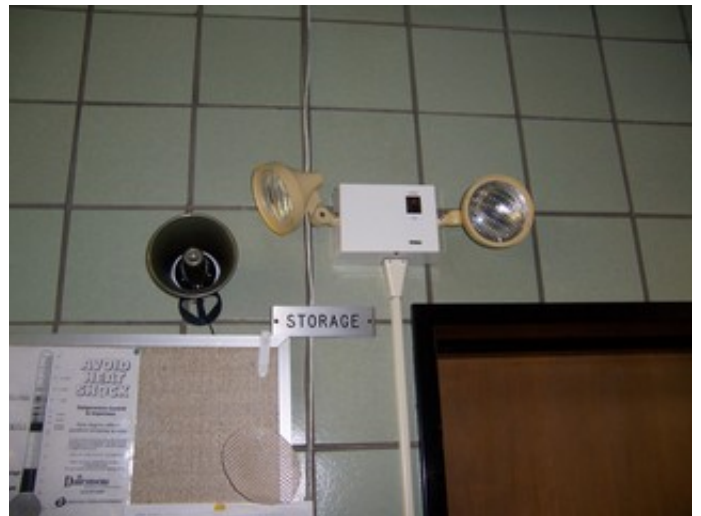
Typical Emergency Light

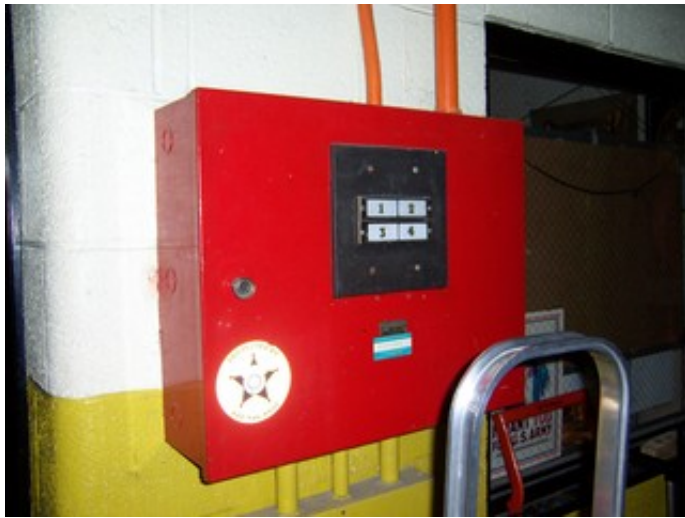
Fire Alarm Control Panel

Recommendations: Recommend providing a complete new Fire Alarm System to meet the Ohio School Design Manual and the Ohio Building Code.

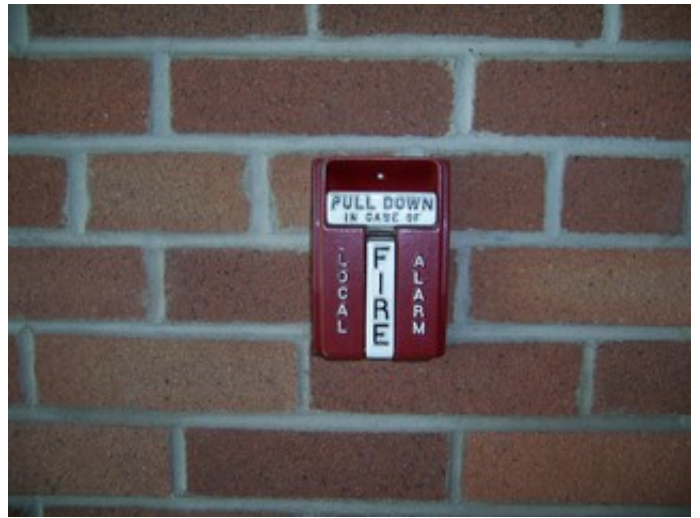
Typical Fire Alarm Device

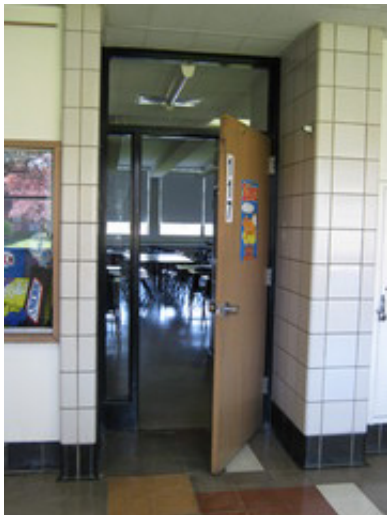
Typical recessed classroom door

Replace Doors:	\$5,000.00	leaf		19 Required	14 Required	4 Required		\$185,000.00	(rework opening and corridor wall to accommodate ADA standards when door opening is set back from edge of corridor and cannot accommodate a wheelchair.)
Remount Restroom Mirrors to Handicapped Height:	\$285.00	per restroom		7 Required	4 Required	3 Required		\$3,990.00	
Sum:			\$349,445.10	\$196,786.00	\$97,749.40	\$51,609.70	\$3,300.00

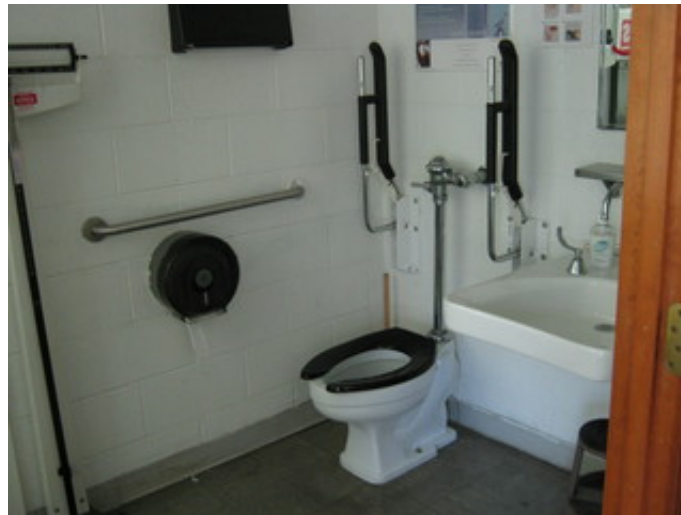
Accessible health clinic restroom

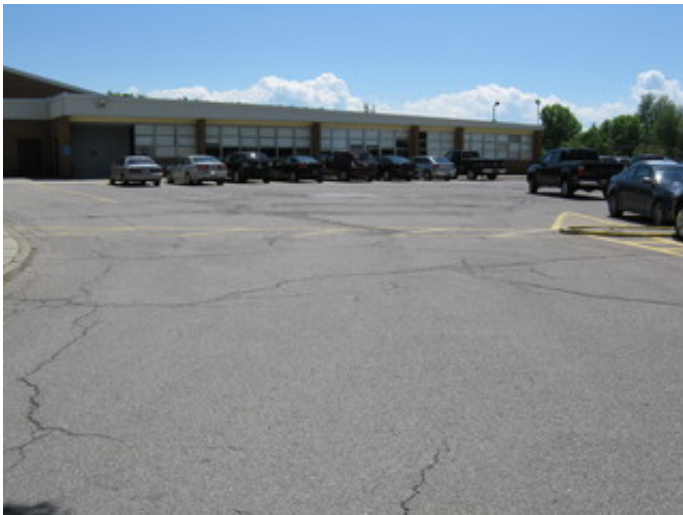
Parking lot

Item	Cost	Unit	Whole Building	1958 Original (1958) 53,910 ft ²	1960 Addition (1960) 20,494 ft ²	1962 Addition (1962) 13,547 ft ²	1975 Addition (1975) 2,860 ft ²	Sum	Comments
Asphalt Paving / New Wearing Course:	\$18.65	sq. yard		10,140 Required				\$189,111.00	(includes minor crack repair in less than 5% of paved area)
Concrete Curb:	\$17.87	in.ft.		310 Required				\$5,539.70	(new)
Concrete Sidewalk:	\$4.69	sq.ft. (Qty)		1,850 Required				\$8,676.50	(5 inch exterior slab)
Provide Concrete Dumpster Pad:	\$2,400.00	each		1 Required				\$2,400.00	(for two dumpsters)
Base Sitework Allowance for Unforeseen Circumstances	\$50,000.00	allowance		Required				\$50,000.00	Include this and one of the next two. (Applies for whole building, so only one addition should have this item)
Sitework Allowance for Unforeseen Circumstances for buildings between 0 SF and 100,000 SF	\$1.50	sq.ft.		Required	Required	Required	Required	\$136,216.50	Include this one <u>or</u> the next. (Each addition should have this item)

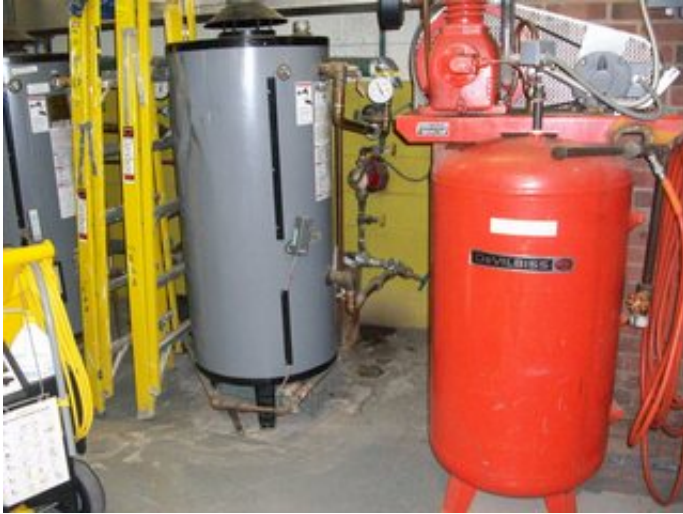
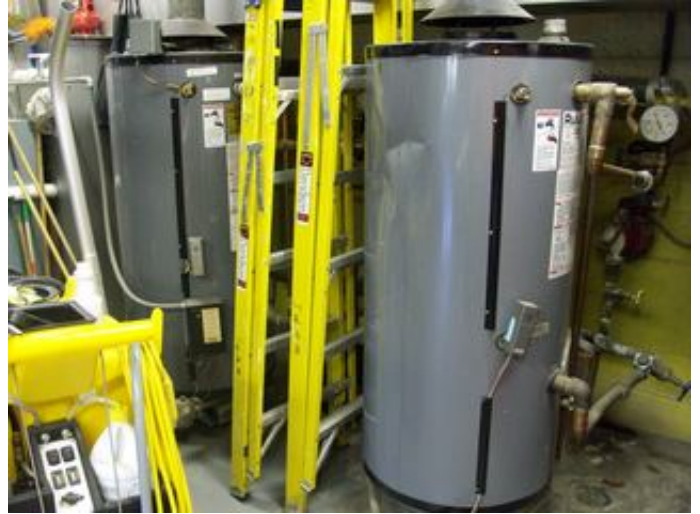
Domestic water heaters

Recommendations: The system does not provide adequate capacity for the future needs of the school. Provide a reduced pressure backflow prevention on the incoming supply, as well as future automated fire suppression system. Funding provided in Item U.

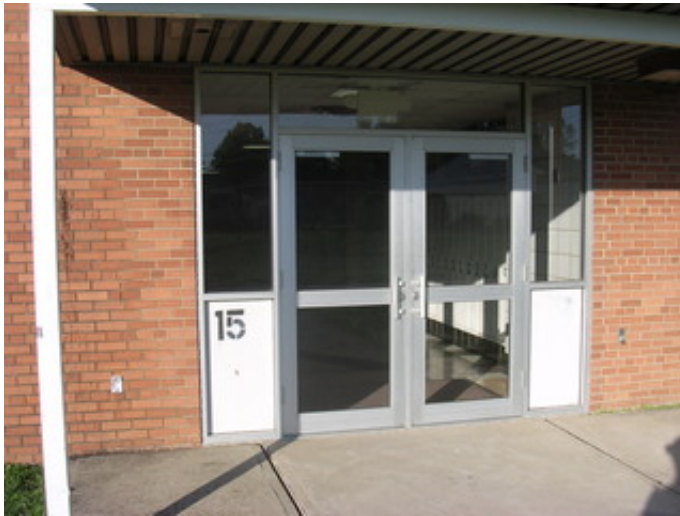
Typical aluminum doors.

Recommendations: Replace all exterior doors to comply with Ohio Building Code, ADA, and Ohio School Design Manual guidelines. Sidelite replacement included in item F.

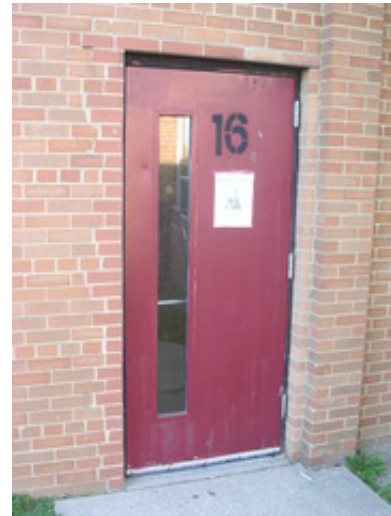
Typical hollow metal doors.

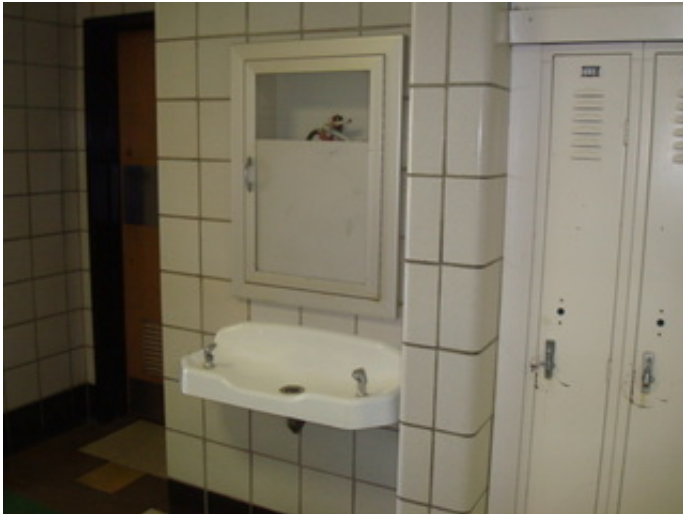
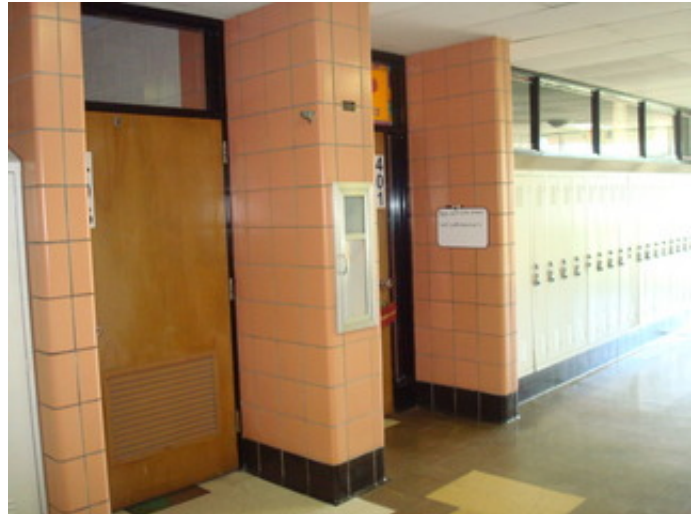
Fire extinguisher cabinet

Recommendations: Provide new automated fire suppression system to meet Ohio School Design Manual guidelines. Provide increased water service of a capacity sufficient to support the fire suppression system, funding included in fire suppression funding.

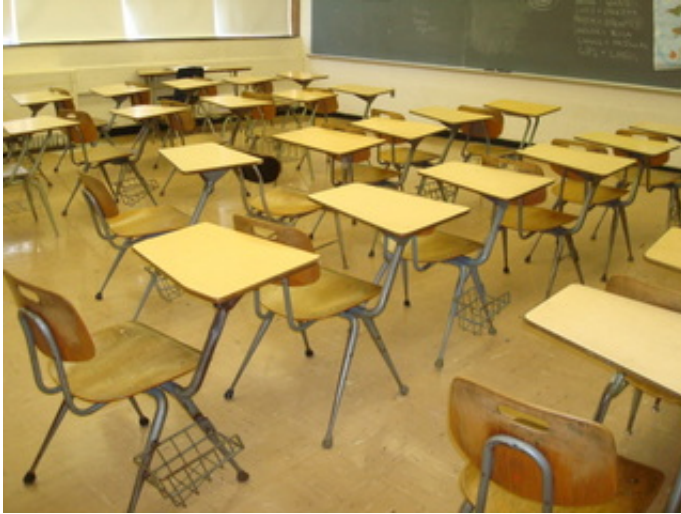
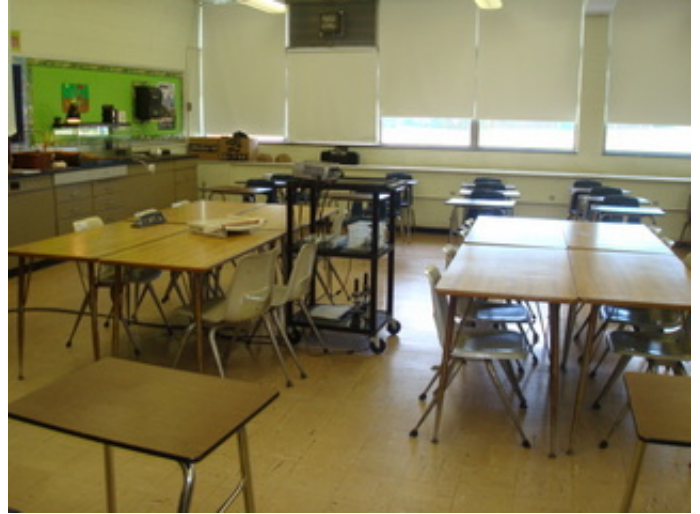
Classroom furniture

Recommendations: Provide for replacement of outdated or inadequate furniture.

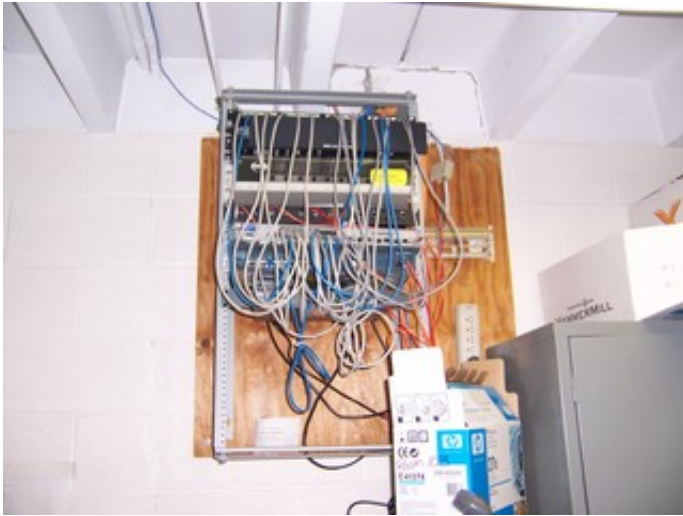
Technology Head-End Equipment Rack

Recommendations: Provide complete replacement of technology systems to meet Ohio School Design Manual requirements for this facility.

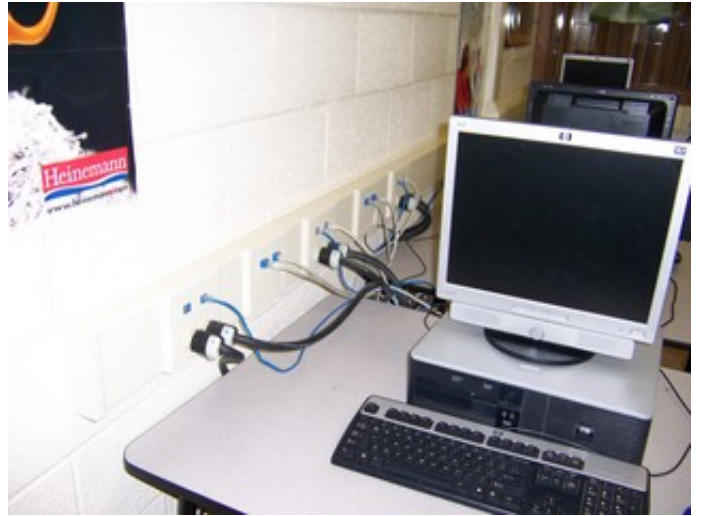
Typical Technology Outlets
